Research Vessel Petrel Baseline Survey of HMAS AE1

April 2018

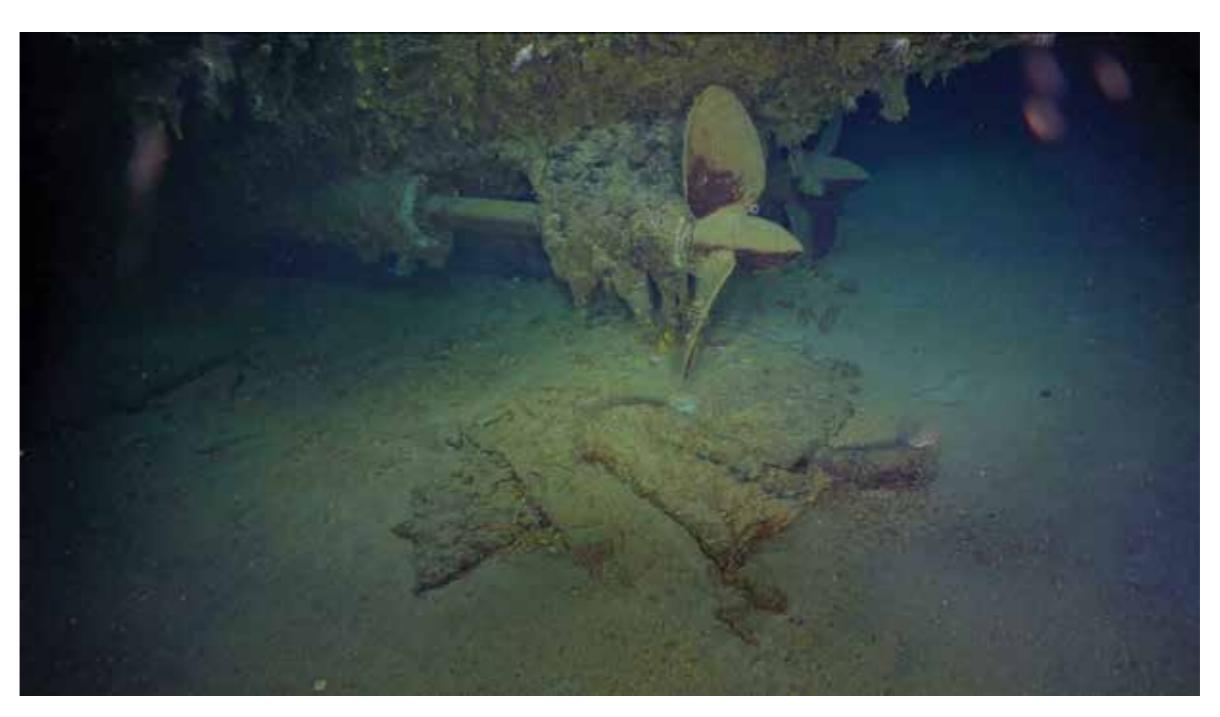
Serial 4 commenced at 0830. On this occasion the current over the wreck was less than on the day before and visibility was excellent. Some time was spent examining the rudder, which has been displaced and is lying under the port propeller, along with its supporting skeg, which has broken off.

Figure 8 – Displaced rudder and supporting skeg lying under port propeller. Image courtesy of Paul G Allen, Find AE1 Ltd, Australian National Maritime Museum and Curtin University. © Navigea Ltd

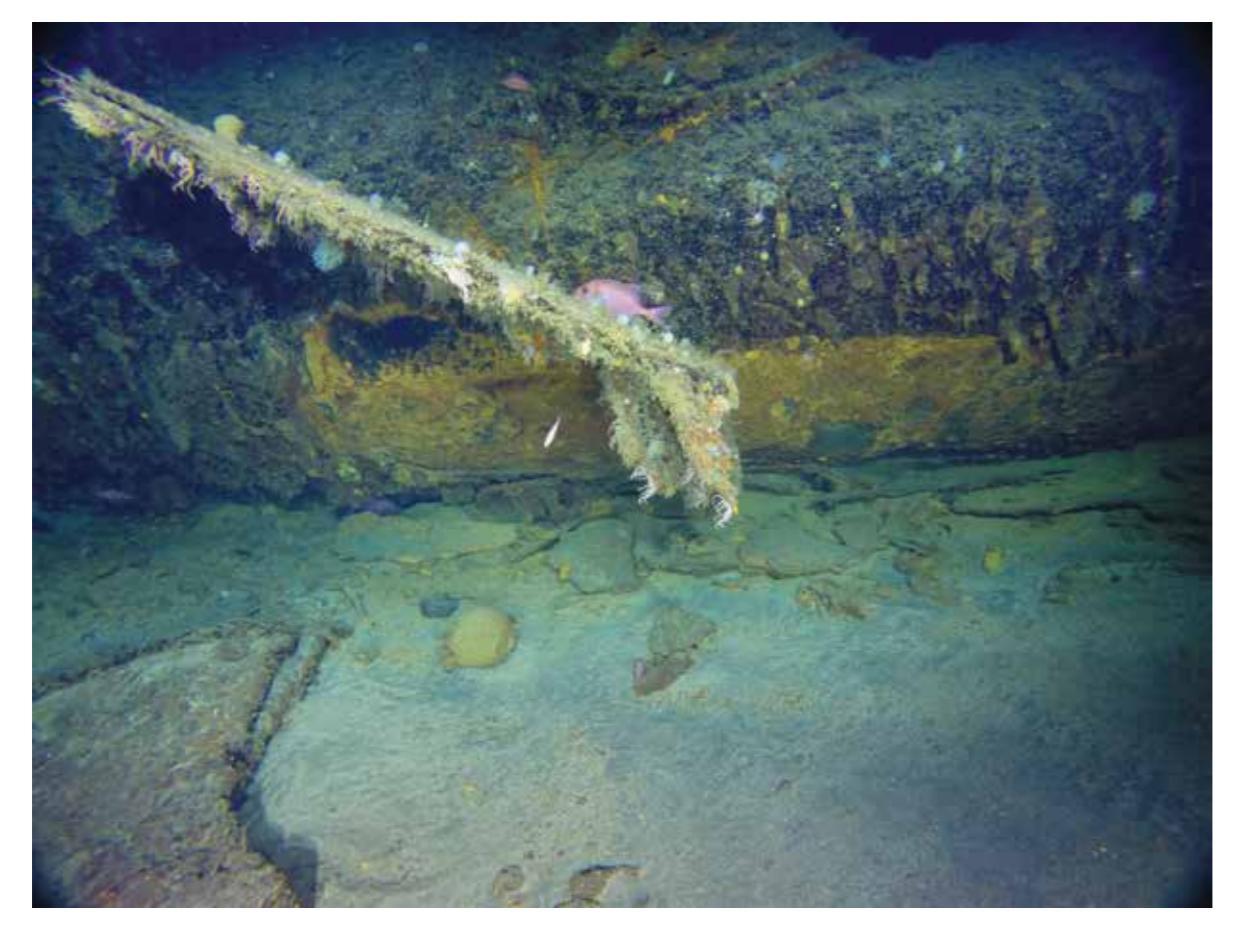
There are several patches where the concretion layer protecting the wreck has dropped away and fresh corrosion is apparent. It is speculated that local seismic activity may be a factor in this situation. Most of the lighter-weight steel plating has disappeared; it is predicted that the wreck will undergo major structural collapse in the next 5-12 years. Further, it is estimated that in 80 years only the conning tower, propellers and shafts and engine bed plates will remain. Additional oceanographic data from the wreck site is required to enable these predictions to be refined. These issues are discussed in detail in Annexes B (see page 47) and D (see page 102).

Figure 11 – Pressure hull near starboard after hydroplane, showing concretion delamination. Image courtesy of Paul G Allen, Find AE1 Ltd, Australian National Maritime Museum and Curtin University. © Navigea Ltd

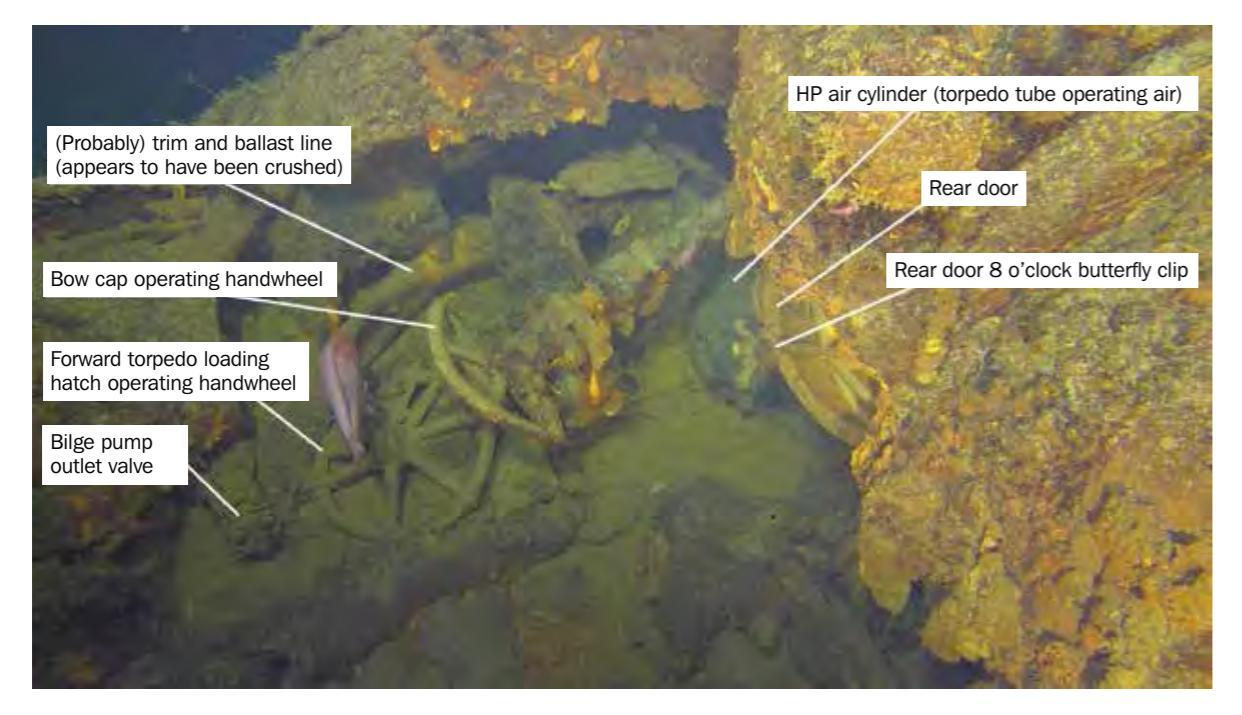
Figure 19 – Forward torpedo tube rear door butterfly clip, open view from starboard. Image courtesy of Paul G Allen, Find AE1 Ltd, Australian National Maritime Museum and Curtin University. © Navigea Ltd

We do not think this was part of the accident sequence; the rear door remains shut, indicating that it was not the source of any flooding. This is corroborated by the implosion over this compartment as flooding would have tended to equalise the external water pressure, making implosion less likely if the compartment had flooded through the forward torpedo tube.

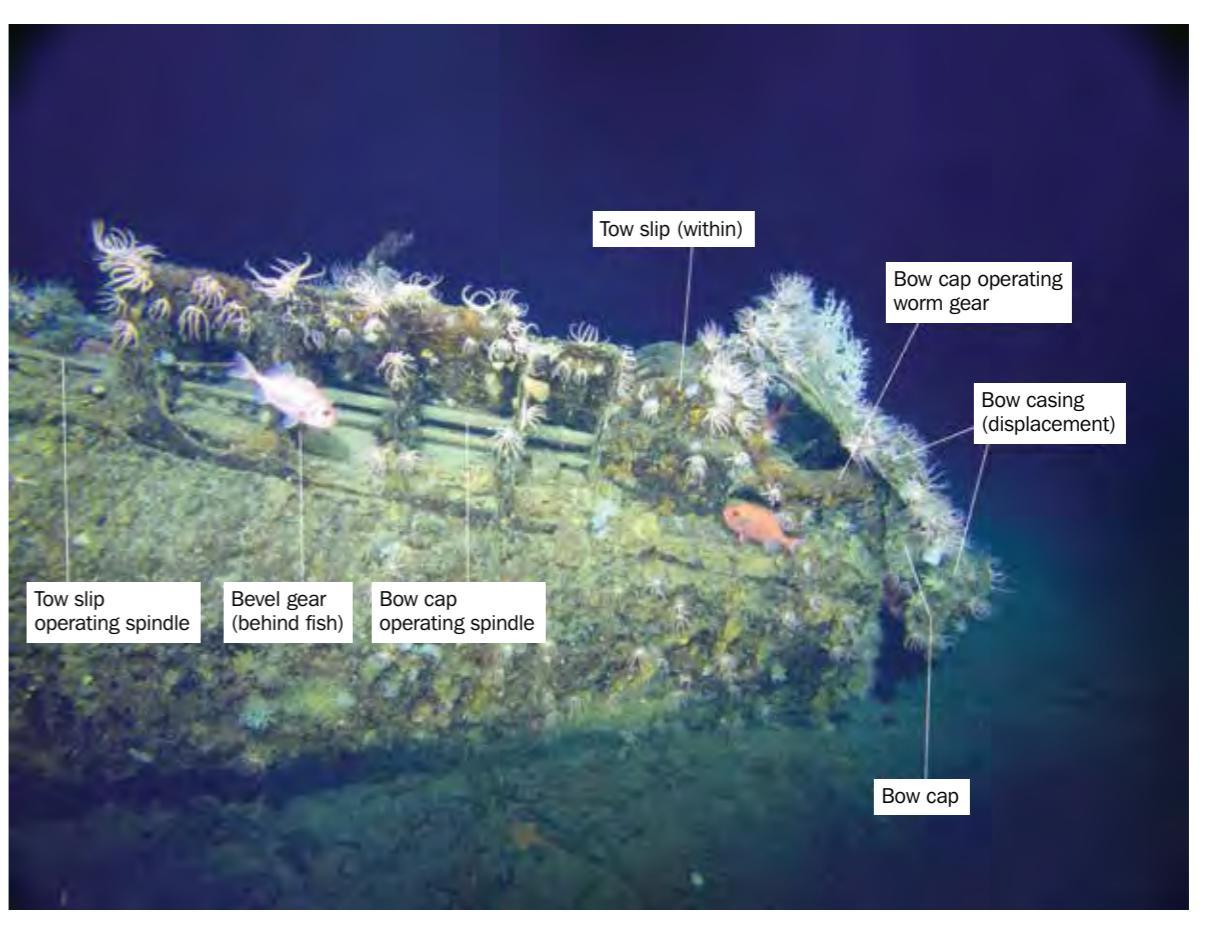
It is possible that the bow cap was also opened as a precaution, to reduce the time necessary to prepare the tube for firing at the same time and for the same reasons as the stern cap. In this case the bow cap was only partially opened to protect the bow cap operating arrangement from damage from the bow wave or flotsam as the submarine moved around on the surface. Alternatively, it could also have been opened as part of a training drill.

We have considered the possibility that the sinking process could have distorted the rod gearing and worm gearing opening arrangements sufficiently to partially open the bow cap, but on balance think the absence of significant impact damage to the bow militates against this explanation.

Figure 20 – Bow cap operating arrangements. Image courtesy of Paul G Allen, Find AE1 Ltd, Australian National Maritime Museum and Curtin University. © Navigea Ltd

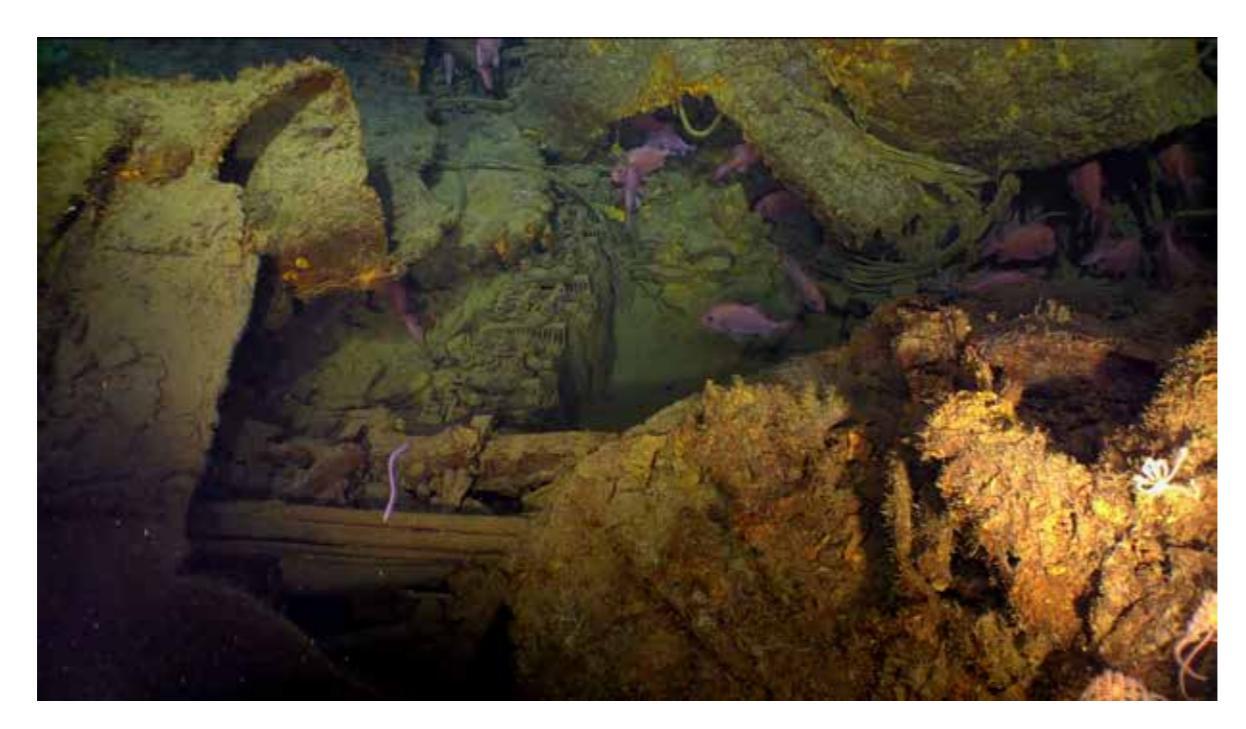
A portion of the forward main battery is visible. This was unexpected. The batteries were secured in a waterproof metal tank with a top cover made up of a double layer of teak boards in turn covered with two layers of painted canvas so as to be waterproof, and was tested to 3 psi (20.68 kilopascals) air pressure to check that it was sealed.¹² These arrangements have obviously broken down with the passage of time. Why only a portion of the battery is visible and there is no sign of the after section of the battery is not known.

Figure 21 – Battery cells visible in the control room. Image courtesy of Paul G Allen, Find AE1 Ltd, Australian National Maritime Museum and Curtin University. © Navigea Ltd

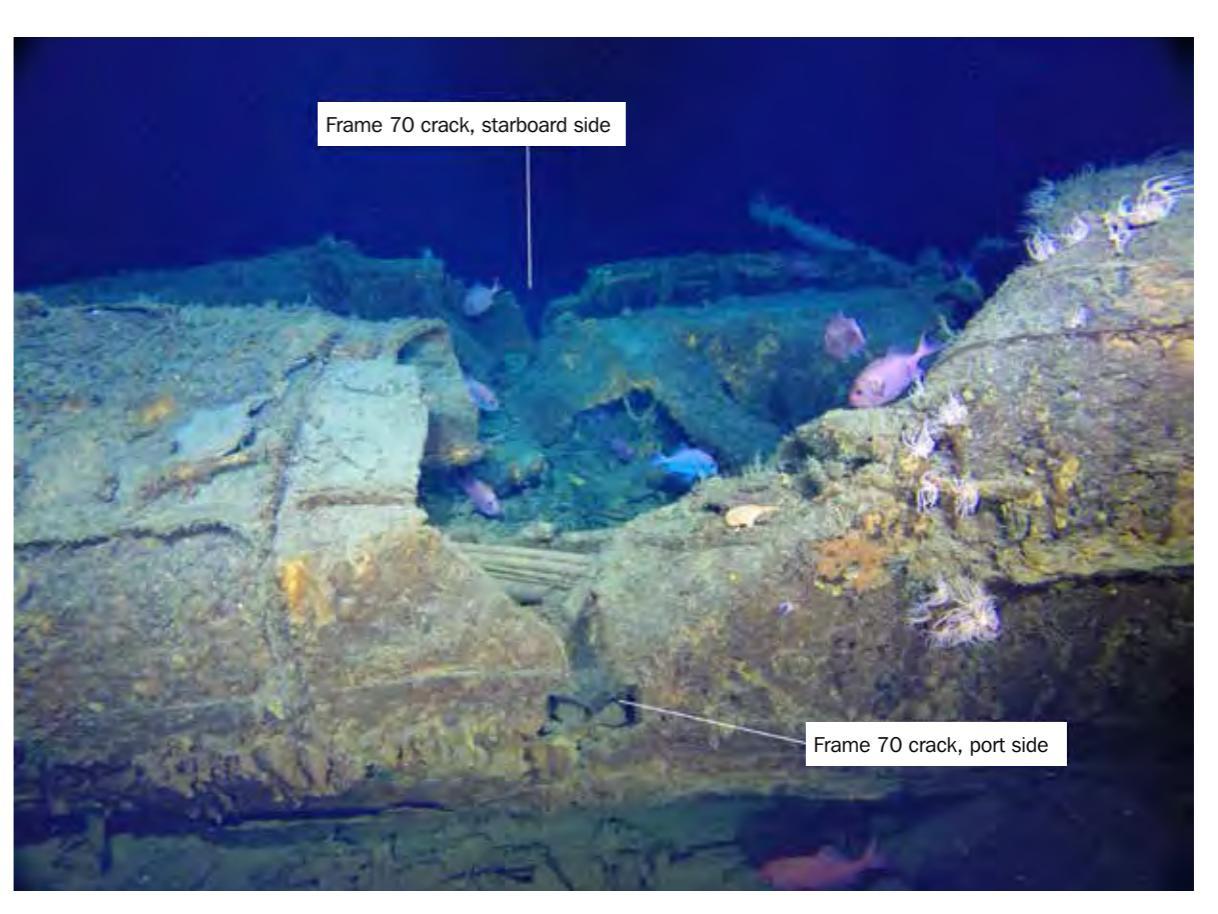
It would appear that the keel and pressure hull have broken in the vicinity of frame 70¹³ and this could explain why one battery section is visible and one has dropped from sight. The apparent split in the pressure hull/keel will be considered further in discussing the sinking process below.

Figure 22 – Pressure hull split at frame 70. Image courtesy of Paul G Allen, Find AE1 Ltd, Australian National Maritime Museum and Curtin University. © Navigea Ltd

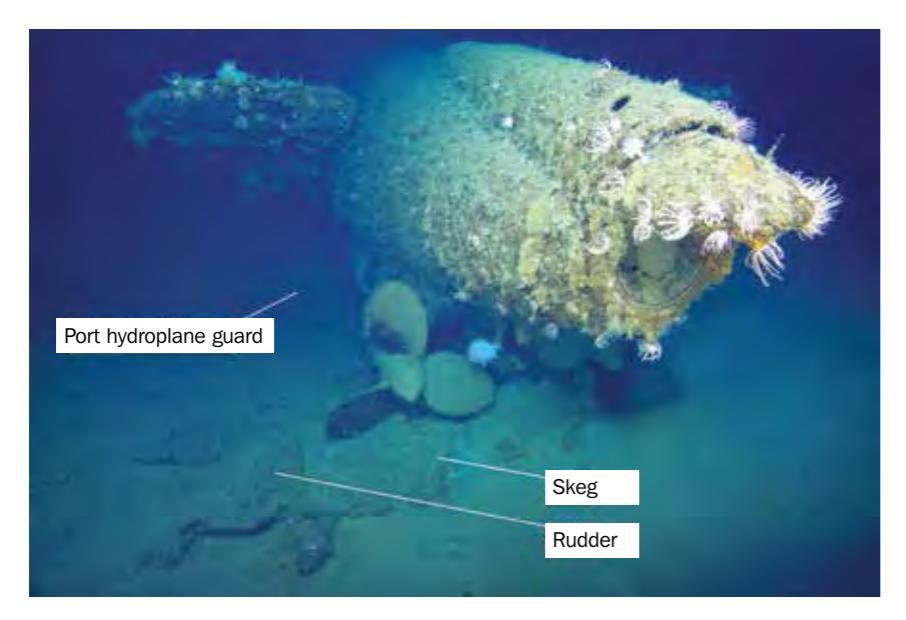
The skeg has broken away from the pressure hull and the rudder has been displaced; both are lying on the sea floor in the vicinity of the port propeller.

Figure 24 – Rudder and skeg lying on the sea floor. Image courtesy of Paul G Allen, Find AE1 Ltd, Australian National Maritime Museum and Curtin University. © Navigea Ltd

Significant force would be required to break the skeg and displace the rudder. This damage is consistent with the initial and major impact of a stern-first grounding. This will be considered in greater detail in the section dealing with the sinking process.

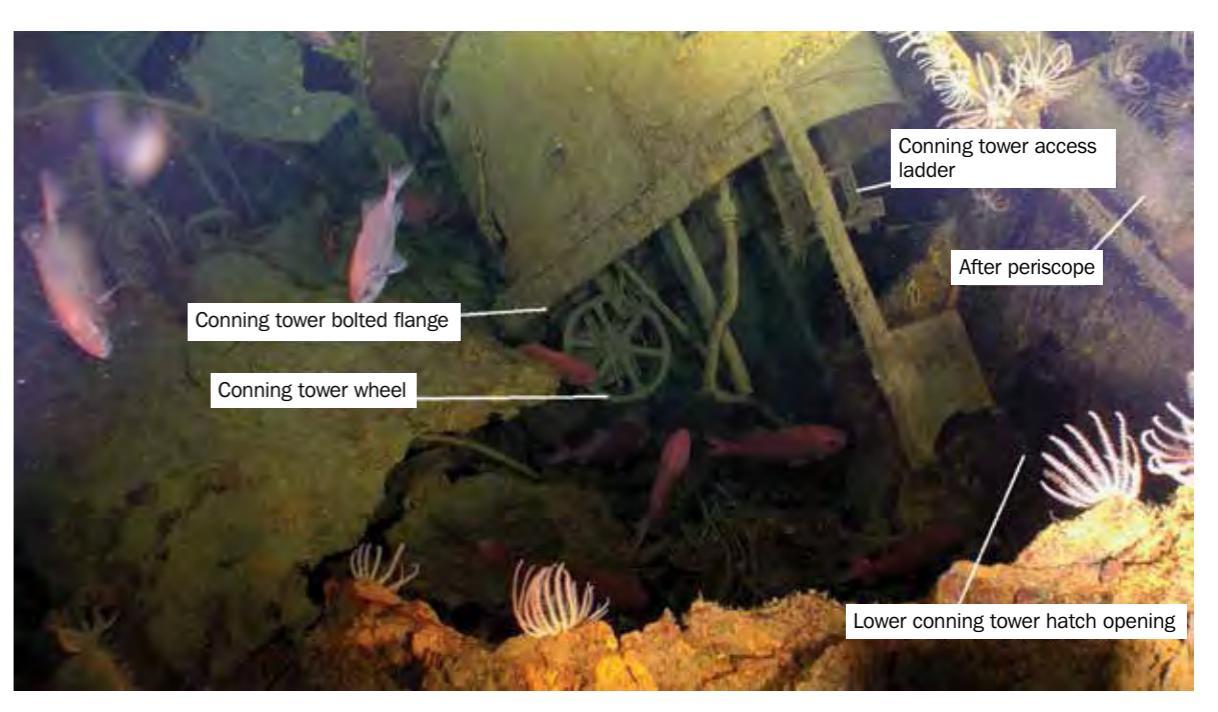
The opening in the pressure hull for the conning tower lower hatch has been identified because it is in a portion of the pressure hull on which the after periscope is mounted. The coaming and hatch are missing; just the opening remains. This is another unexplained puzzle and is discussed further in Annex C (see page 59).

Figure 25 – Conning tower lower hatch opening. Image courtesy of Paul G Allen, Find AE1 Ltd, Australian National Maritime Museum and Curtin University. © Navigea Ltd

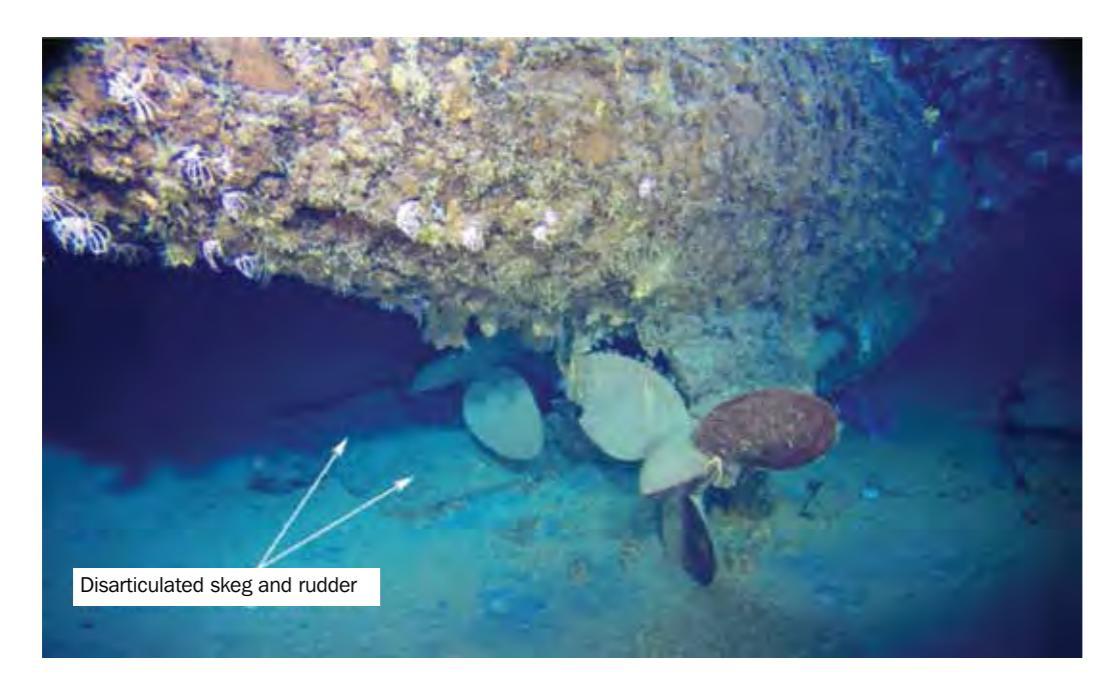
Figure 4 – AE1's disarticulated skeg and rudder are lying flat on the seabed beneath the stern. Note the relatively undamaged condition of the propellers. Image courtesy of Paul G Allen, Find AE1 Ltd, Australian National Maritime Museum and Curtin University. © Navigea Ltd

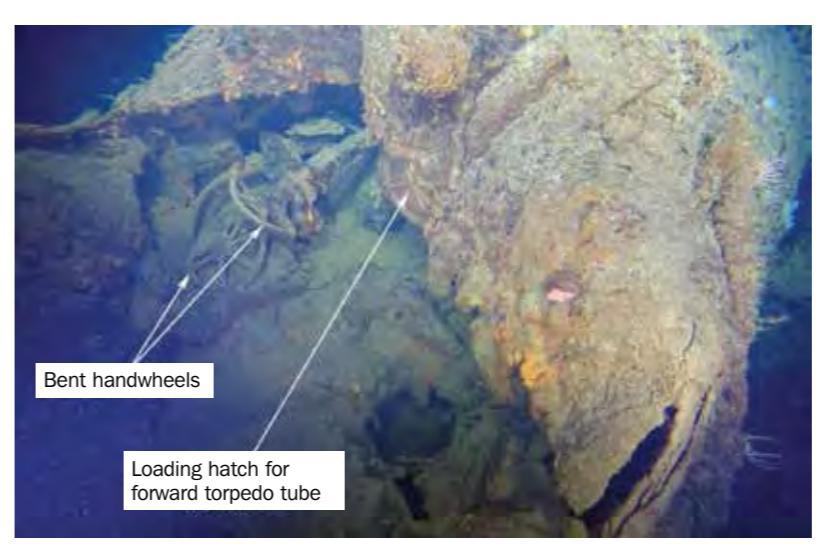
Figure 6 – AE1's devastated forward torpedo compartment, showing folded hull plating and the damage to handwheels wrought by the implosion event. Image courtesy of Paul G Allen, Find AE1 Ltd, Australian National Maritime Museum and Curtin University. © Navigea Ltd

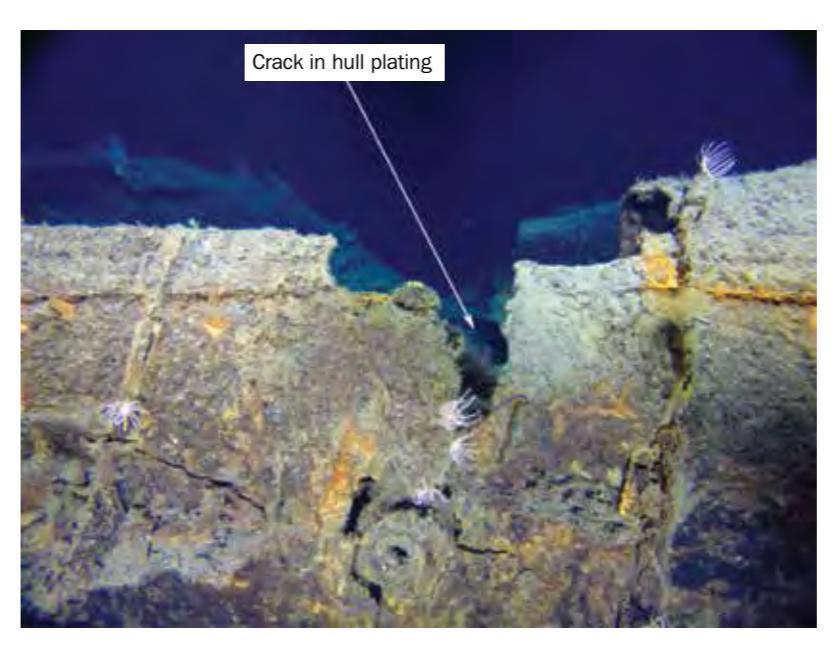
Figure 7 – Vertical fissure in AE1's port side pressure hull at Frame 70. Image courtesy of Paul G Allen, Find AE1 Ltd, Australian National Maritime Museum and Curtin University. © Navigea Ltd

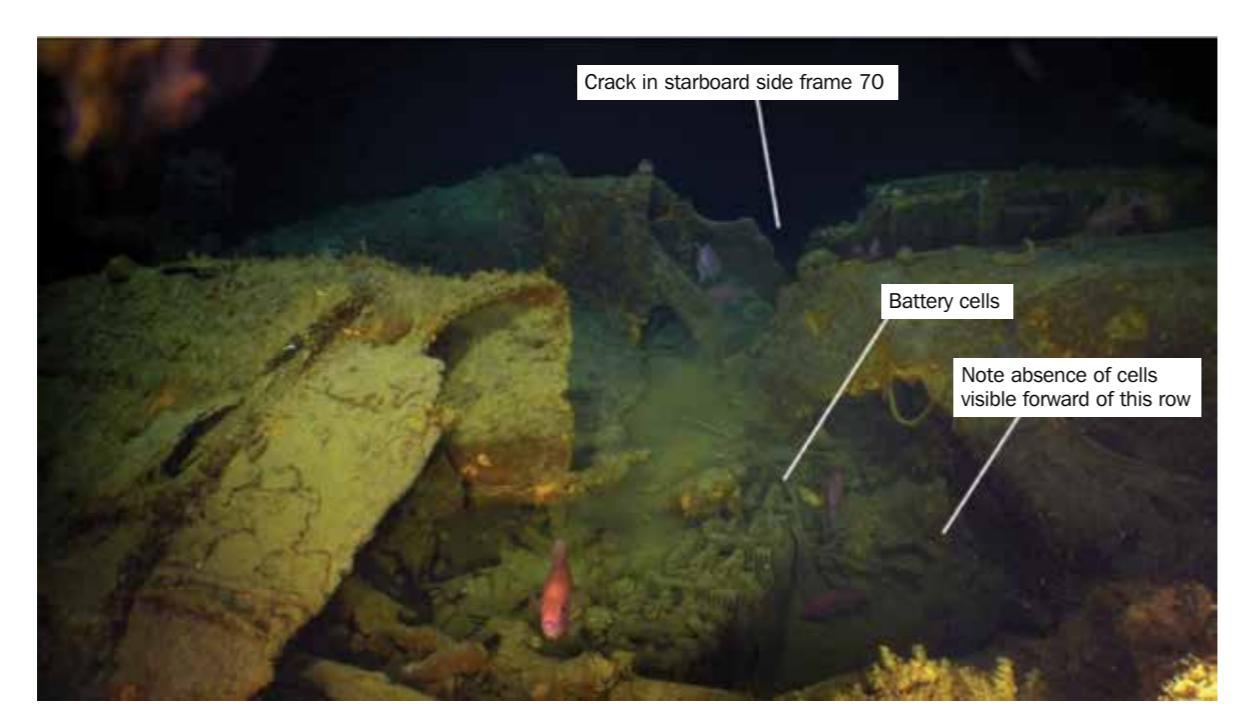
Figure 6 – Control room implosion area and Frame 70 crack in pressure hull. Image courtesy of Paul G Allen, Find AE1, Australian National Maritime Museum and Curtin University. © Navigea Ltd

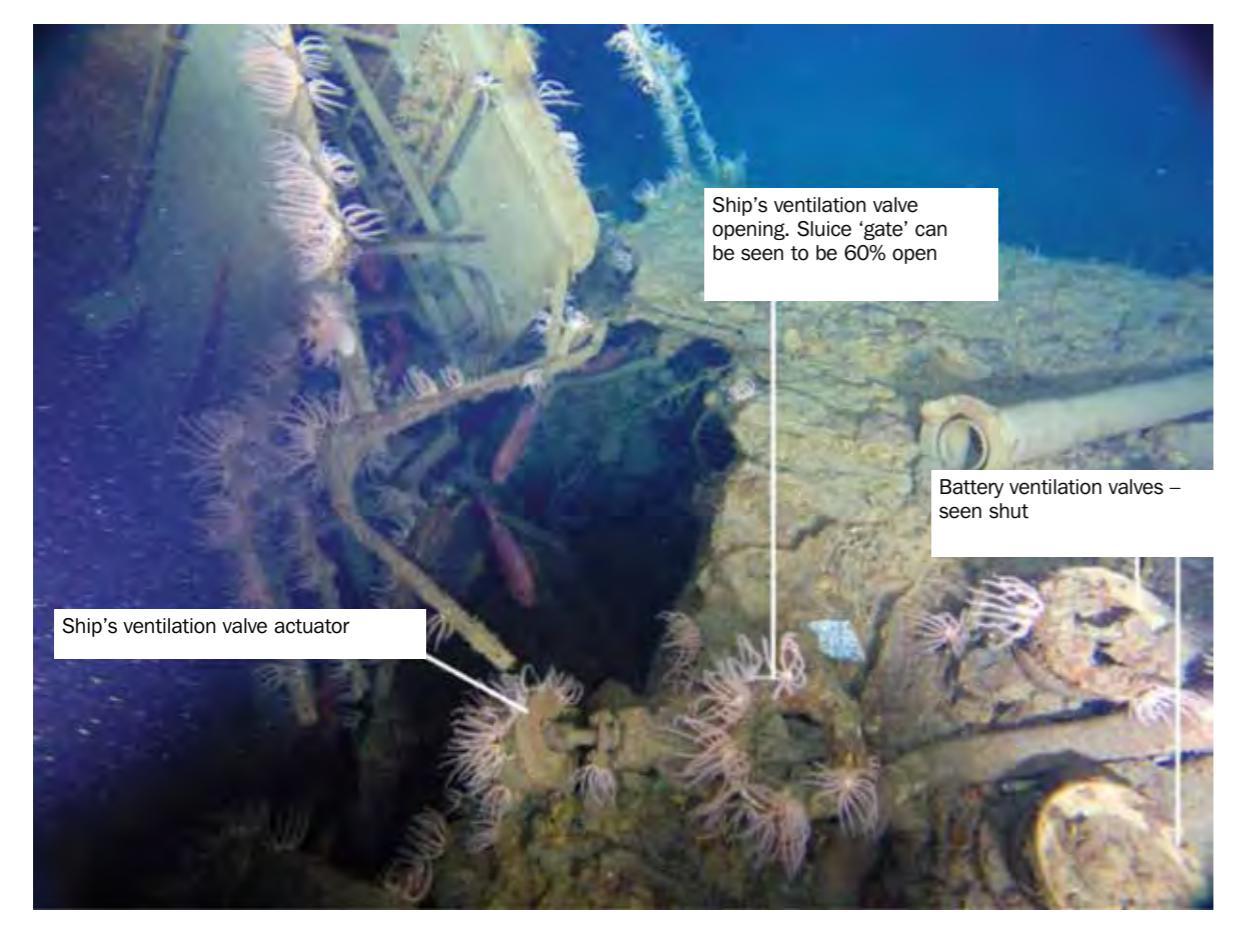
The ship's ventilation hull valve has been found 60% open; this may have initiated a sequence that led to the flooding of the after end of the submarine, causing it to sink, out of control, past its crush depth, leading to an implosion that would have killed the crew instantaneously. The submarine then appears to have sunk stern first to the bottom. We don't know why the valve was not shut prior to diving.

Figure 24 – Ship's ventilation hull valve. Image courtesy of Paul G Allen, Find AE1, Australian National Maritime Museum and Curtin University. © Navigea Ltd

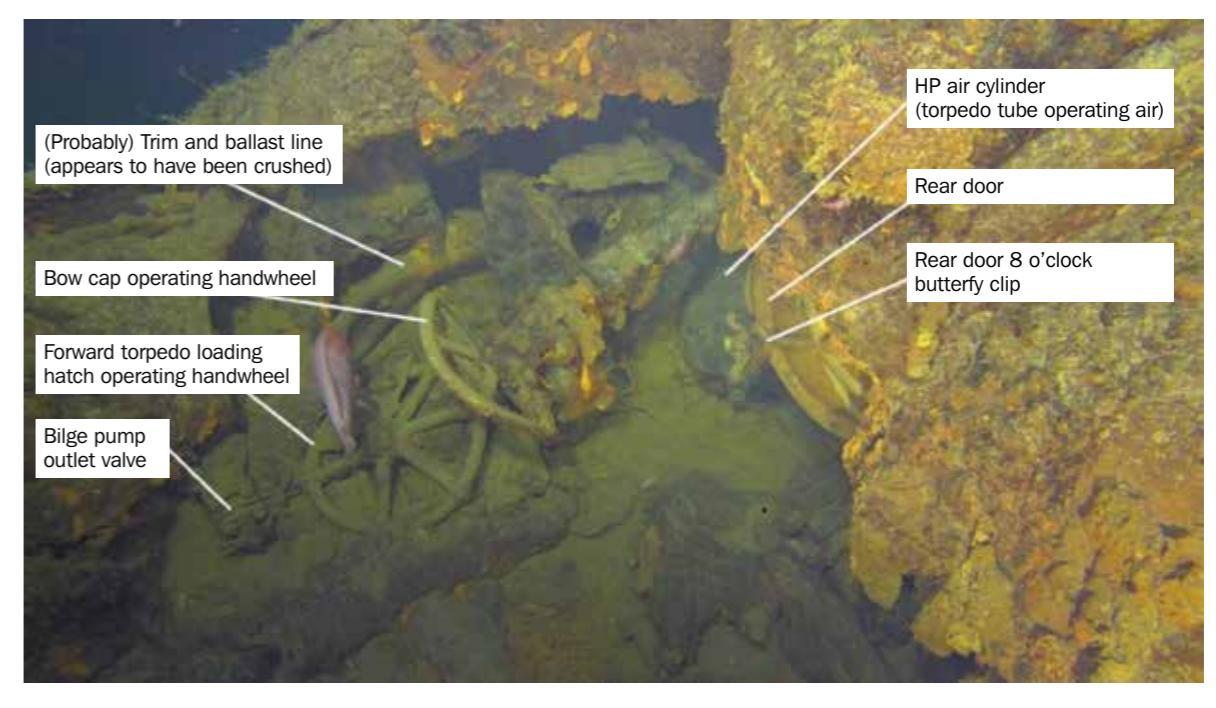
Figure 31 – Forward torpedo compartment implosion area (see also Figure 4, page 67). Image courtesy of Paul G Allen. Find AE1. Australian National Maritime Museum and Curtin University. © Navigea Ltd

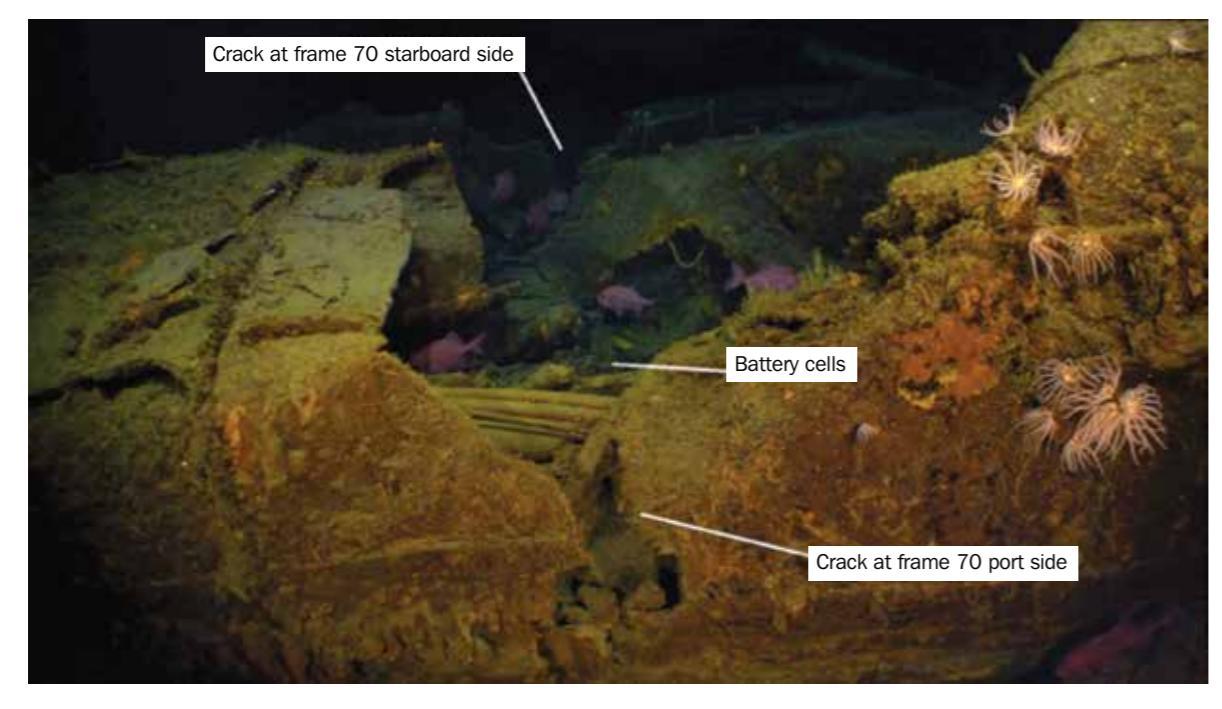
Figure 32 – Side-on view of Frame 70 pressure hull crack. Image courtesy of Paul G Allen, Find AE1, Australian National Maritime Museum and Curtin University. © Navigea Ltd

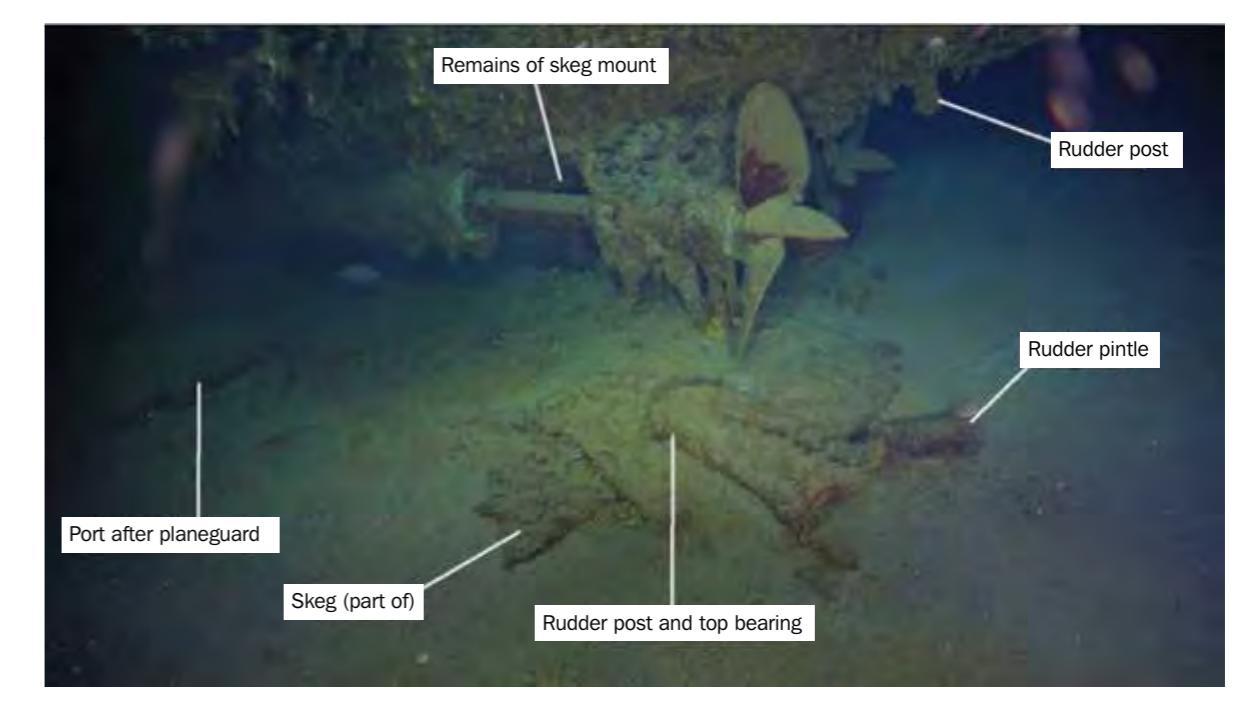
Figure 36 - Rudder and skeg on seabed. Image courtesy of Paul G Allen, Find AE1, Australian National Maritime Museum and Curtin University. © Navigea Ltd

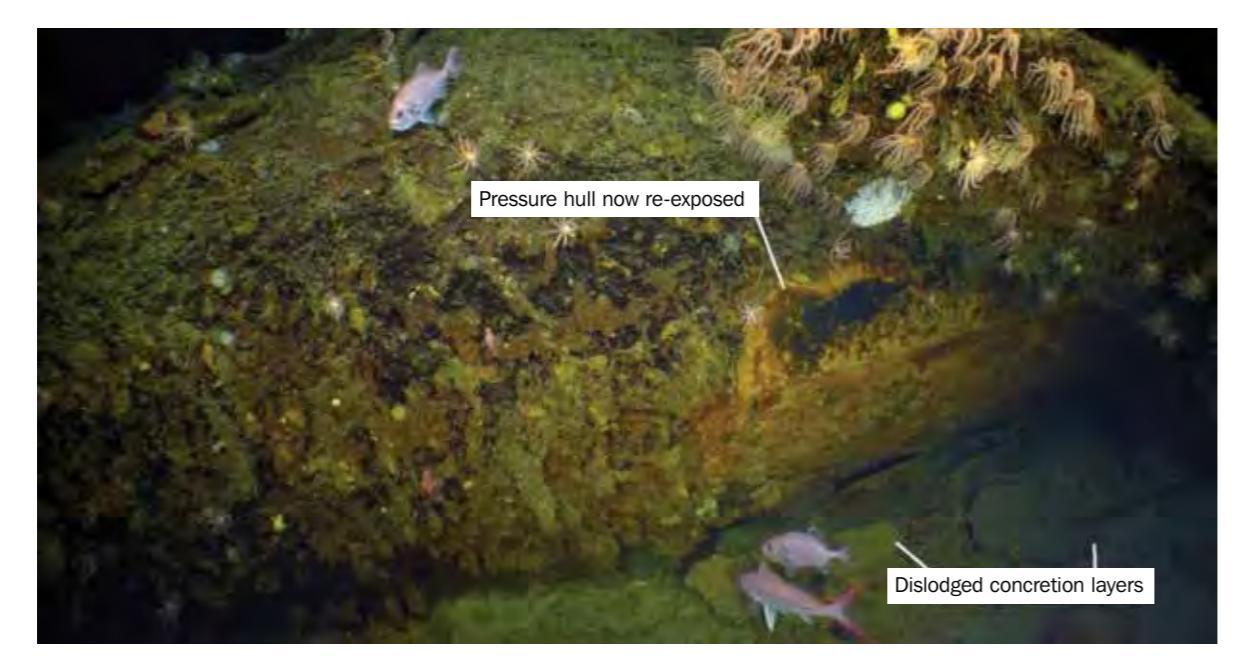
Figure 47 – Example of concretion delamination under foreplane. Image courtesy of Paul G Allen, Find AE1, Australian National Maritime Museum and Curtin University. © Navigea Ltd

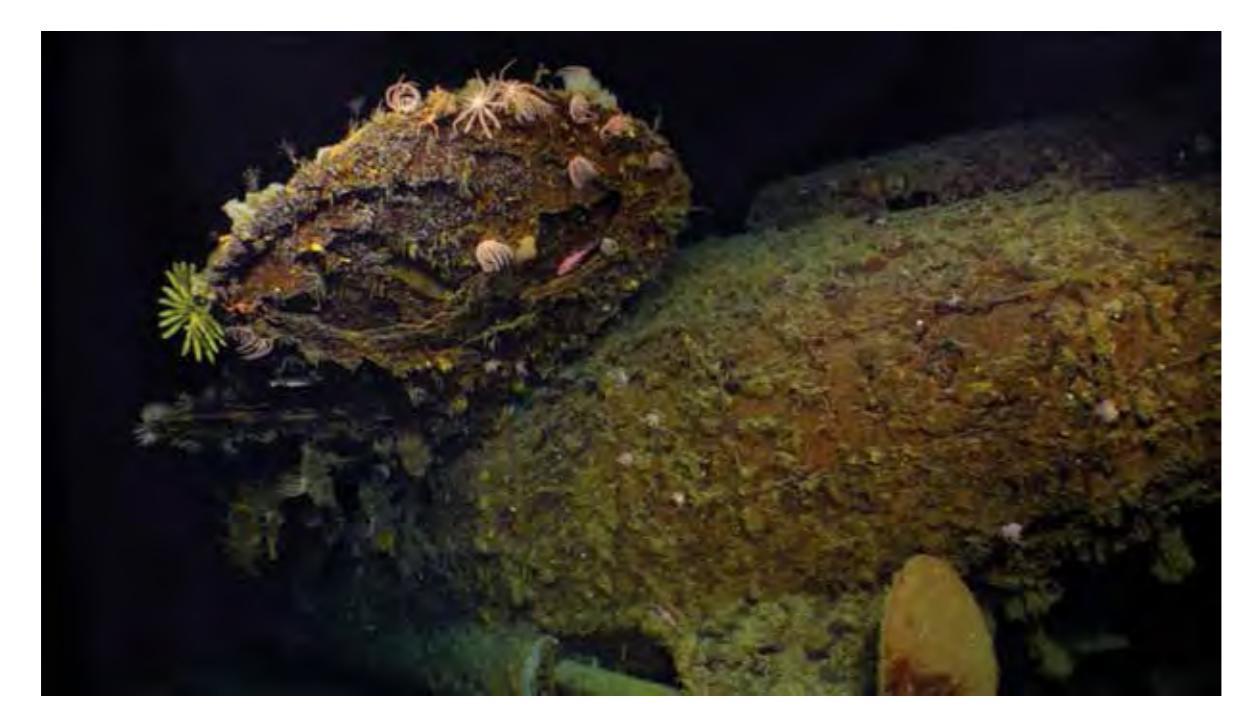
Figure 48 – Example of plate corrosion under port afterplane. Image courtesy of Paul G Allen, Find AE1, Australian National Maritime Museum and Curtin University. © Navigea Ltd

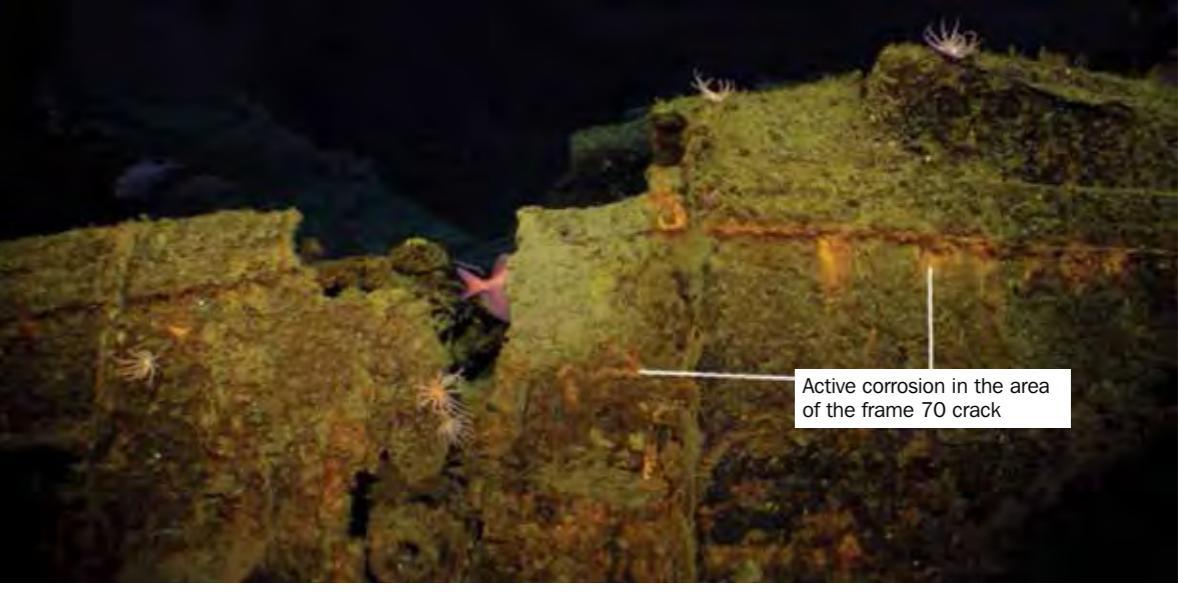
Figure 49 – Examples of (the many) areas of active corrosion. Image courtesy of Paul G Allen, Find AE1, Australian National Maritime Museum and Curtin University. © Navigea Ltd

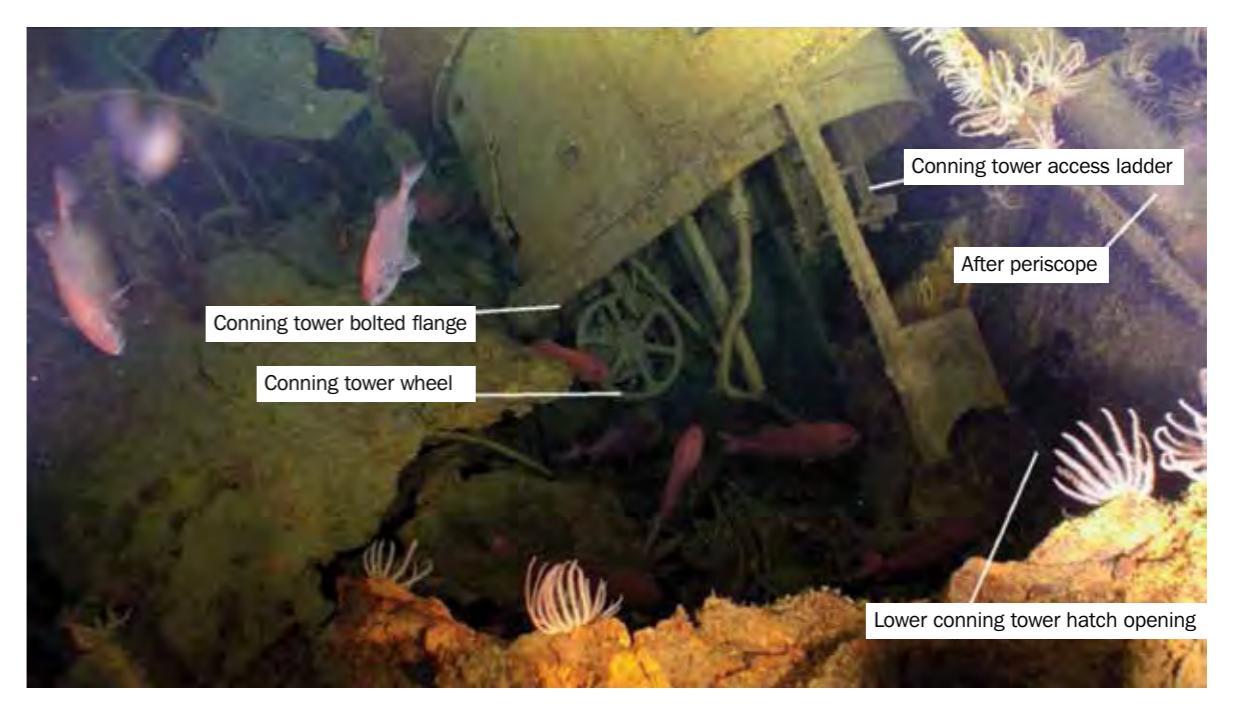
Figure 50 - Underside of toppled fin. Image courtesy of Paul G Allen, Find AE1, Australian National Maritime Museum and Curtin University. © Navigea Ltd

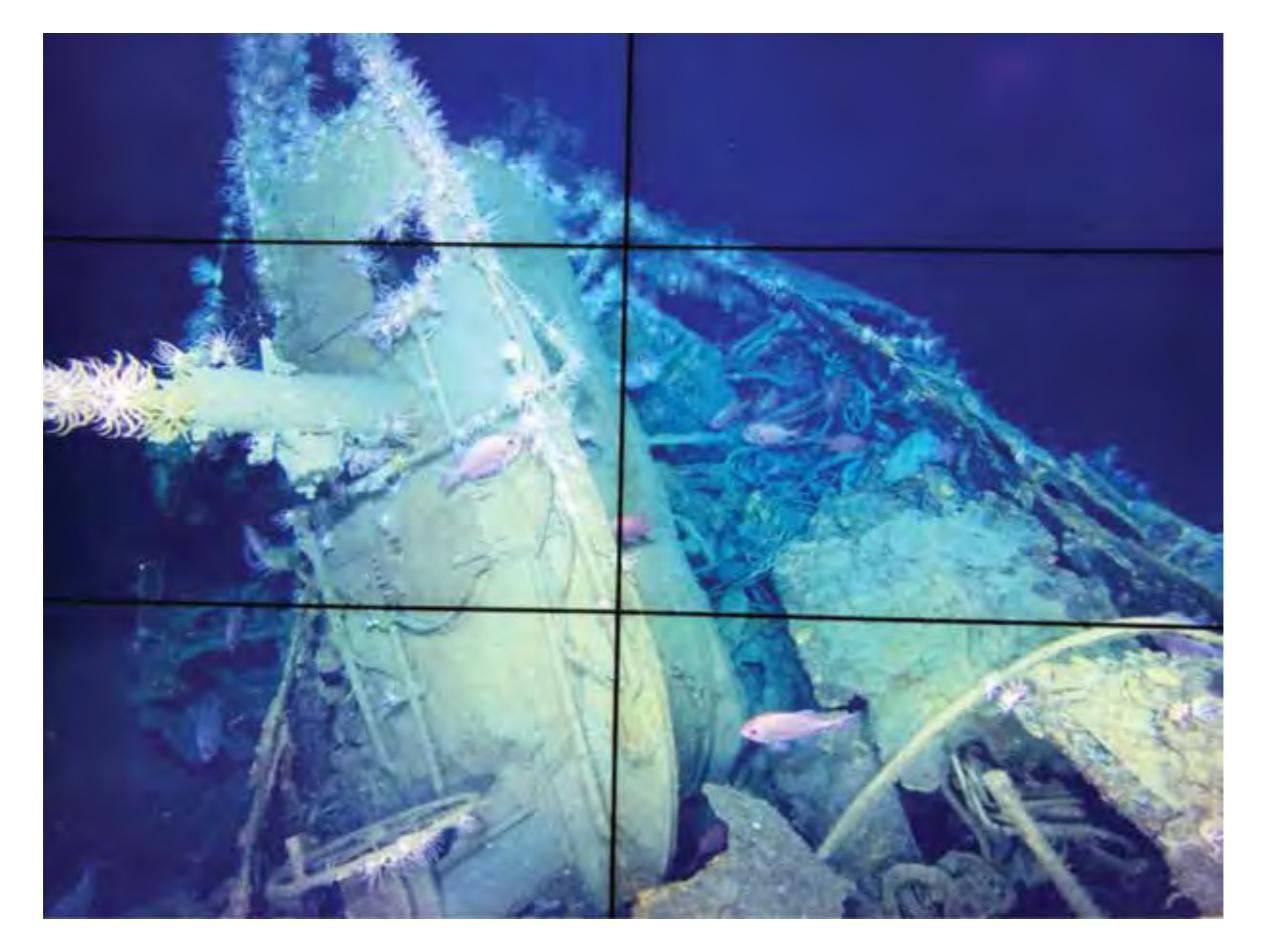
View of the fin and residual pressure hull showing implosion damage. Image courtesy of Paul G Allen, Find AE1 Ltd, Australian National Maritime Museum and Curtin University. © Navigea Ltd

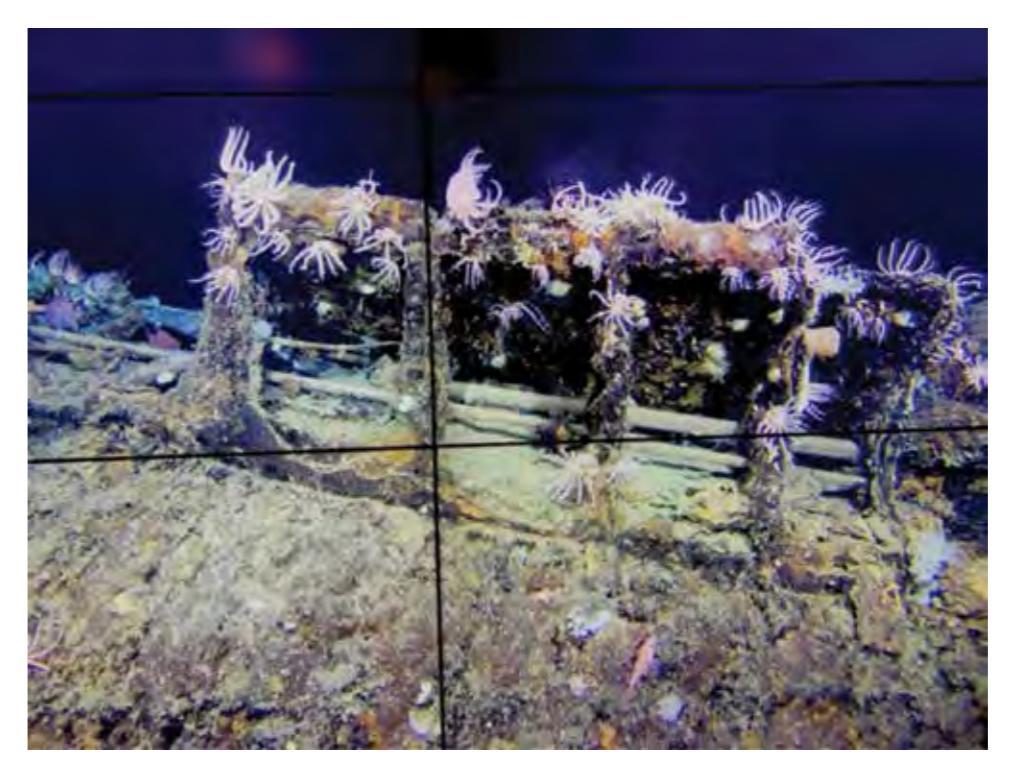
Figure 4 – A few metres aft of the bow the 17-pound (10.6 mm) plate of the forward firing tank has corroded away leaving the frames in a half-corroded state. Image courtesy of Paul G Allen, Find AE1 Ltd, Australian National Maritime Museum and Curtin University. © Navigea Ltd

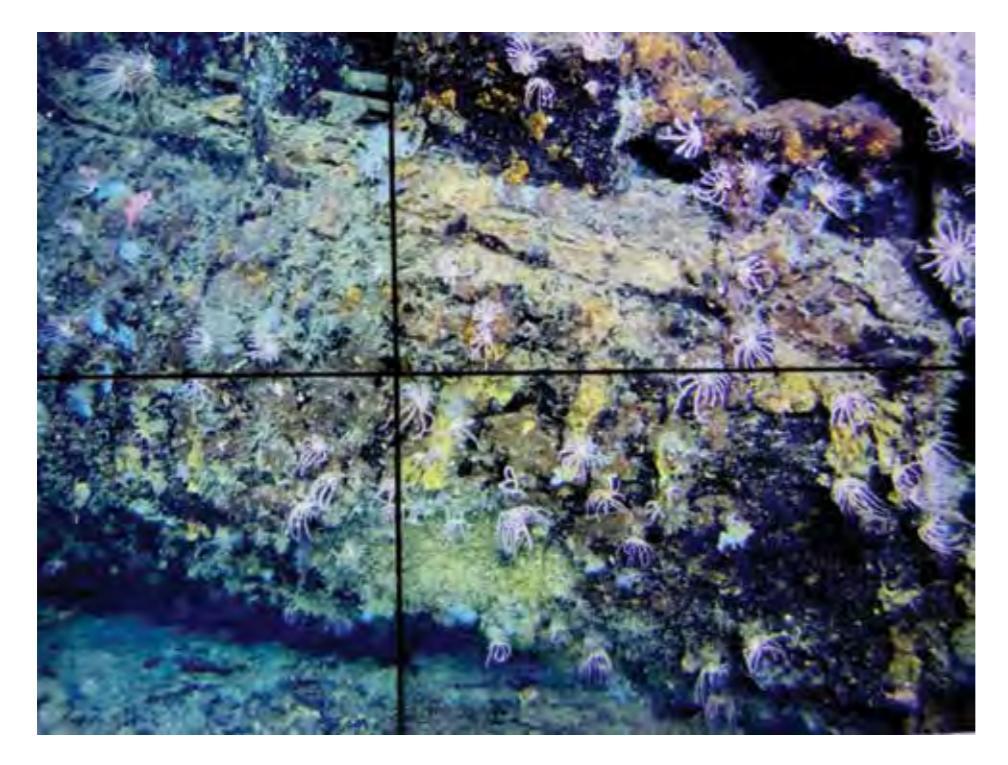
Figure 5 – Some weeping rusticles on port side and apparent separation of hull plates. Image courtesy of Paul G Allen, Find AE1 Ltd, Australian National Maritime Museum and Curtin University. © Navigea Ltd
