Research Vessel Petrel Baseline Survey of HMAS AE1

April 2018

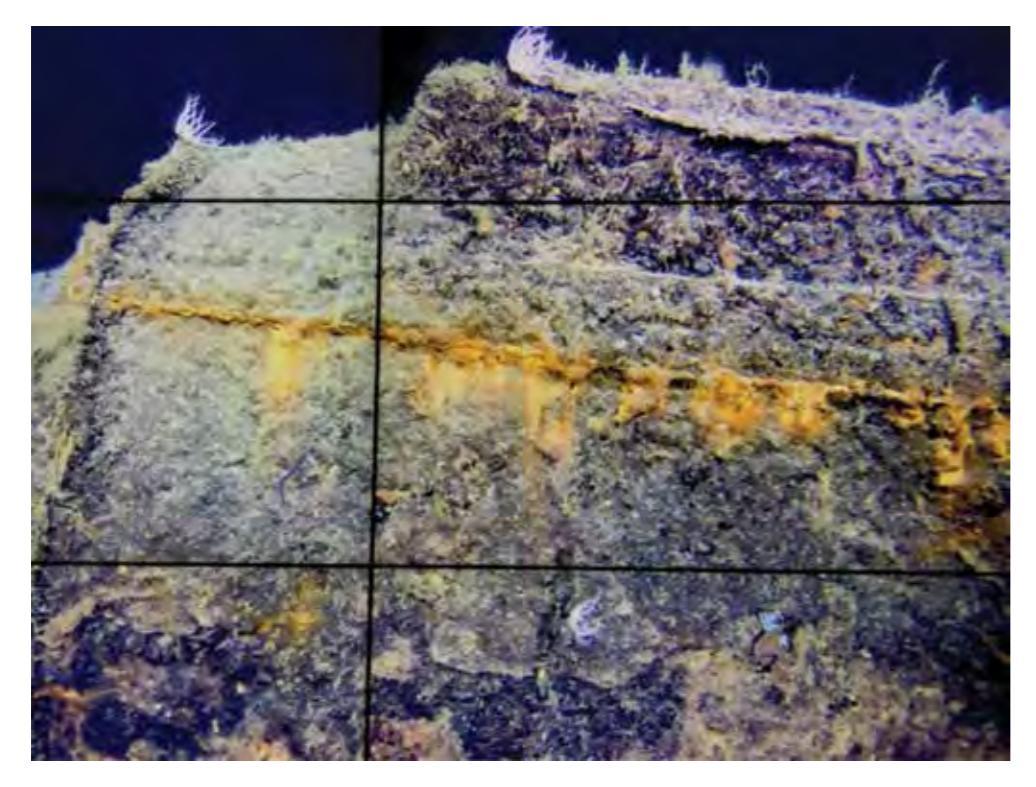
Figure 7 – Image 90-16134, showing corrosion at the join between plates below a doubling line. Image courtesy of Paul G Allen, Find AE1 Ltd, Australian National Maritime Museum and Curtin University. © Navigea Ltd

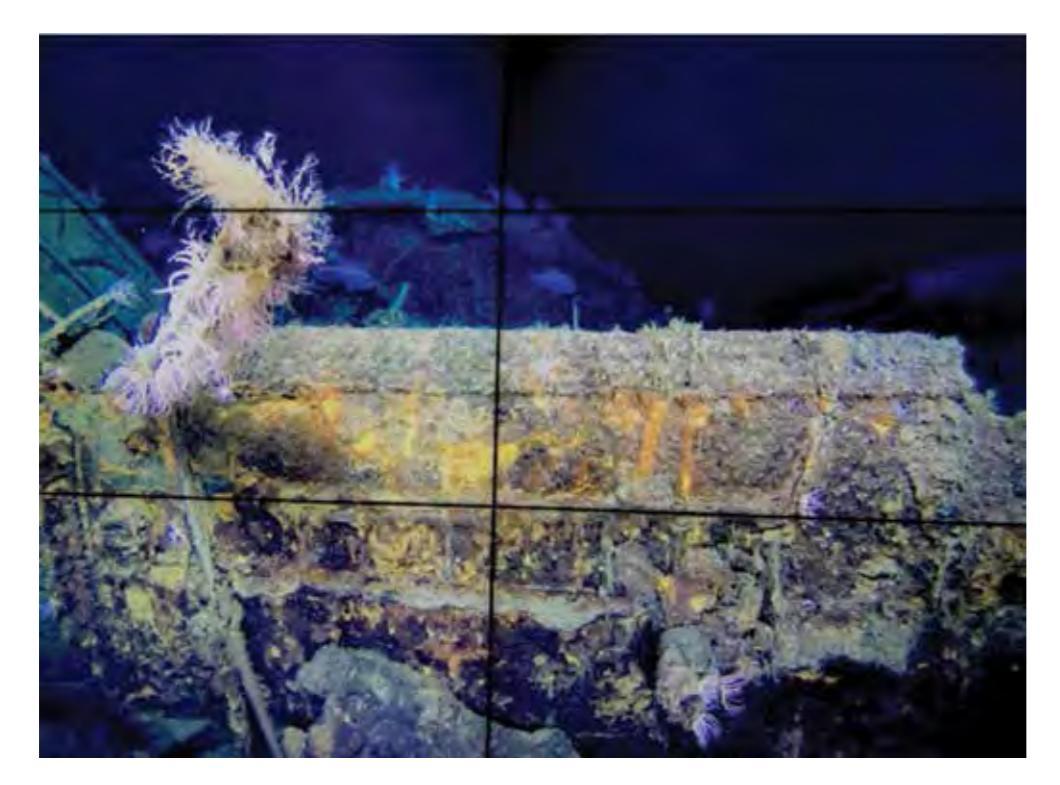
Figure 8 – Upper section of the submarine (starboard side of control room) showing weeping corrosion lines from the horizontal seam. Image courtesy of Paul G Allen, Find AE1 Ltd, Australian National Maritime Museum, and Curtin University. © Navigea Ltd

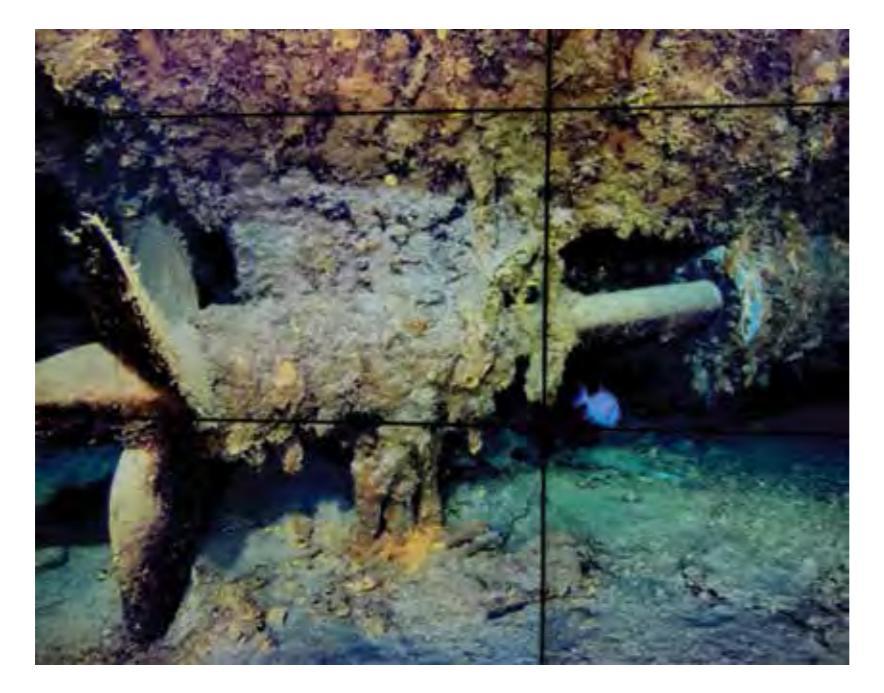
Figure 11 – Image 91-76390, showing starboard propeller and rusticles flowing from the A bracket. Image courtesy of Paul G Allen, Find AE1 Ltd, Australian National Maritime Museum and Curtin University. © Navigea Ltd

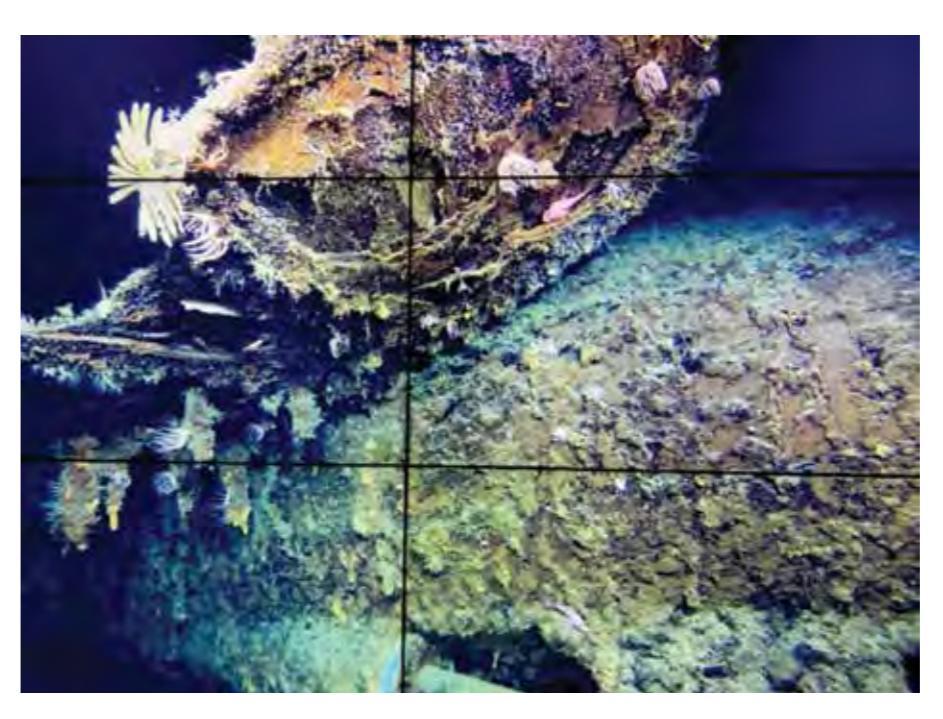
Figure 13 – Image 91-76463 of the port aft hydroplane, showing partial skin loss. Image courtesy of Paul G Allen, Find AE1 Ltd, Australian National Maritime Museum and Curtin University. © Navigea Ltd

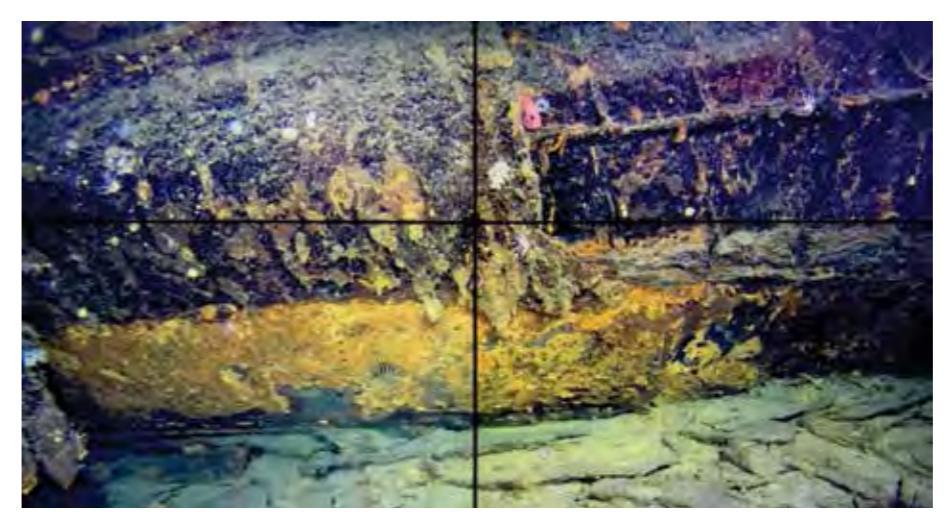
Figure 14 - Image 91-78424, showing significant active corrosion of lower hull plate among debris. Image courtesy of Paul G Allen, Find AE1 Ltd, Australian National Maritime Museum and Curtin University. © Navigea Ltd
