## The Search For AE1

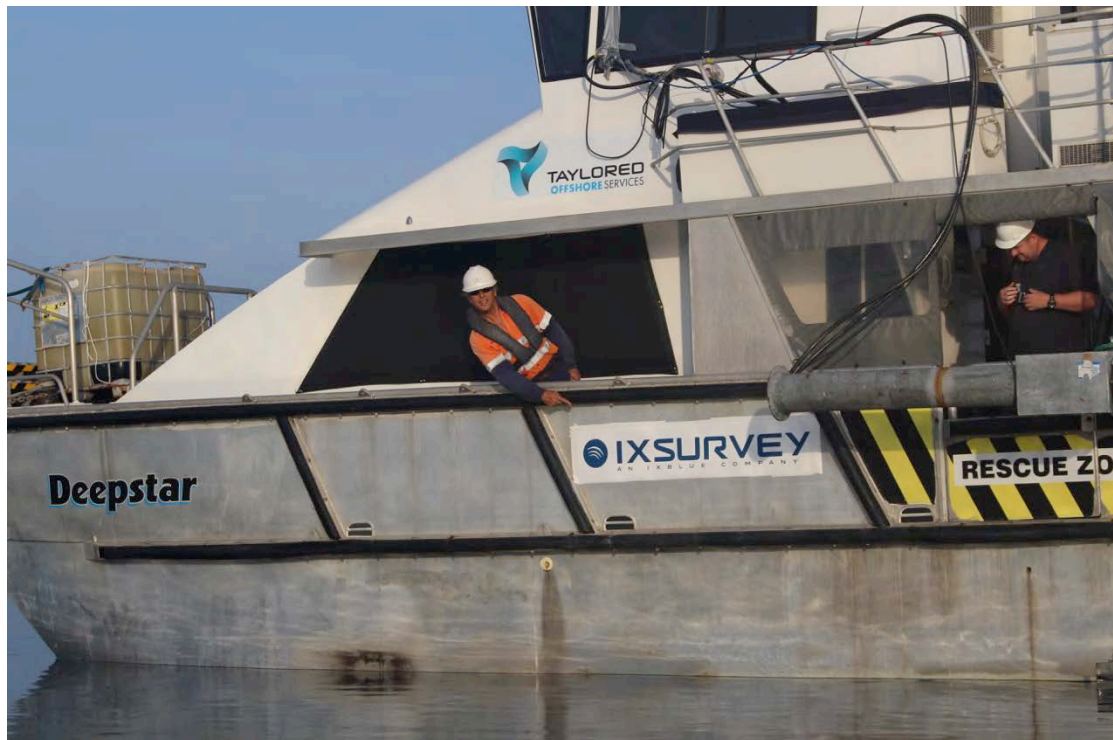
Figure 1 -Taylored Offshore Services Pty Ltd Vessel Deepstar off Kokopo

The vessels' skipper Benny seen on the left above, and local crew, Benny (B1 & B2) assisted with fitting the multi beam echo sounder and high precision survey systems to collect and analyse the data streaming in from the sonar. This technology is similar to that used to undertake a marine survey, with positional accuracy of 10 cm on the surface, the sonar transmits 512 beams, typically every half second, using software to process this into a 3D map, able to detect a bump of 12 cm on the bottom at 200m depth.

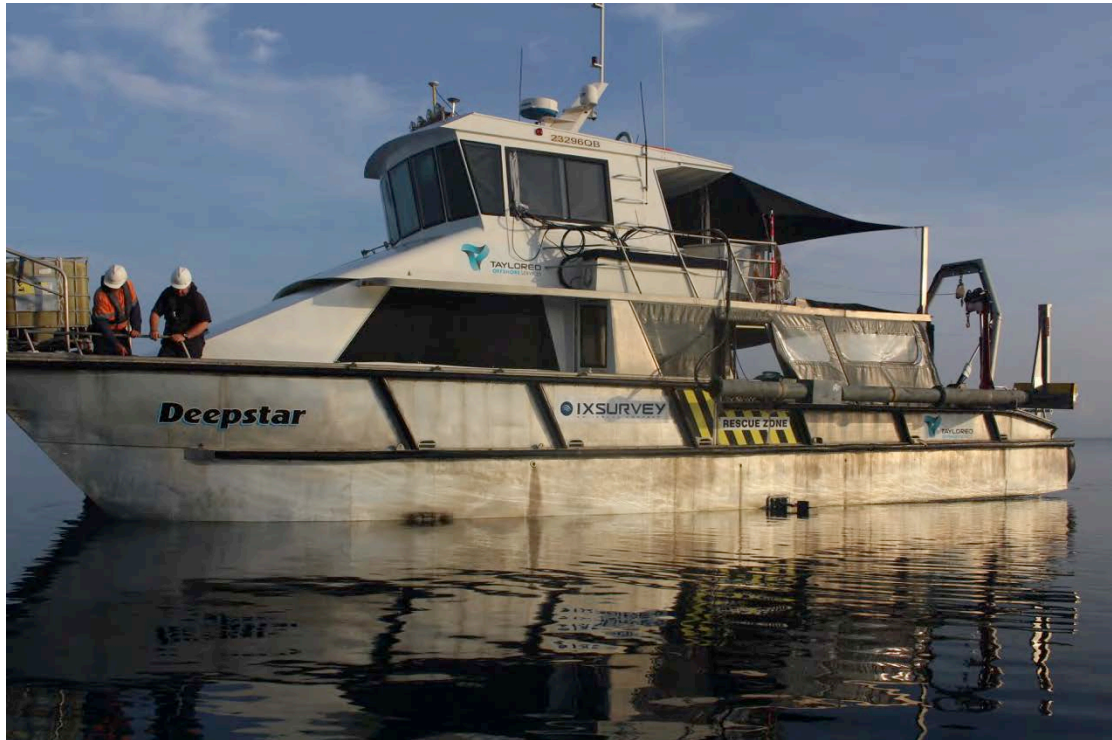
Figure 2 – Deepstar with MBES transducers on the right hand end of the raised pole

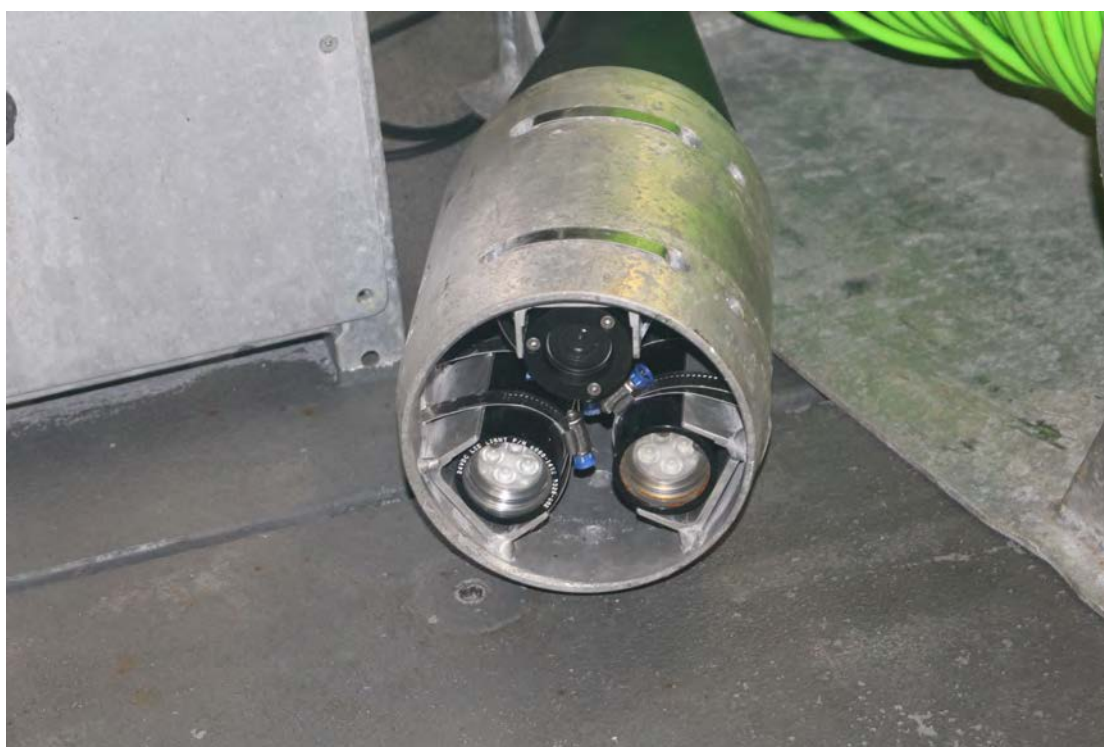
Figure 14 – Drop Camera showing two lights and lense

This camera gave us a basic capability to examine the bottom. To do so the vessel had to manoeuvre so that the camera hanging beneath us on 250m of umbilical would pass directly and slowly over the contact. The fully extended 250m umbilical was only just long enough and required us to be stationery for sufficient time for the camera to settle close to the bottom. The camera's limited visibility of 1-2m added to the complexity. With a great team effort coordinating the operation of the winch, camera and some dexterous ship handling we made 5 camera passes, drifting over the contact in the early morning calm.
