Research Vessel Petrel Baseline Survey of HMAS AE1

April 2018

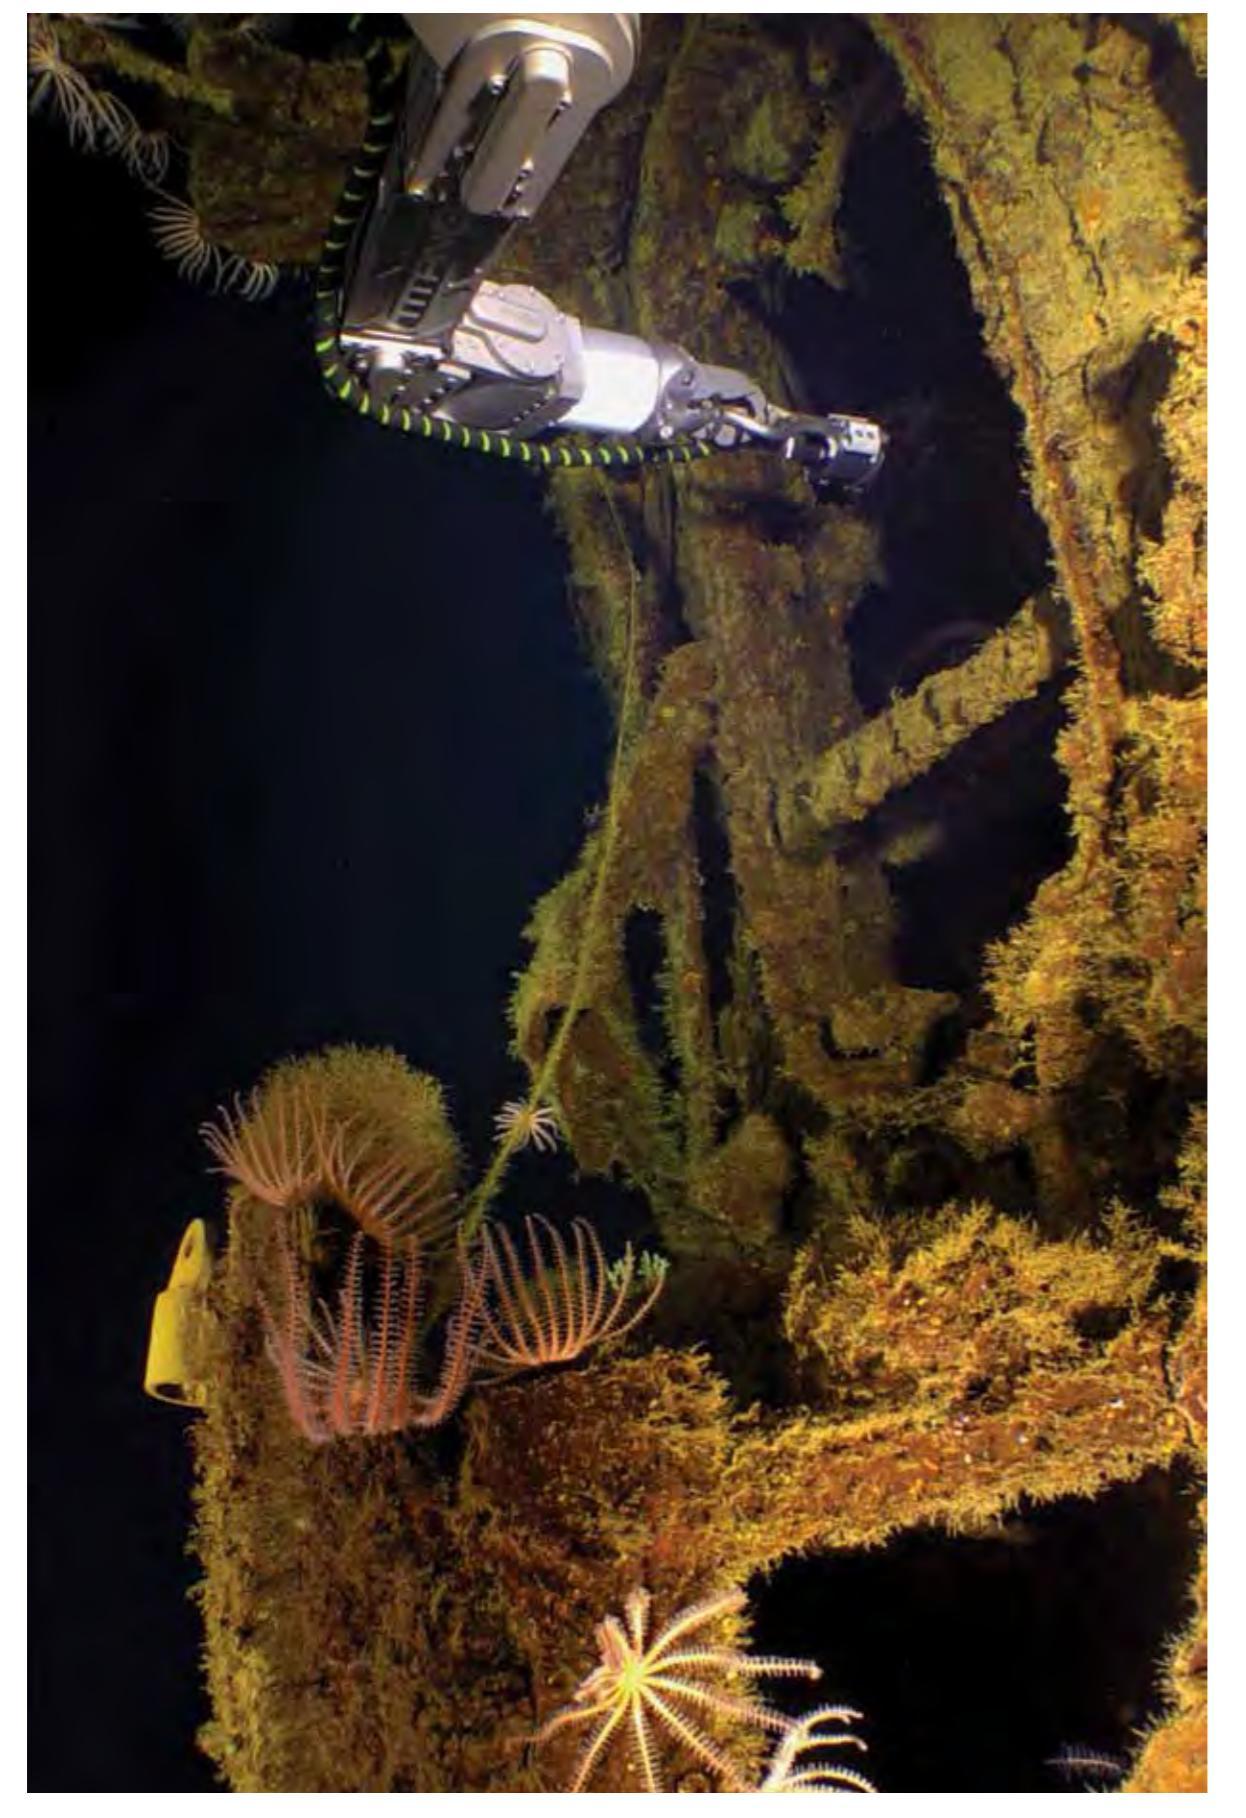
Examining the engine room hatch opening using the ROV's manipulator arm camera. Image courtesy of Paul G Allen, Find AE1 Ltd, Australian National Maritime Museum and Curtin University. © Navigea Ltd

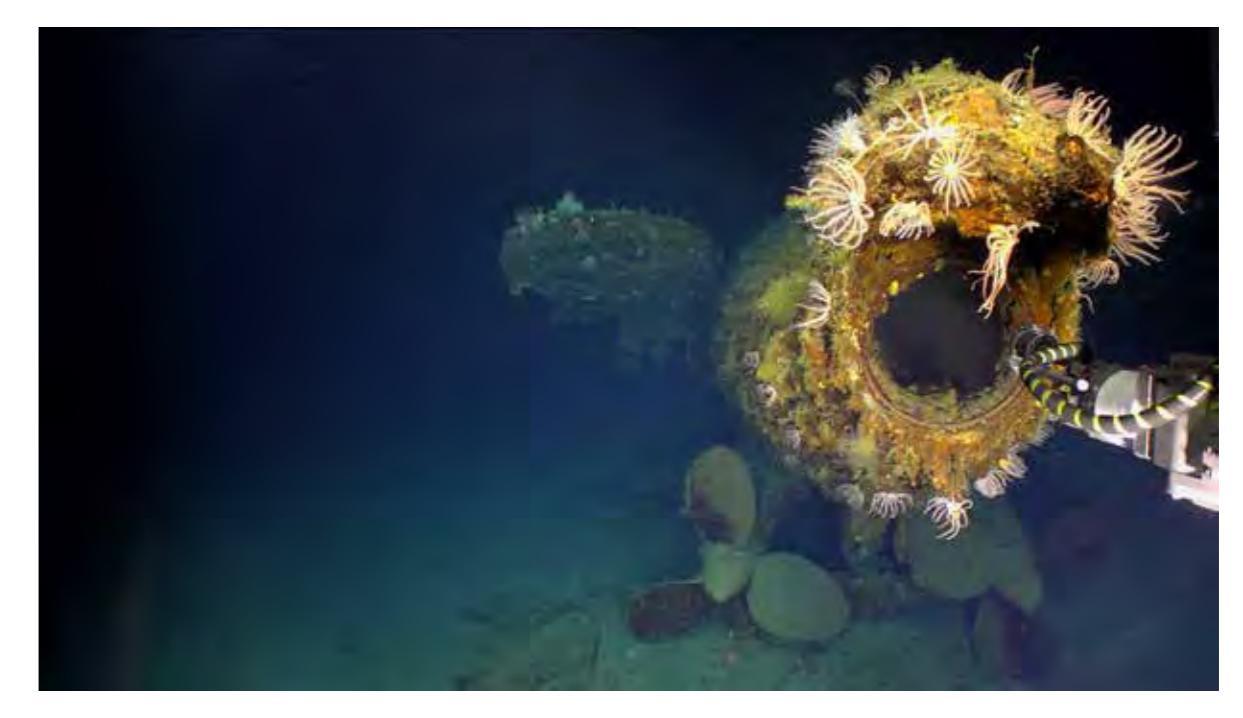
Figure 7 – Examining the after torpedo tube sluice valve. Image courtesy of Paul G Allen, Find AE1 Ltd, Australian National Maritime Museum and Curtin University. © Navigea Ltd

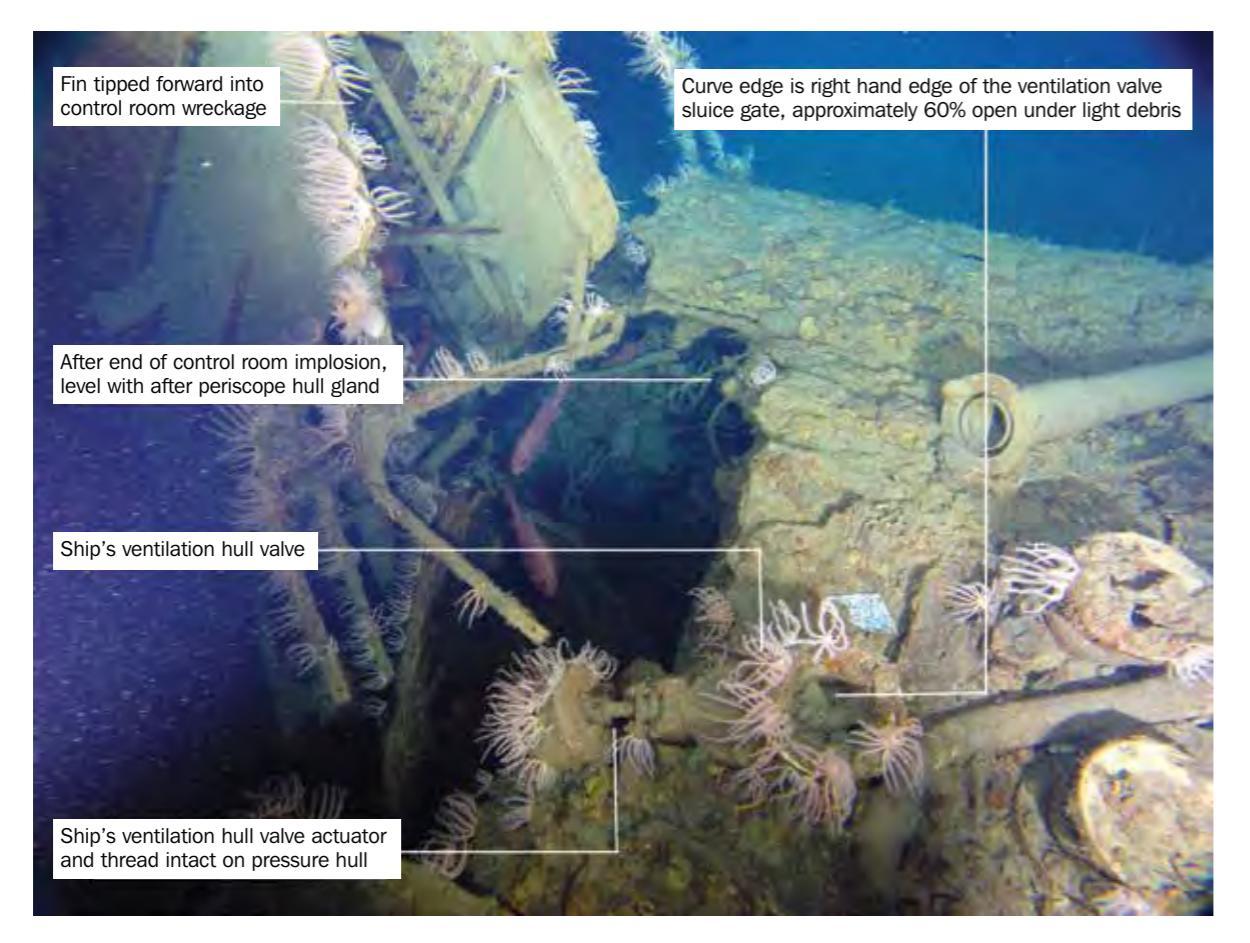
The ship's ventilation hull valve has been found 60% open; this may have initiated a sequence that led to the flooding of the after end of the submarine, causing it to sink, out of control, past its crush depth, leading to an implosion that would have killed the crew instantaneously. The submarine then appears to have sunk stern first to the bottom. We don't know why the valve was not shut prior to diving.

The valve is a sluice or gate valve construction, external to the hull and operated by a handwheel, driving through a rod gearing to turn a thread on the valve shaft, in order to drive the sluice across the opening. The thread actuator remains intact and attached to the pressure hull and therefore we think it most unlikely that the valve has been pulled open by the force of the implosion. In the image below, the curved leading edge of the sluice valve is clearly visible beneath some light debris - it is ~60% open.

Figure 14 – The open ship's ventilation hull valve. Image courtesy of Paul G Allen. Find AE1 Ltd. Australian National Maritime Museum and Curtin University. © Navigea Ltd

This would have allowed water to enter the ship's ventilation system as soon as the ventilation trunking in the fin was under water. The specification we believe was used for constructing AE1 calls for a quick-acting valve to be fitted as a back-up to the hull valve and the associated pipework to be pressure tested to 50 pounds per square inch (344.74 kilopascals, equivalent to 30 metres of seawater). The 'as built' drawing package held by the National Archive of Australia includes drawings covering the ventilation system but we have been unable to locate a quick-acting valve on any of these drawings. It may or may not have been fitted.

It is considered likely that the normal state of the quick-acting valve when on the surface (that is, prior to diving) would be open. In this case, with the quick-acting valve open (or not fitted), or if the trunking failed to hold the pressure build-up, then water could have entered the after end of the submarine immediately on diving. The water could quickly make its way to the lower section of the after end of the submarine containing the after main battery and vital systems supplying power, lighting and the port main propulsion motor. The additional water would also cause a loss of buoyancy, causing AE1 to sink faster. As it sank deeper the volume of water entering the submarine would increase dramatically.¹¹ The combined effect would be a rapid loss of control and the depth excursion that caused the fatal implosion.

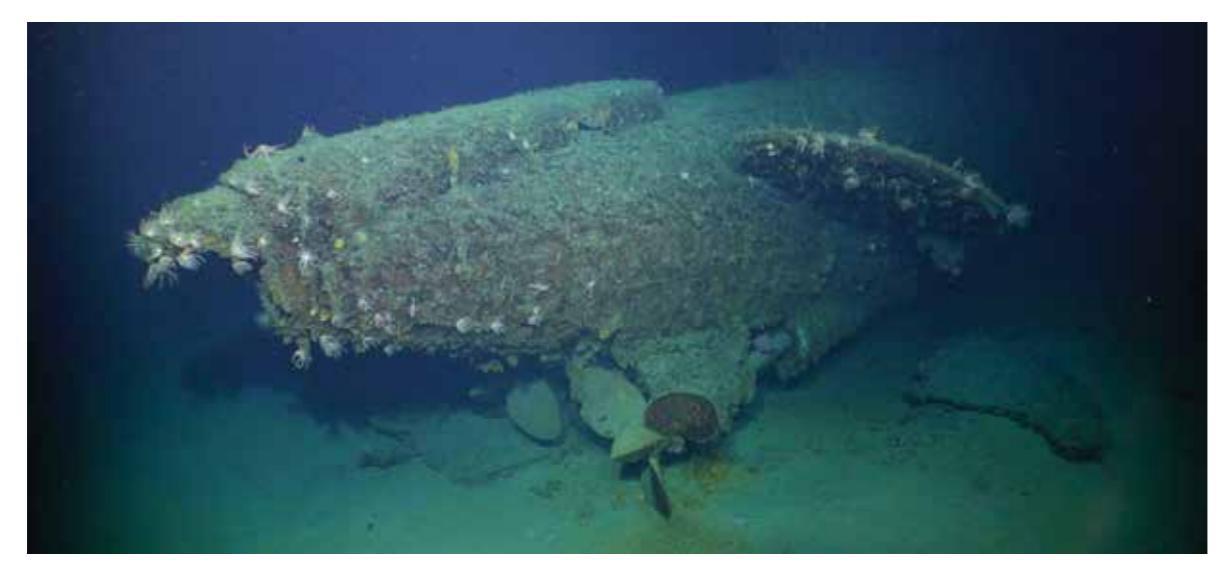
- The stern cap is the outer opening on the after torpedo tube.
- It is backed up by a sluice valve in the tube positioned about 2 metres forward of the stern cap.
- The torpedo is stowed forward of this, with a rear door giving access to the tube inside the after torpedo compartment.
- The stern cap is opened by a handwheel operated from the after torpedo compartment, driving through a rod gearing to an external worm gearing arrangement to open the stern cap.
- The whole arrangement is shielded by a casing external to the pressure hull.
 - This casing is intact.

• The gearing arrangement would have been very resistant to opening caused by the sinking process.

Figure 15 – Protective casing over stern cap operating rod. Image courtesy of Paul G Allen, Find AE1 Ltd, Australian National Maritime Museum and Curtin University. © Navigea Ltd

It is therefore considered highly likely that the stern cap was opened as a result of deliberate action by the crew. Why would this step be taken?

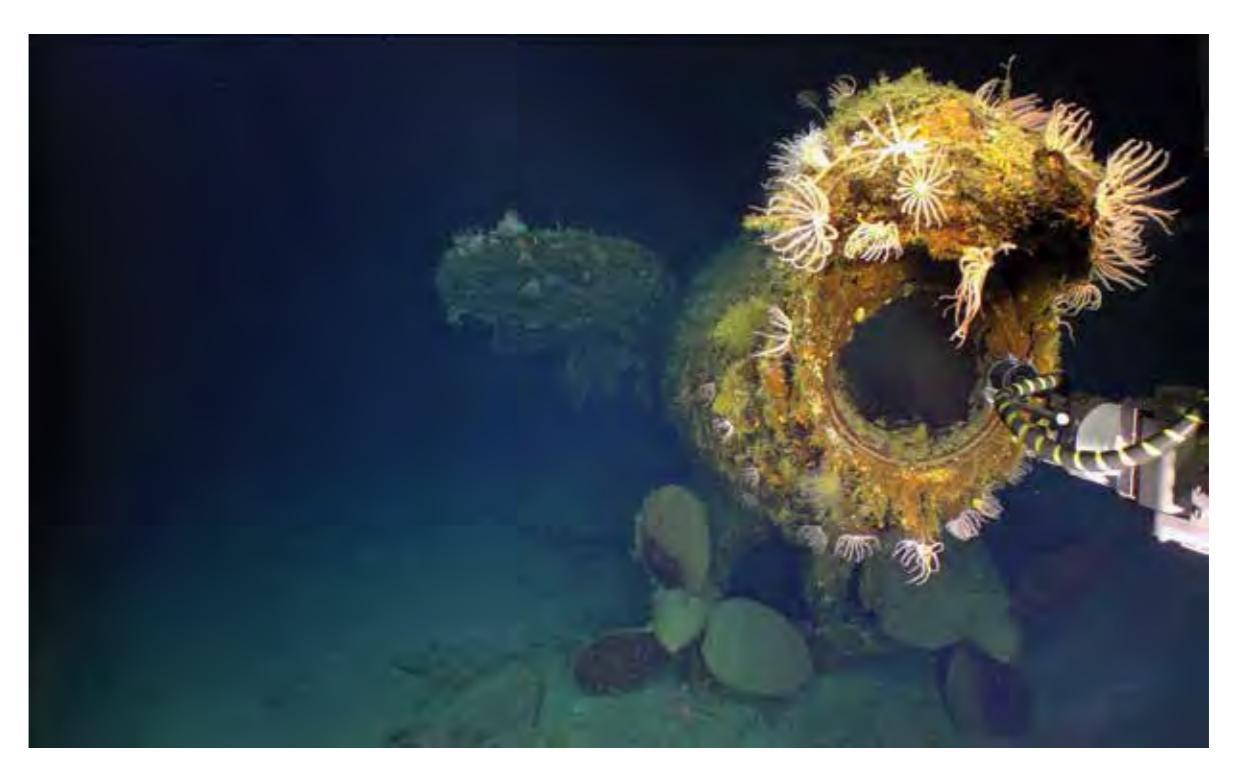
- Possibly a precautionary step to prepare the tube for action in anticipation of locating the German steamer, which we believe caused the commanding officer to divert to the Duke of York Islands.
- The after torpedo tube's sluice valve has been sighted shut using the ROV manipulator camera.
 - We assume the torpedo remains unfired in the torpedo tube on the other side of the sluice valve.
- Why start to prepare the after torpedo tube?
 - This initial step does not expose the torpedo to seawater and could be simply executed as the bow and stern caps were at the waterline and partially under water on the surface.
 - The after tube would have been less vulnerable to damage from flotsam or the wash compared to the bow tube, enabling the stern cap to be fully opened with little risk of damage.
- Alternatively, it could have been opened as a training drill. •

Figure 16 – Examining the after torpedo tube using the ROV manipulator arm camera. Image courtesy of Paul G Allen, Find AE1 Ltd, Australian National Maritime Museum and Curtin University. © Navigea Ltd

Given the flooding scenario set out above there would have been no time to open the stern cap after diving. It is therefore considered most likely that the stern cap was opened prior to the dive, possibly some time earlier in the day, and that it played no part in the accident sequence.

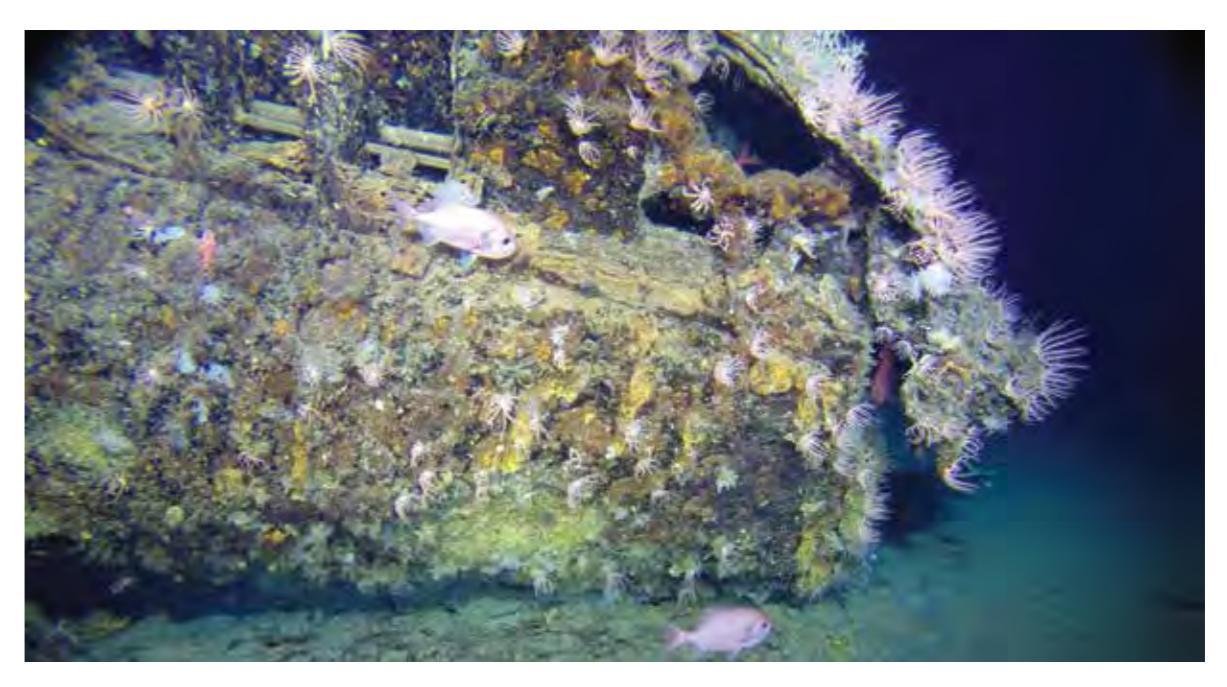
The bow cap on the forward torpedo tube is partially opened, say 20–25 degrees of the 90 degrees necessary to be fully opened.

Figure 17 - Partially open bow cap. Image courtesy of Paul G Allen, Find AE1 Ltd, Australian National Maritime Museum and Curtin University. © Navigea Ltd

It is possible that the bow cap was also opened as a precaution, to reduce the time necessary to prepare the tube for firing at the same time and for the same reasons as the stern cap. In this case the bow cap was only partially opened to protect the bow cap operating arrangement from damage from the bow wave or flotsam as the submarine moved around on the surface. Alternatively, it could also have been opened as part of a training drill.

We have considered the possibility that the sinking process could have distorted the rod gearing and worm gearing opening arrangements sufficiently to partially open the bow cap, but on balance think the absence of significant impact damage to the bow militates against this explanation.

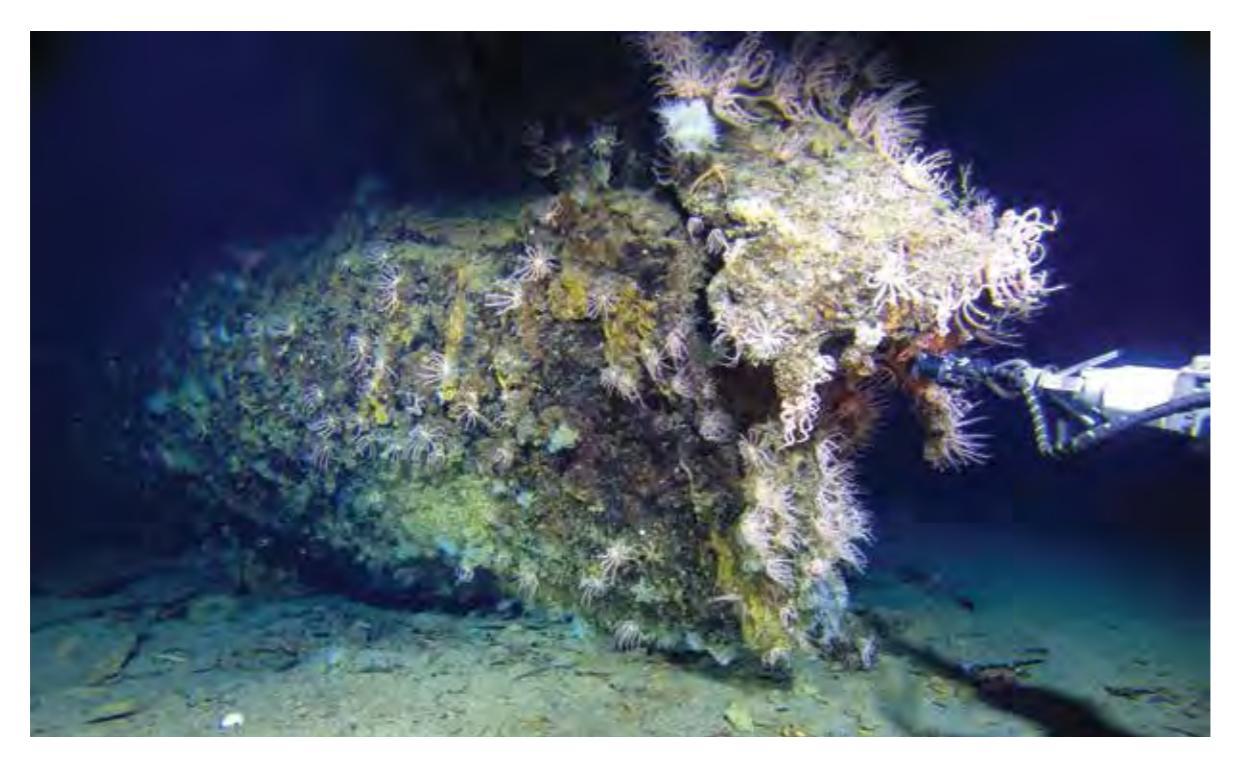
We were unable to inspect the forward torpedo tube sluice valve due to the bow cap obstructing access.

Figure 18 – Failed attempt to inspect bow torpedo tube. Image courtesy of Paul G Allen, Find AE1 Ltd, Australian National Maritime Museum and Curtin University. © Navigea Ltd

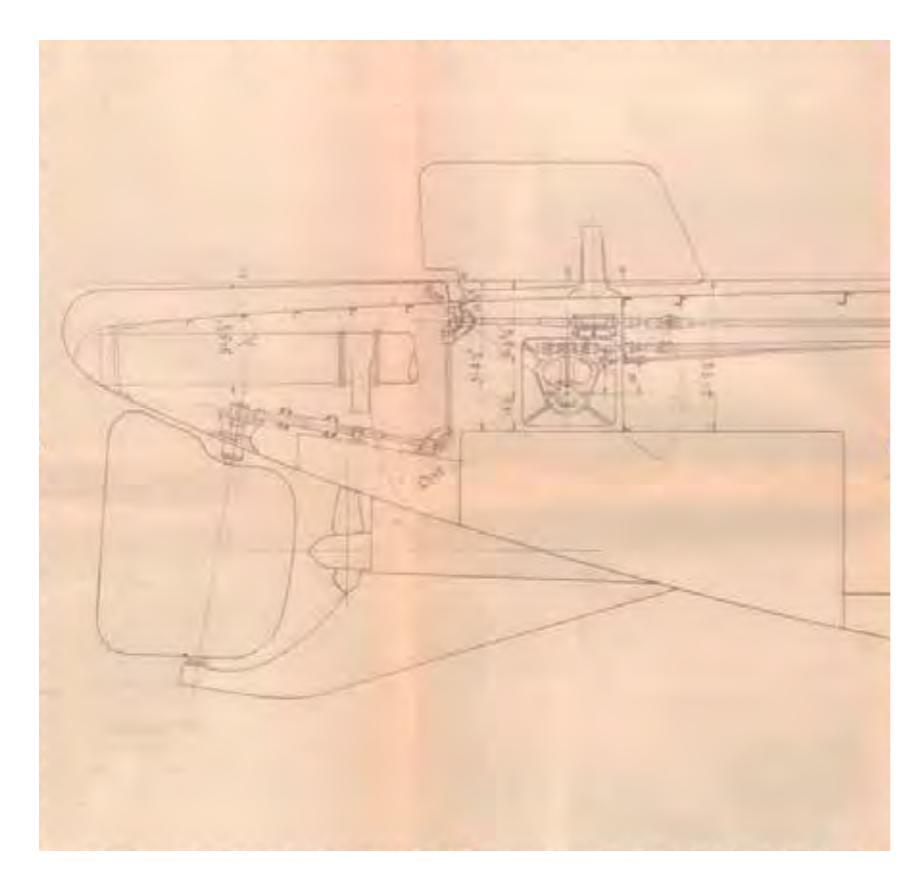
Figure 23 - Rudder and skeg arrangement, from as built drawings. Image courtesy of National Archives of Australia

The skeg has broken away from the pressure hull and the rudder has been displaced; both are lying on the sea floor in the vicinity of the port propeller.

Significant force would be required to break the skeg and displace the rudder. This damage is consistent with the initial and major impact of a stern-first grounding. This will be considered in greater detail in the section dealing with the sinking process.

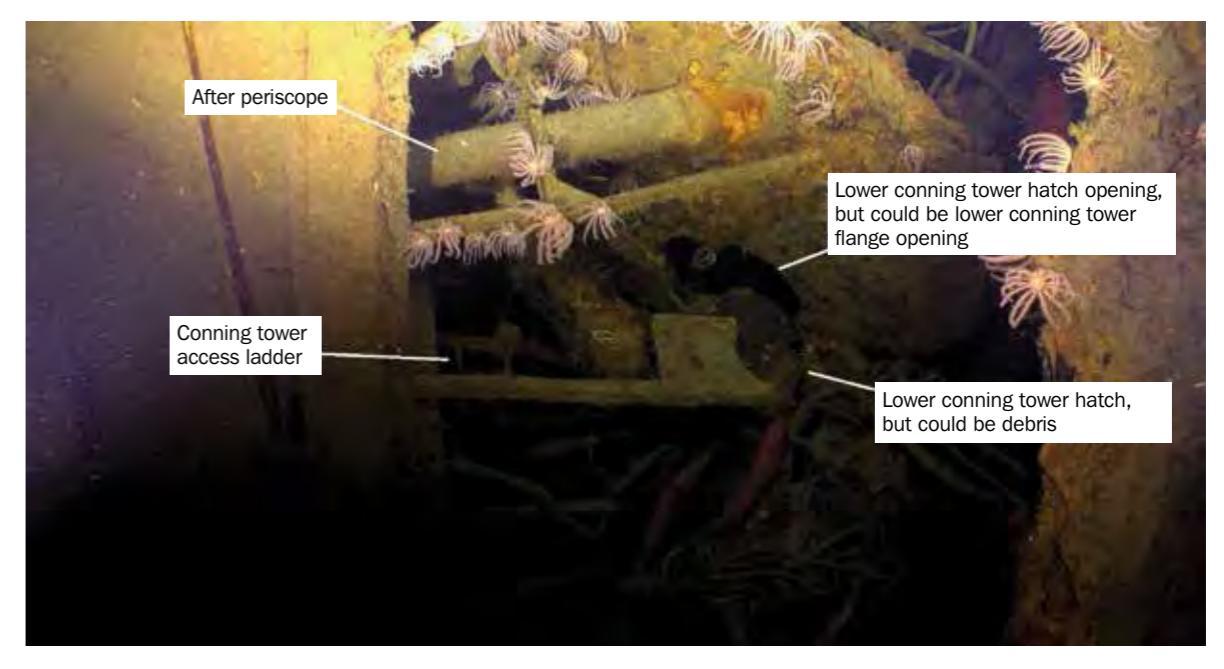
Figure 26 – Possibly the lower conning tower hatch. Image courtesy of Paul G Allen, Find AE1 Ltd, Australian National Maritime Museum and Curtin University. © Navigea Ltd

The survey reveals a number of unresolved puzzles that invite follow-up in any future surveys of the wreck. including the location of the lower conning tower hatch, possibly blown clear of the hull opening by the implosion, but more likely simply corroded away in the presence of the galvanic action arising from the manganese bronze conning tower.

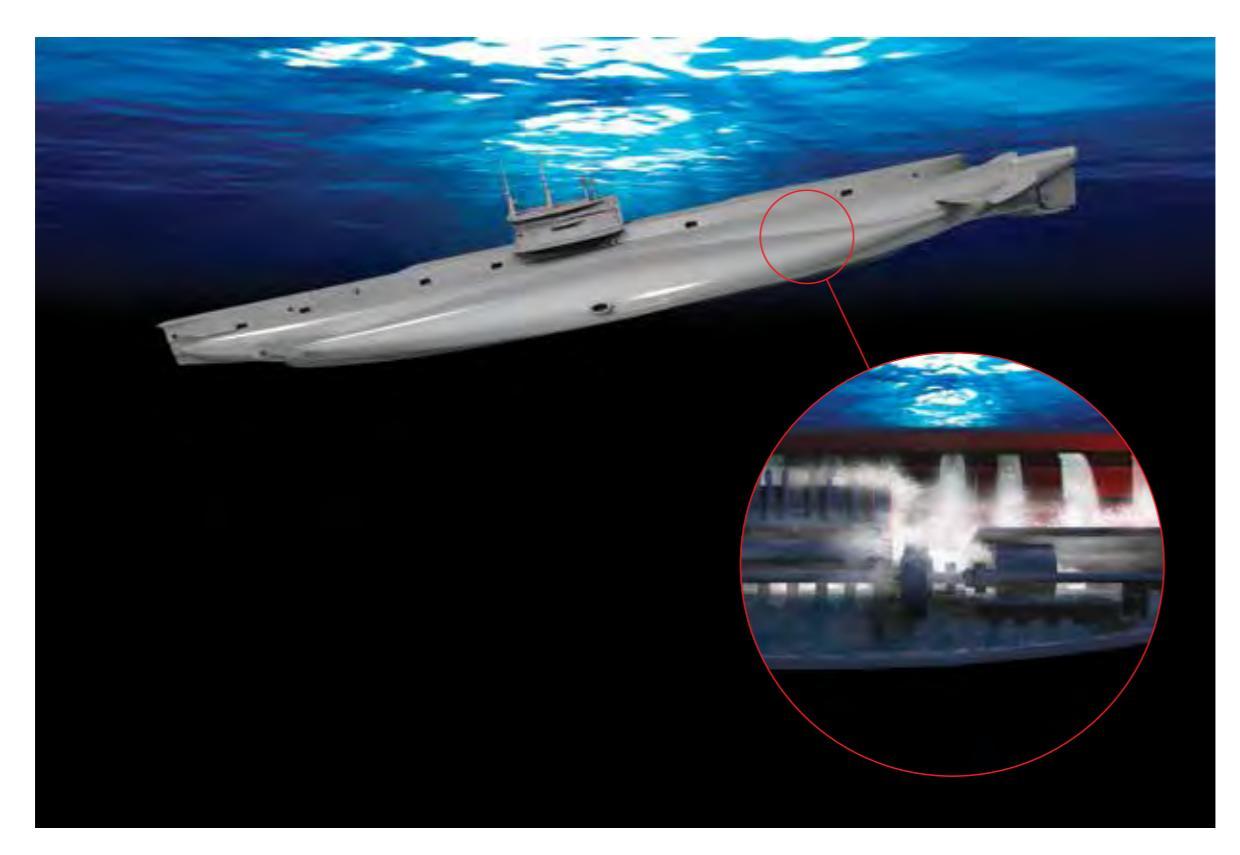
- From these clues we believe it is likely that the submarine began to flood through the ship's ventilation system shortly after diving.
- The ventilation system directed water into the after section of the hull, causing a loss of buoyancy aft (in submarine trim terminology, making the submarine heavy overall and heavy aft).
- The submarine began to sink stern first.
- As the flooding progressed the submarine became progressively more negatively buoyant (heavier).
- The influx increased dramatically as the submarine sank deeper.
- Propulsion would have been lost once the flood waters reached any or all of the after main battery, port propulsion motor or their associated power supply arrangements.
- Note, we believe that only the port main motor was available when the boat was dived, due to a defect on the starboard main engine clutch.¹⁴

Figure 27 – Artist's impression of the situation on diving. Grant Gittus for Find AE1 Ltd

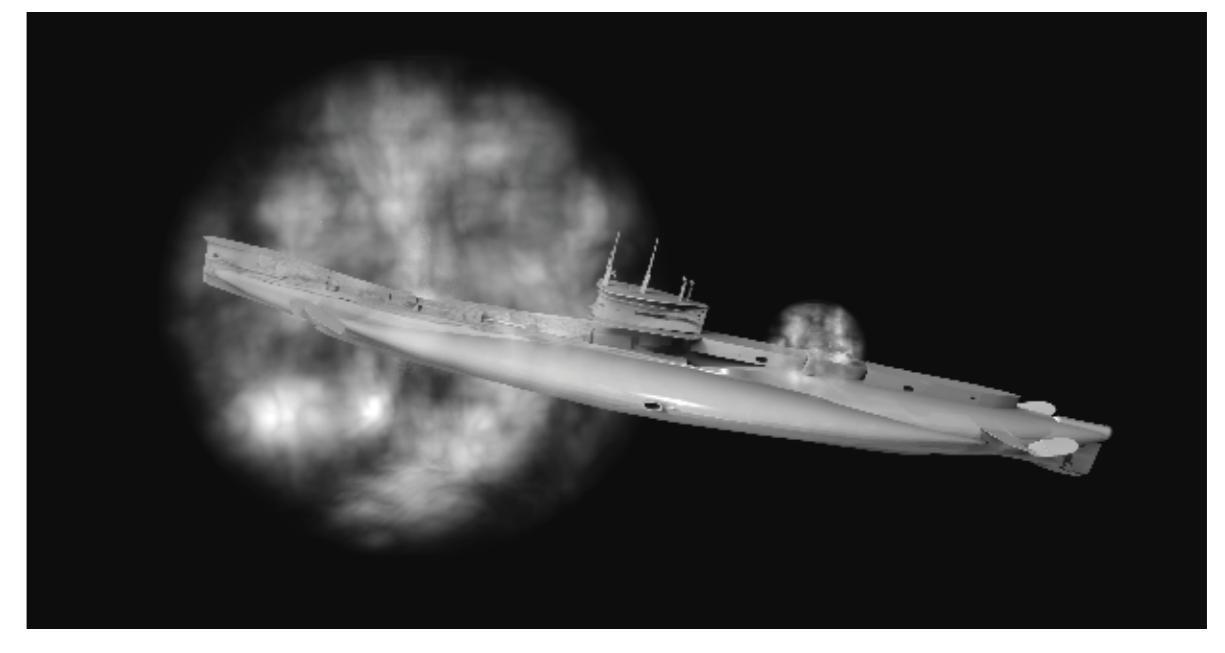
The submarine exceeded its crush depth (\sim 90–120 metres) and the pressure hull imploded over the control room and forward torpedo compartment. The after end of the submarine, by then substantially flooded, did not implode; however, the shock wave from the implosion of the forward compartments blew off the engine room hatch.

Figure 28 – Artist's impression of the implosion. Grant Gittus for Find AE1 Ltd

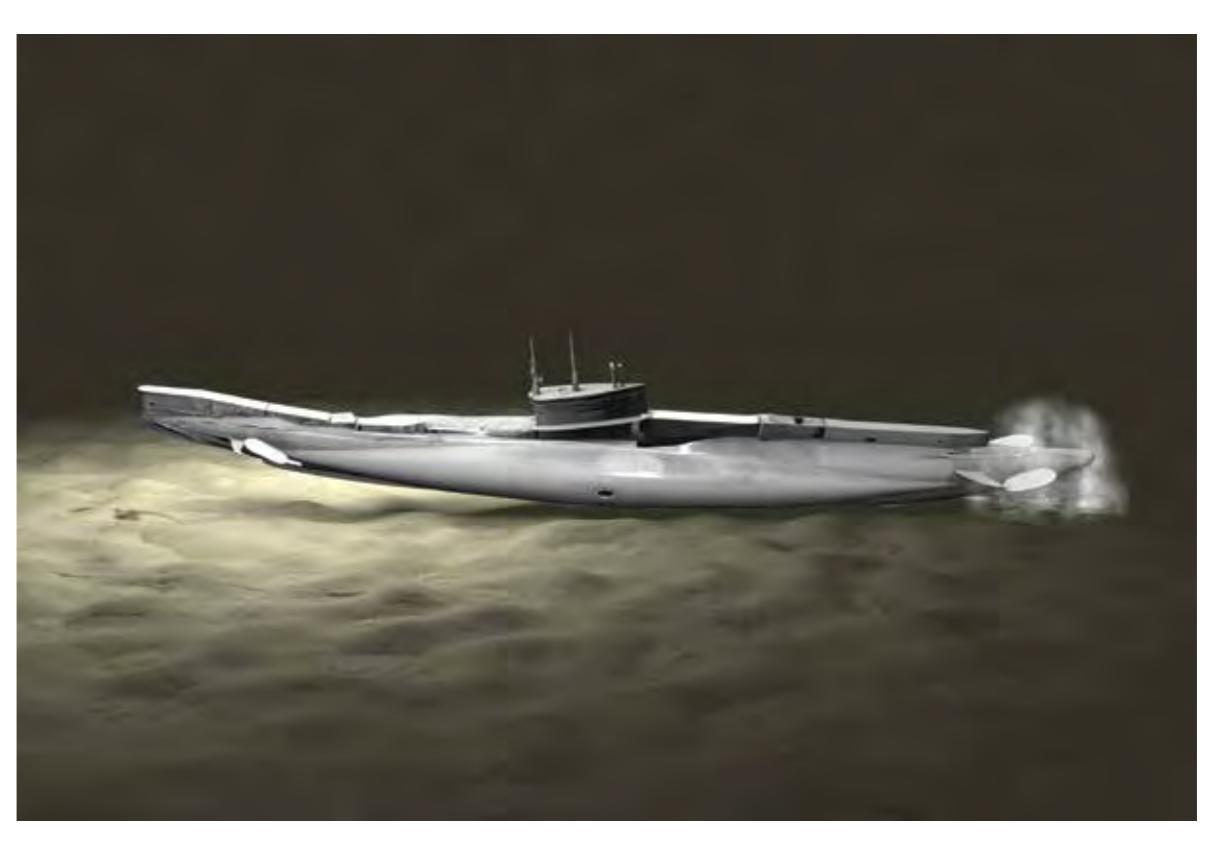
The rudder and skeg absorbed the main impact as the submarine struck the bottom with a slightly stern down angle and little or no headway, snapping off the skeg and displacing the rudder. The first impact may have caused the after hydroplane guards to break away and drop to the bottom, close to their normal positions on the hull.

Figure 29 – Artist's impression of the first impact on rudder and skeg. Grant Gittus for Find AE1 Ltd

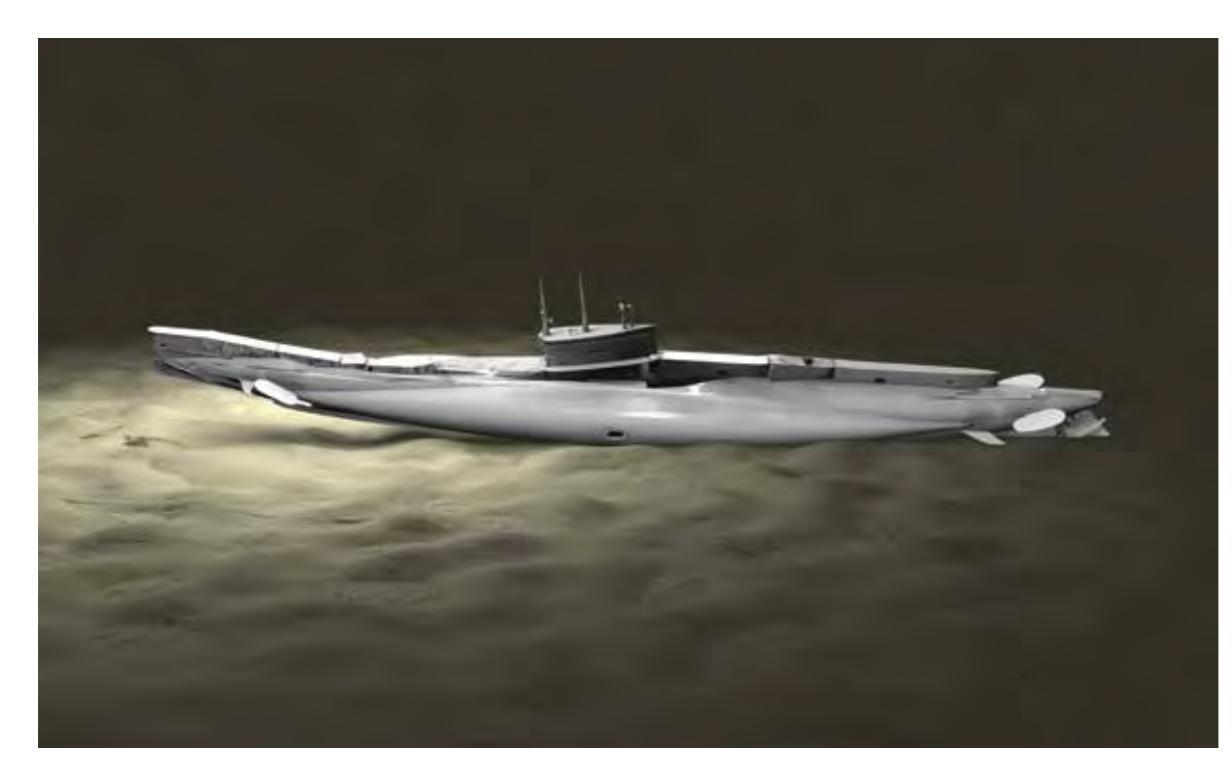
The submarine then pitched forward to land on its keel. The second impact may have also contributed to unseating the fin, already weakened by the implosion damage to its footings, causing it to start its movement forward into the wreckage over the control room. The location of the toilet bowl shards in the fin suggest that the fin movement may have taken some time, slowly settling forward, as a higher-energy event could be expected to shatter the bowl and scatter the remnants.

Figure 30 – Artist's impression of second impact: landing on the keel. Grant Gittus for Find AE1 Ltd

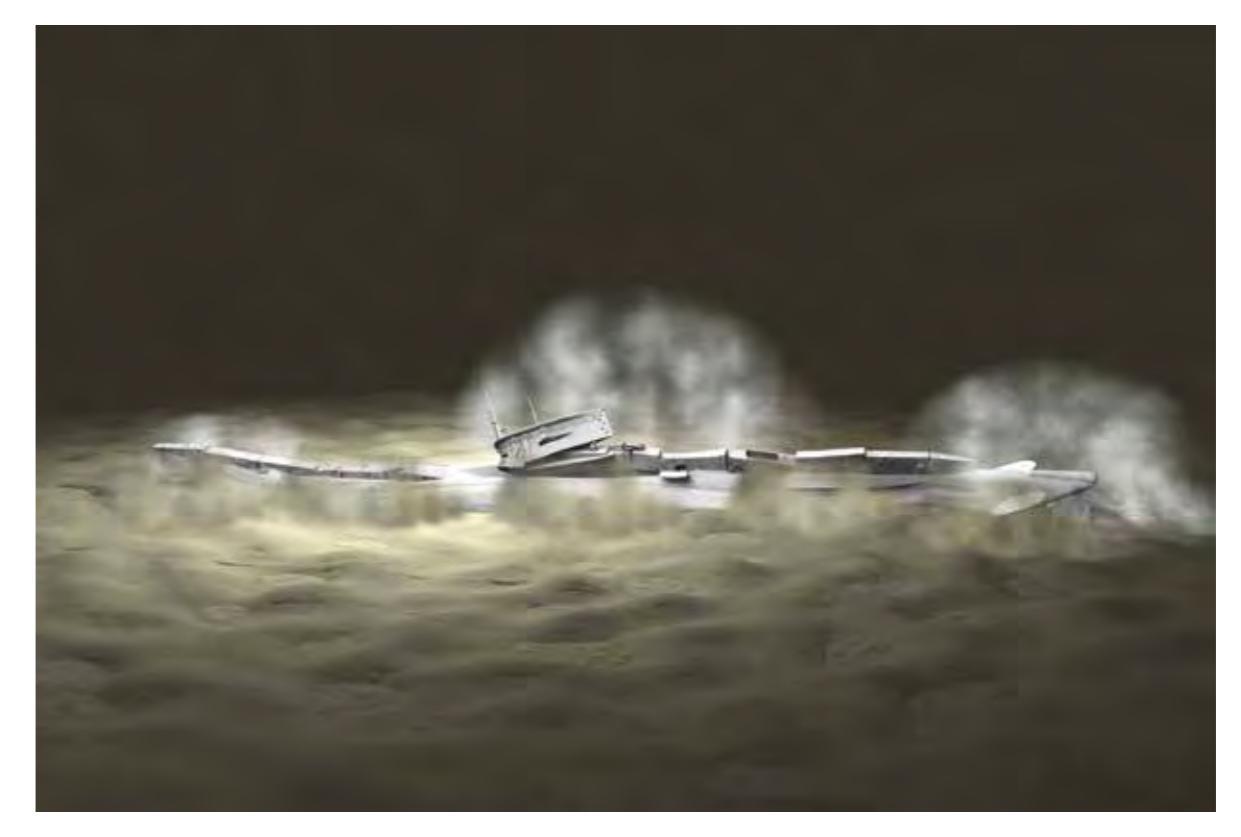
Figure 31 – Artist's impression of final situation as submarine settled on the bottom. Grant Gittus for Find AE1 Ltd

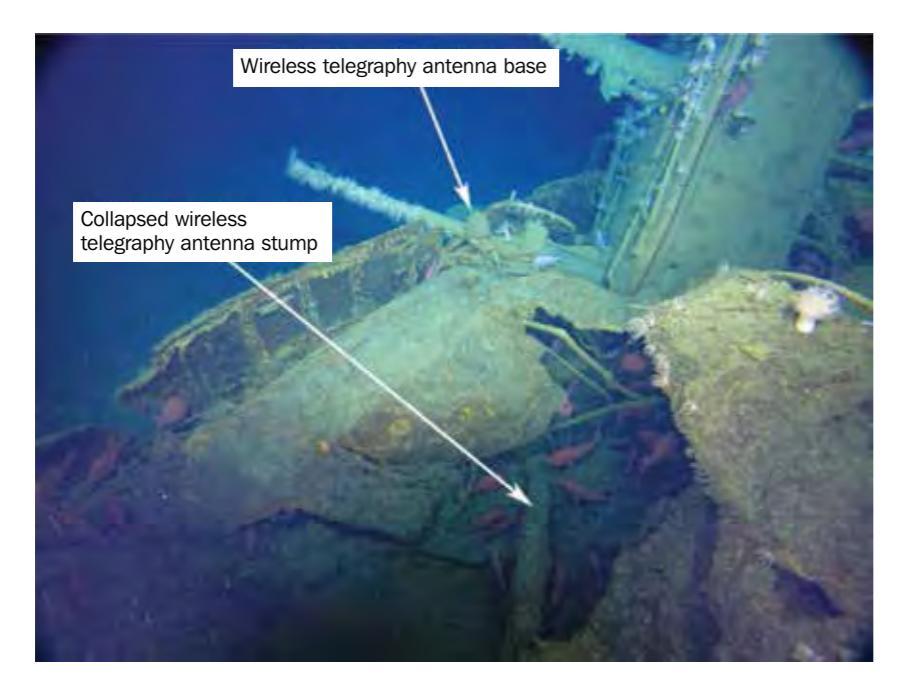
Figure 2 – Remnants of *AE1*'s devastated control room, showing the locations of the collapsed wireless telegraphy antenna and its base, which remains *in situ*. The collapsed fin is visible in the background. Image courtesy of Paul G Allen, Find AE1 Ltd, Australian National Maritime Museum and Curtin University. © Navigea Ltd

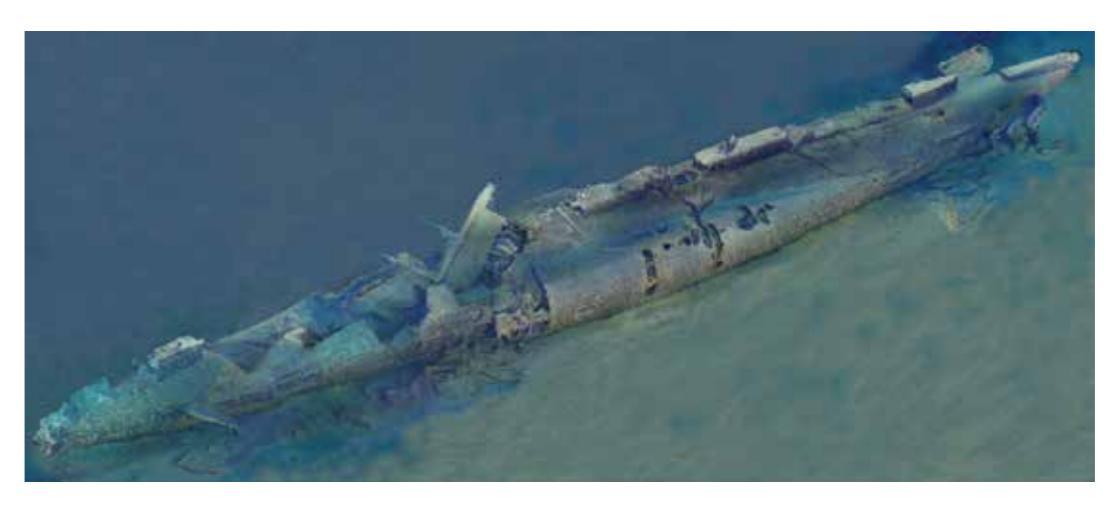
AE1's overall appearance is shown in the interim photogrammetric full 3D model developed by Curtin University's HIVE (Figure 3). AE1 is resting upright on a largely flat, featureless sand/silt seabed and is almost completely exposed, with only the keel and the tip of a blade from each propeller buried in the surrounding silt. While the approximate aft half of the submarine is largely intact, hull sections forward of the fin have collapsed inwards as a consequence of a catastrophic implosion event. Specific activity areas within AE1 devastated by implosion damage include the control room and forward torpedo compartment. Structural failure of the forward pressure hull has resulted in the fin collapsing and toppling forward into the remnants of the control room.

While still largely intact, the submarine's hull has been detrimentally affected by differential corrosion of its various metallic components. This is perhaps most evident in the destruction of *AE1*'s side-mounted 'saddle' ballast tanks, which were constructed of lighter-grade steel than the pressure hull and appear to have preferentially corroded, fragmented and collapsed to the seabed. Other disarticulated hull elements observed during the survey include *AE1*'s hydroplane guards, rudder and skeg. All four guards are lying flat on the seabed, just beneath their respective hydroplanes. While natural processes such as corrosion could have caused them to fall away from the hull, a more likely explanation is that they snapped off as *AE1* fell onto its keel after initially striking the seabed stern first and pitching forward. *AE1*'s rudder and skeg were found lying beneath the port side propeller. Both appear to have been broken off by the submarine striking the seabed stern first; however, the angle of the impact was shallow enough that it did not damage *AE1*'s propellers.

Figure 3 – Interim 3D photogrammetric model of *AE1*. The submarine's port side is shown, and the bow is at image left. 3D models by Curtin University from images courtesy of Paul G Allen, Find AE1 Ltd, Australian National Maritime Museum and Curtin University. © Curtin University

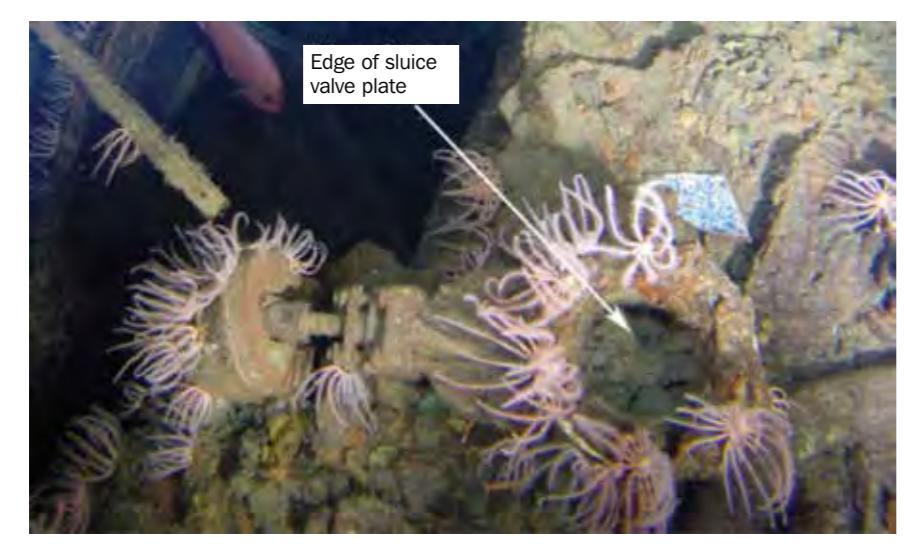
Close inspection of the submarine's ventilation valve – which was positioned in the after section of the fin and is currently exposed as a consequence of the fin toppling forward and dislodging the valve's associated ventilation trunking – revealed that the edge of its sluice plate is positioned across the valve so that it was ~60% open (Figure 5). Given that the ventilation valve was not completely shut, it would have served as a point of ingress for water while the submarine was submerged, and likely was the primary contributing factor to its loss. The ventilation valve's mechanism, and its hypothesised role in *AE1*'s loss, are discussed in greater detail in Annex C (see page 59).

Figure 5 - AE1's open ventilation valve; the arrow indicates the edge of the valve's sluice plate. Image courtesy of Paul G Allen, Find AE1 Ltd, Australian National Maritime Museum and Curtin University. © Navigea Ltd

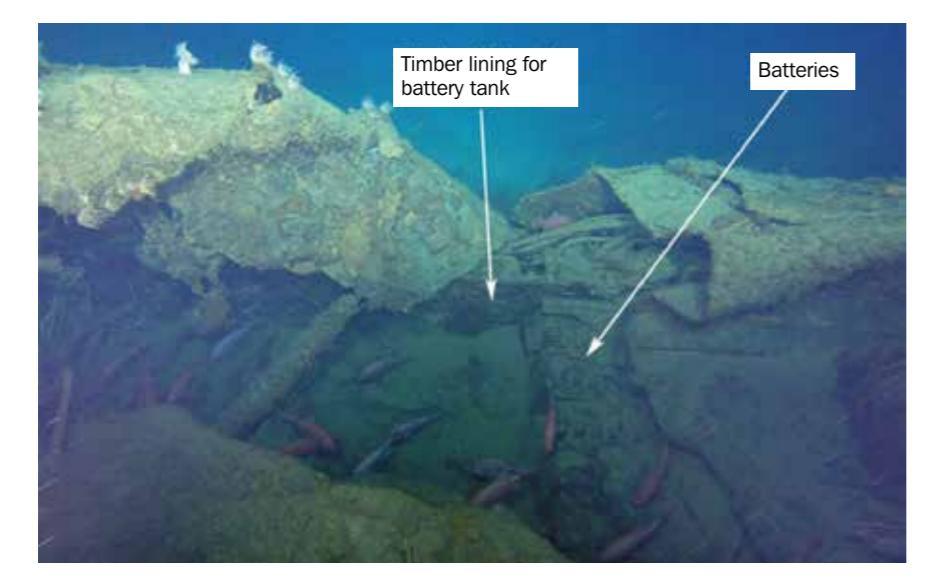
Figure 8 - Remnants of the timber lining for one of AE1's battery tanks, located within the remains of the control room along the submarine's starboard interior hull. Image courtesy of Paul G Allen, Find AE1 Ltd, Australian National Maritime Museum and Curtin University. © Navigea Ltd

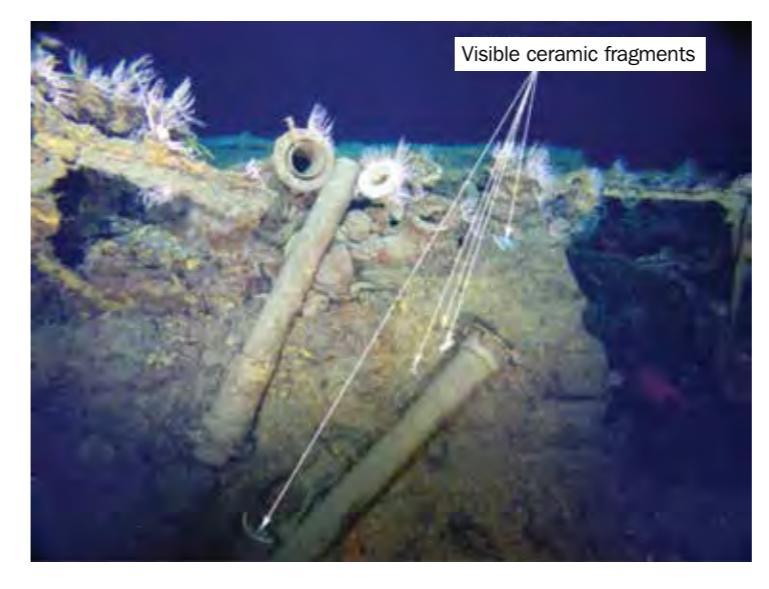
Five fragments of a basin-shaped ceramic vessel were discovered in the approximate location of the aft end of AE1's fin and appear to be remnants of either a porcelain chamber-pot or the basin from a purpose-made ship's head (Figure 9). One fragment clearly has a blue-and-white floral motif and appears to be transferprinted whiteware. Efforts are ongoing to identify the specific transfer-printed pattern on these fragments and determine the date range, origin and purpose of the ceramic vessel. While it is possible the ceramic fragments could be intrusive, the fact that there are multiple examples relatively close to one another, and that at least one is pinned beneath hardware from the submarine, lends credence to its being associated directly with AE1. If this is the case, the presence of the fragments also strongly suggests the fin did not completely dislodge until the submarine struck the seabed, as relatively light artefacts of this type would almost certainly have been removed from context and dispersed into the water column.

Figure 9 – Upper surface of AE1's pressure hull at its junction with the after end of the fin, showing five ceramic fragments believed to have once comprised one of the submarine's heads. Image courtesy of Paul G Allen, Find AE1 Ltd, Australian National Maritime Museum and Curtin University. © Navigea Ltd

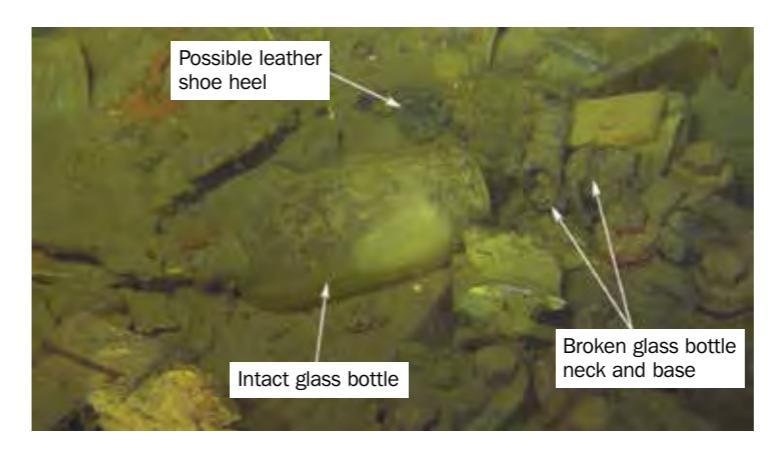
Figure 10 – Small finds located within AE1's control room, including an intact glass bottle, two bottle fragments and what appears to be a leather shoe or boot heel. Image courtesy of Paul G Allen, Find AE1 Ltd, Australian National Maritime Museum and Curtin University. © Navigea Ltd

Two fragments of another glass bottle are located immediately adjacent to the first and comprise a complete neck with rim and part of the base. In terms of appearance, the neck and rim most closely approximate a spirit (beer or wine) bottle. The glass does not appear to be transparent, although its colour is difficult to discern due to adhering marine growth and available image resolution (the bottle fragments and other artefacts were only captured by one of the ROV's standard-definition video cameras). As with the intact bottle, no diagnostic markings are visible on either fragment. What appears to be a leather shoe or boot heel is located a short distance forward of the bottle neck. It is roughly triangular in shape, brownish-black in colour, and appears to be positioned with its upper (interior) surface facing upwards. The glass artefacts and possible heel were located in the approximate location of the officers' wardroom lockers and may represent clothing and personal belongings that were stowed at the time of AE1's loss.
