Research Vessel Petrel Baseline Survey of HMAS AE1

April 2018

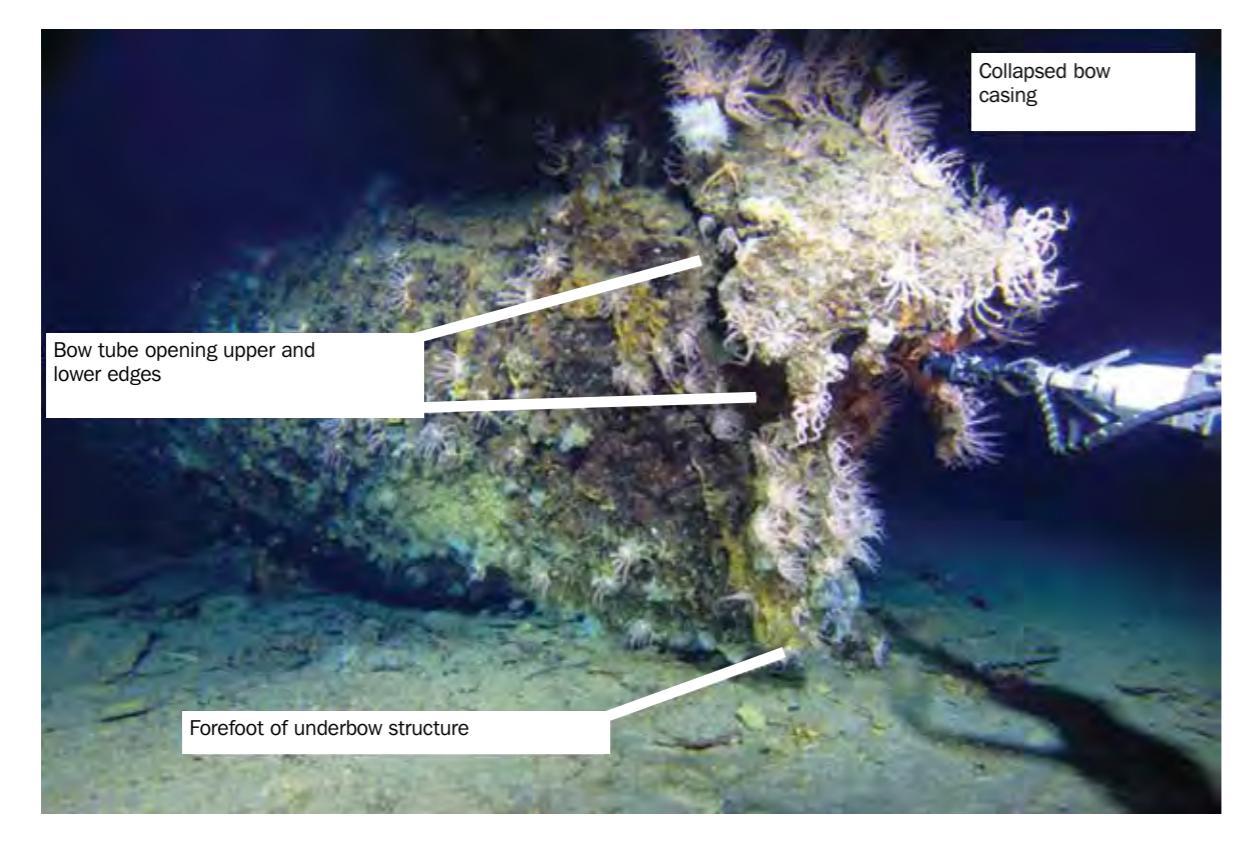
- The structure beneath the forward tube (bow, forefoot and supporting structure) is intact, with no sign of impact damage. This section appears to be clear of the seabed.

Figure 1 – Bow section.

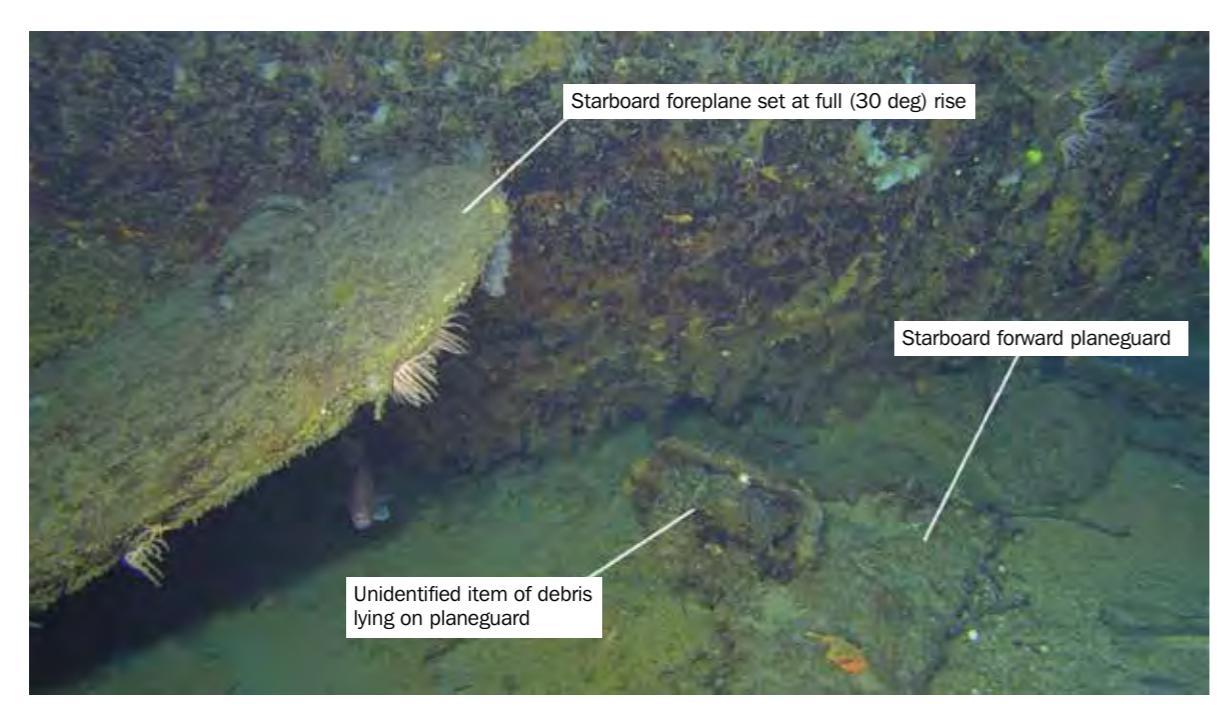
- The foreplanes are set hard (30 degrees) to rise.
- The forward planeguards are lying on the seabed close to below their mounted position.
- The forward planeguard securing points appear to have the same degree of corrosion/concretion/marine growth as the surrounding pressure hull.

Figure 2 – Starboard foreplane and planeguard. Image courtesy of Paul G Allen, Find AE1, Australian National Maritime Museum and Curtin University. © Navigea Ltd

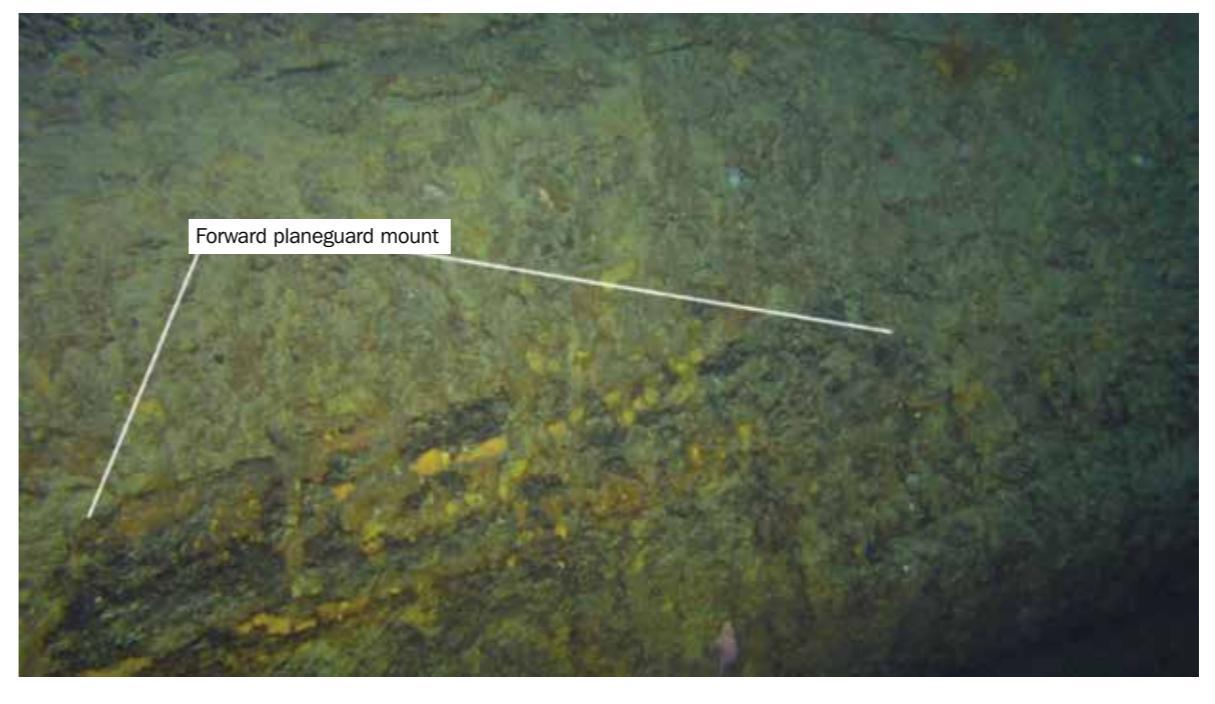
Figure 3 – Starboard forward planeguard mount. Image courtesy of Paul G Allen, Find AE1, Australian National Maritime Museum and Curtin University. © Navigea Ltd

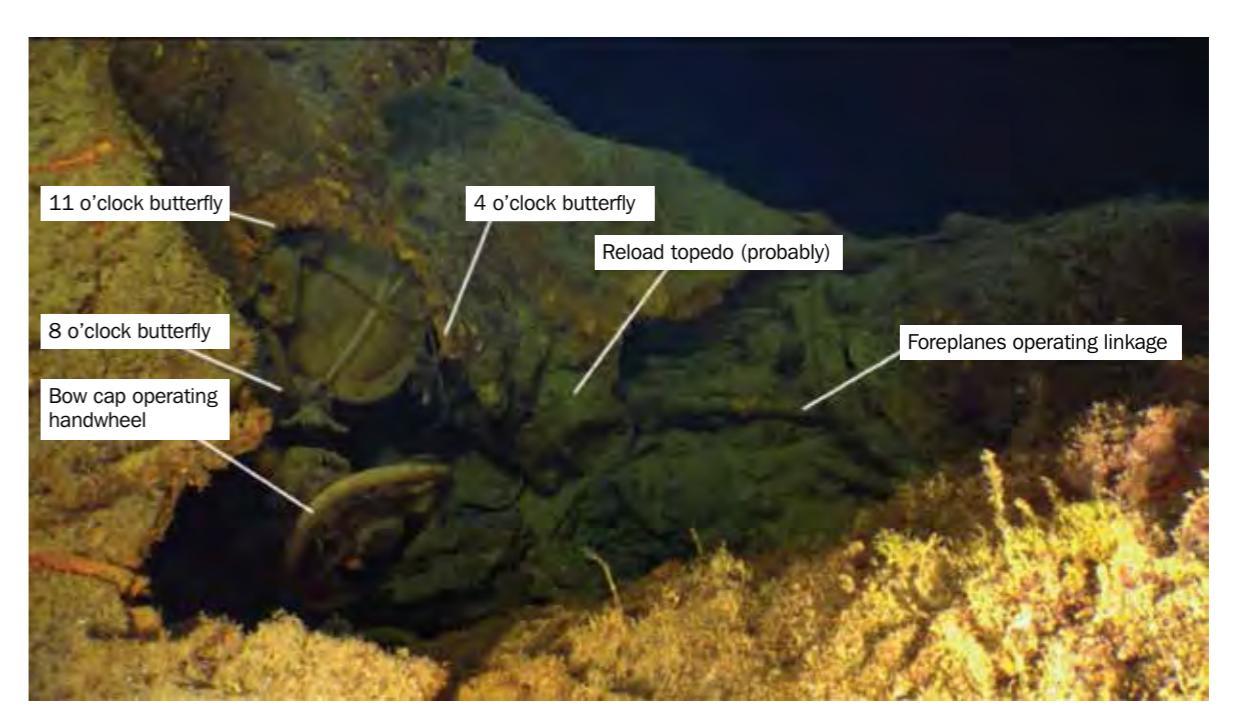
- The forward torpedo compartment has suffered a complete implosion, with the pressure hull folded flat to the point of failure with sections of the hull now lying on what was the deck of the forward torpedo compartment.

Figure 4 – Forward implosion area and forward tube rear door. Image courtesy of Paul G Allen, Find AE1, Australian National Maritime Museum and Curtin University. © Navigea Ltd

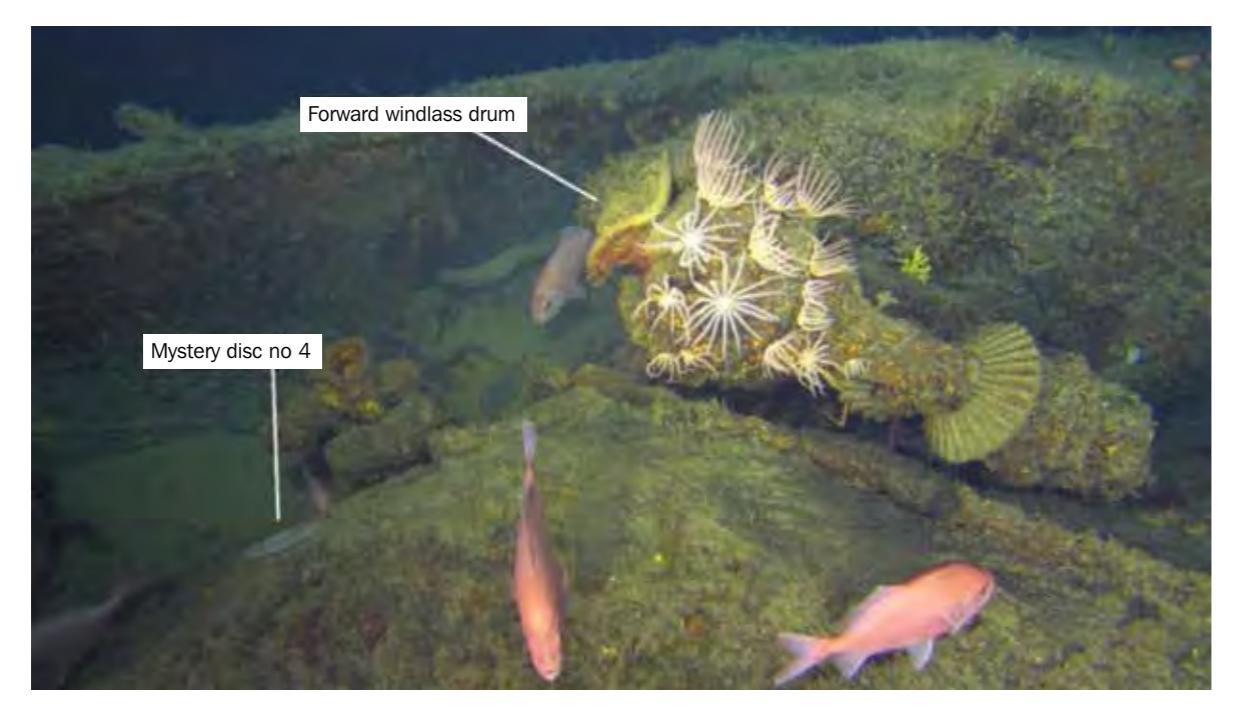
Figure 5 – Forward windlass. Image courtesy of Paul G Allen, Find AE1, Australian National Maritime Museum and Curtin University. © Navigea Ltd

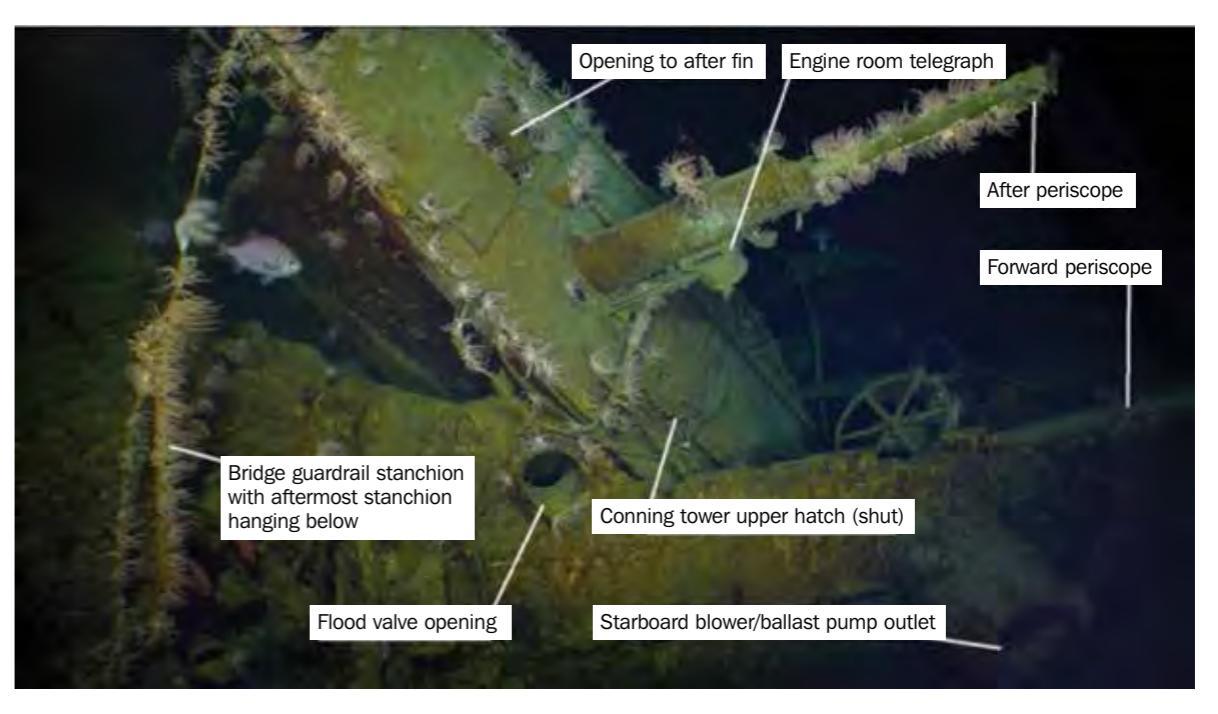
Figure 7 – Fin area from starboard. Image courtesy of Paul G Allen, Find AE1, Australian National Maritime Museum and Curtin University. © Navigea Ltd

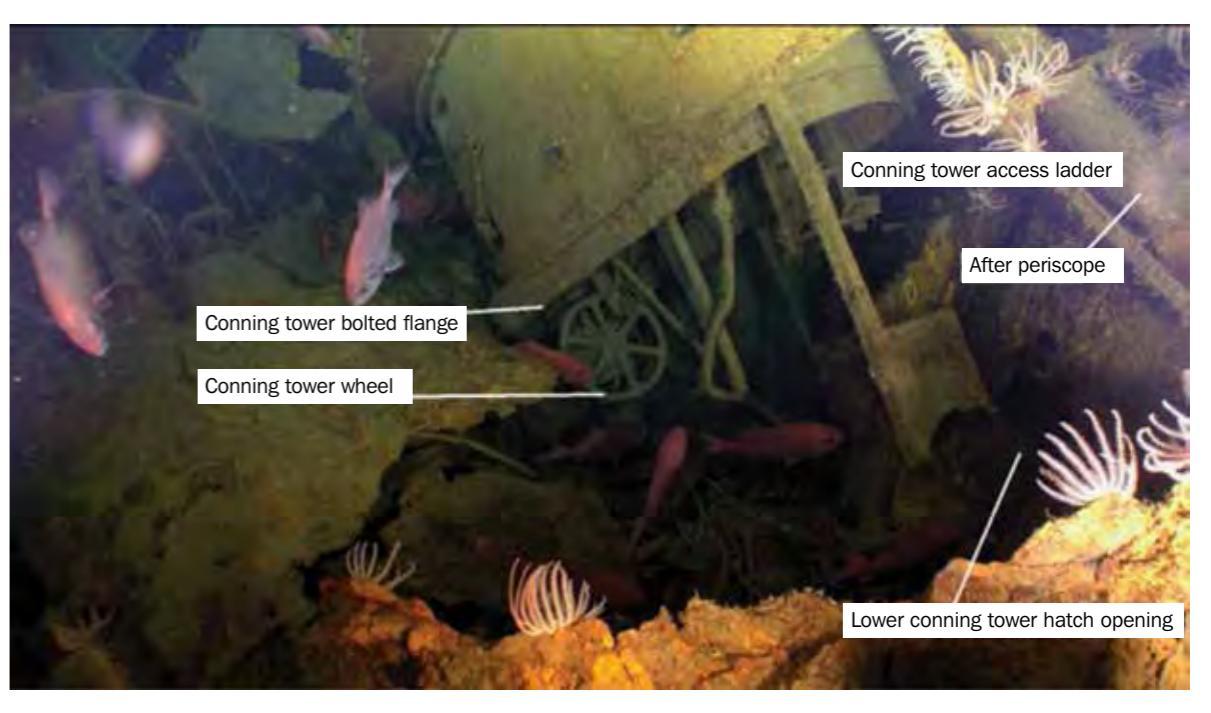
Figure 8 – Fin from port. Note absence of conning tower lower section. Image courtesy of Paul G Allen, Find AE1, Australian National Maritime Museum and Curtin University. © Navigea Ltd

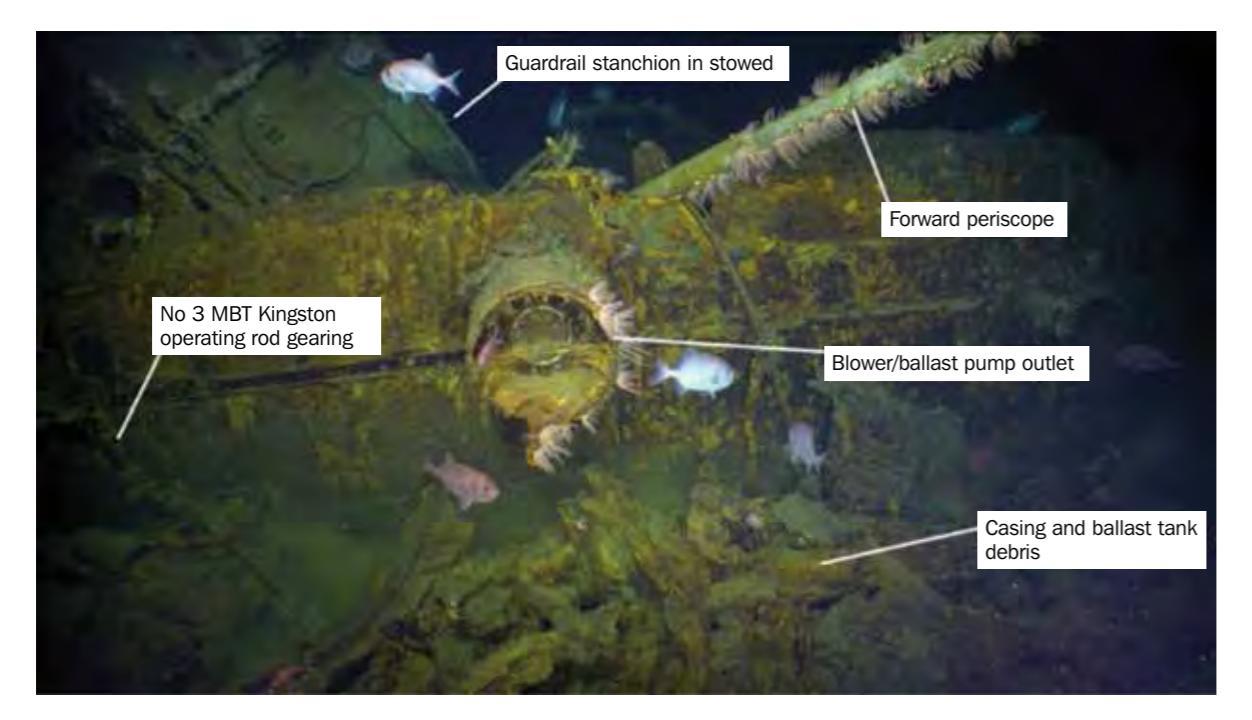
Figure 9 – Starboard blower and No. 3 main ballast tank debris. Image courtesy of Paul G Allen, Find AE1, Australian National Maritime Museum and Curtin University. © Navigea Ltd

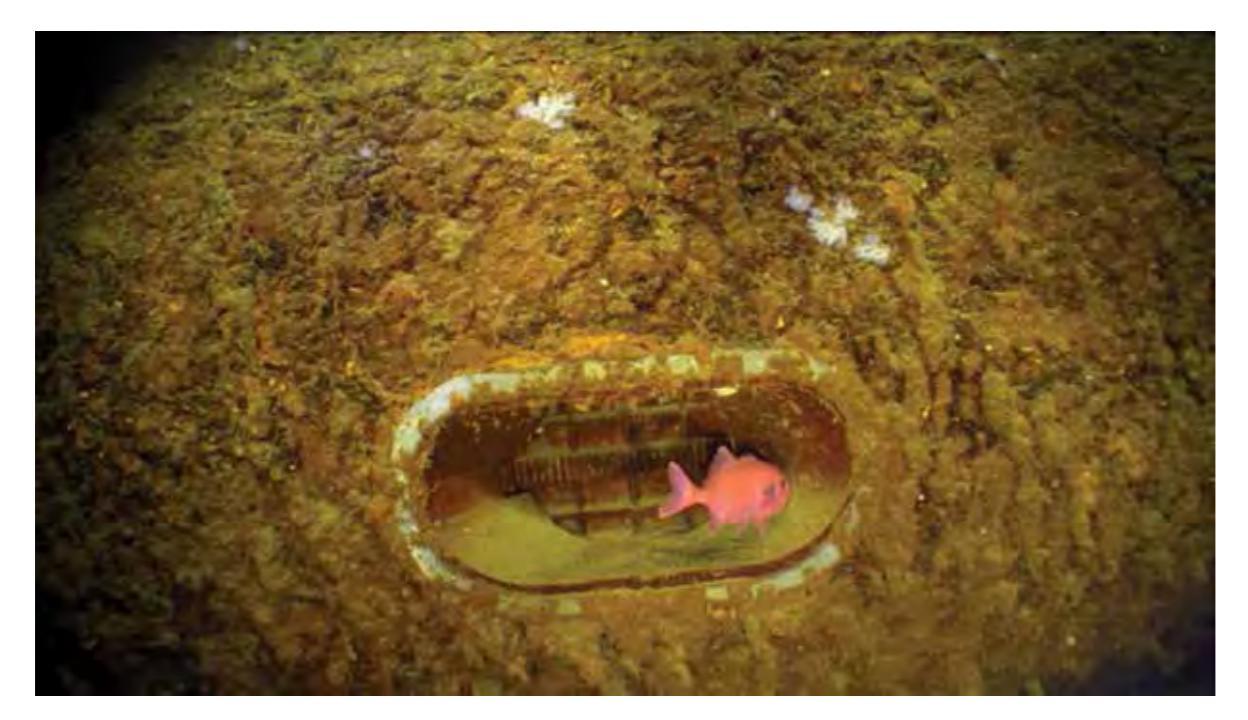
Figure 10 – Starboard beam tube outer door (shut). Image courtesy of Paul G Allen, Find AE1, Australian National Maritime Museum and Curtin University. © Navigea Ltd

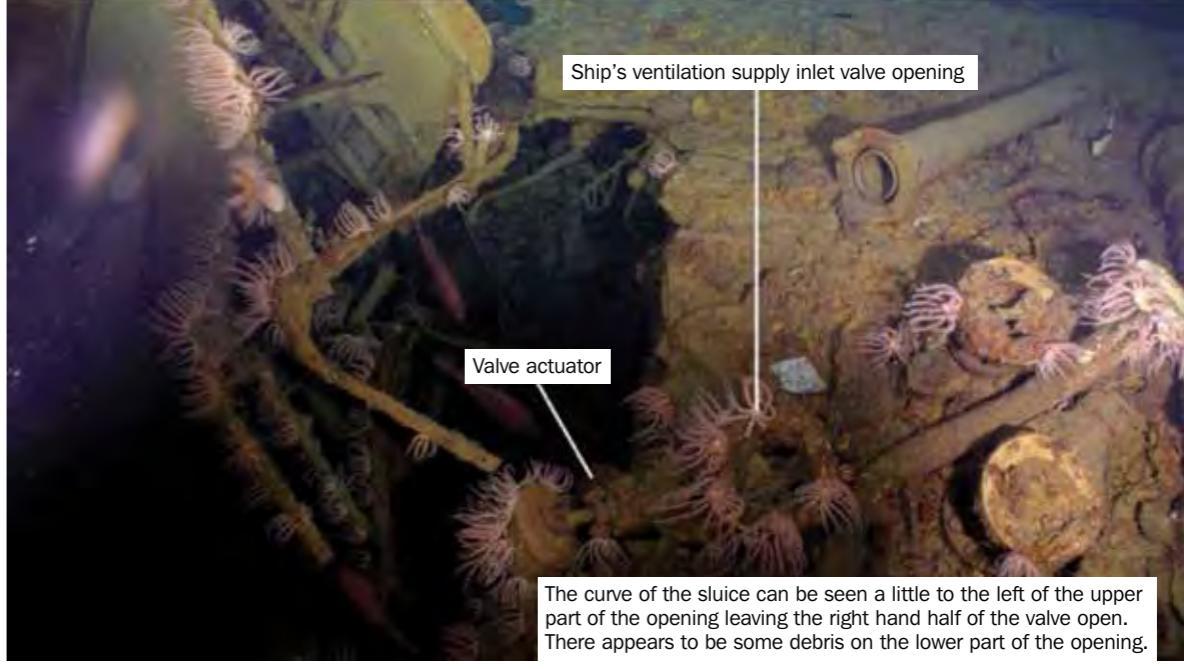
Figure 11 – Ventilation trunking and hull valves. Image courtesy of Paul G Allen, Find AE1, Australian National Maritime Museum and Curtin University. © Navigea Ltd

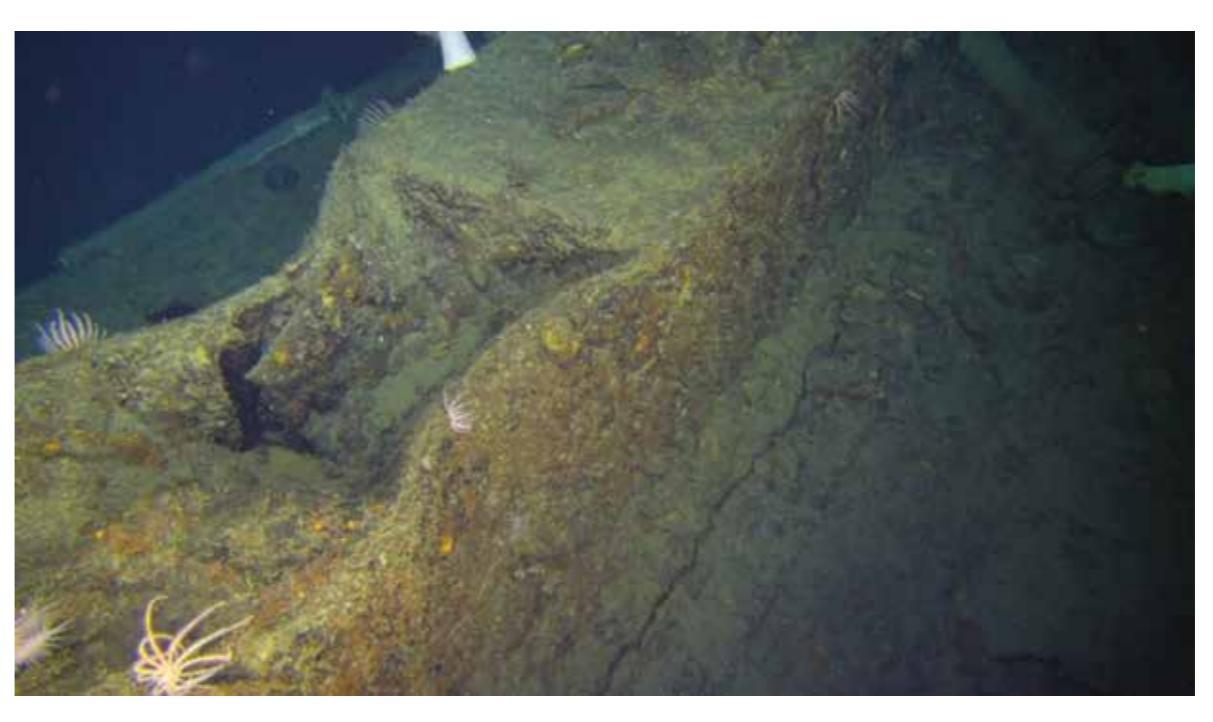
Figure 12 – Beam tube firing tanks. Image courtesy of Paul G Allen, Find AE1, Australian National Maritime Museum and Curtin University. © Navigea Ltd

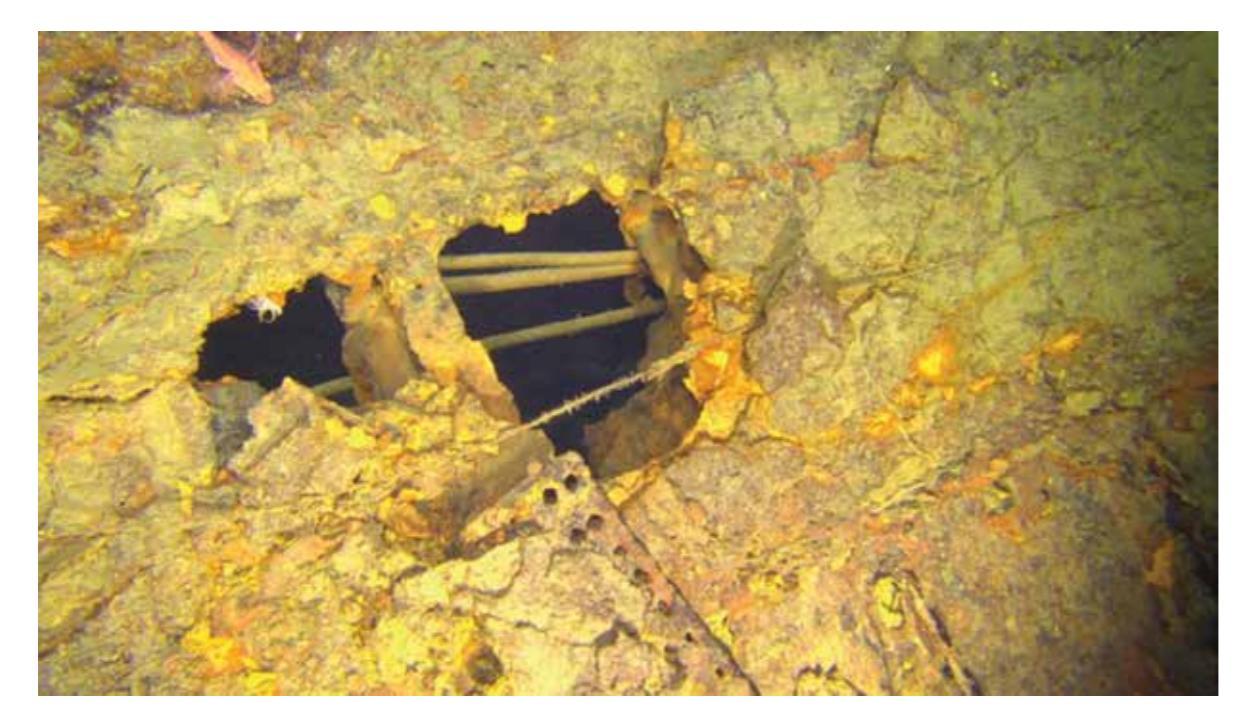
Figure 13 – Hole over senior sailors' mess. Image courtesy of Paul G Allen, Find AE1, Australian National Maritime Museum and Curtin University. © Navigea Ltd

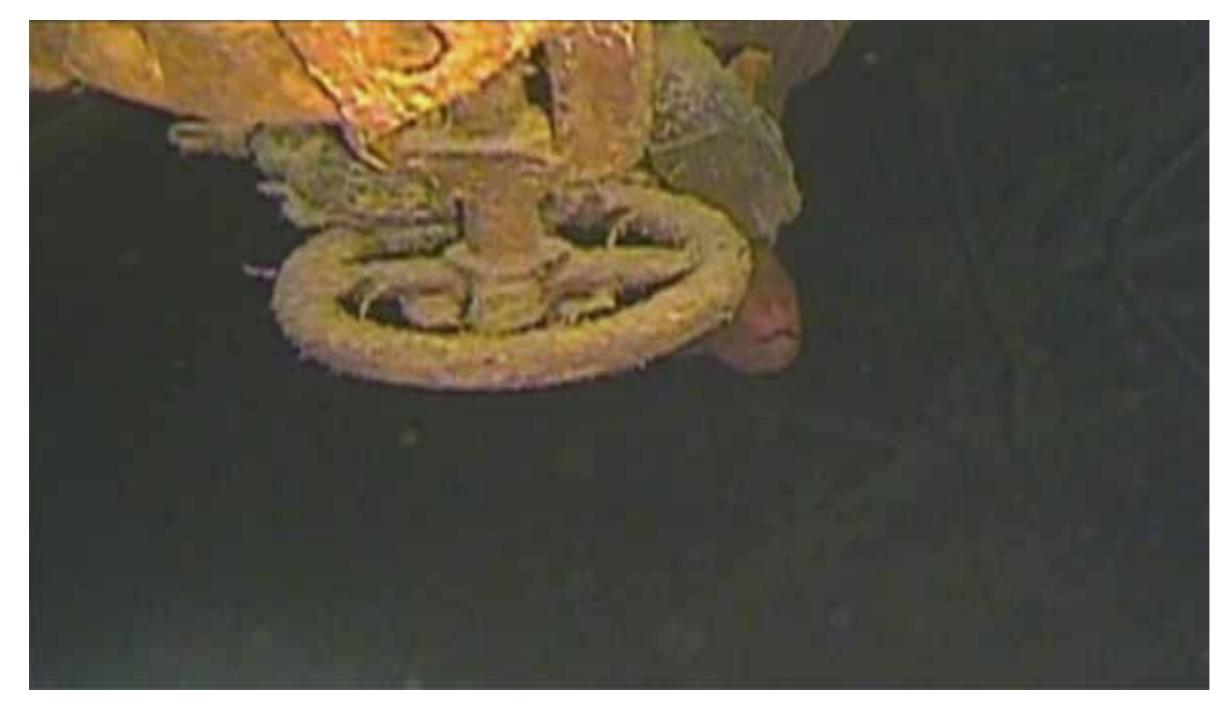
Figure 14 – No. 5 main vent valve handwheel. Image courtesy of Paul G Allen, Find AE1, Australian National Maritime Museum and Curtin University. © Navigea Ltd

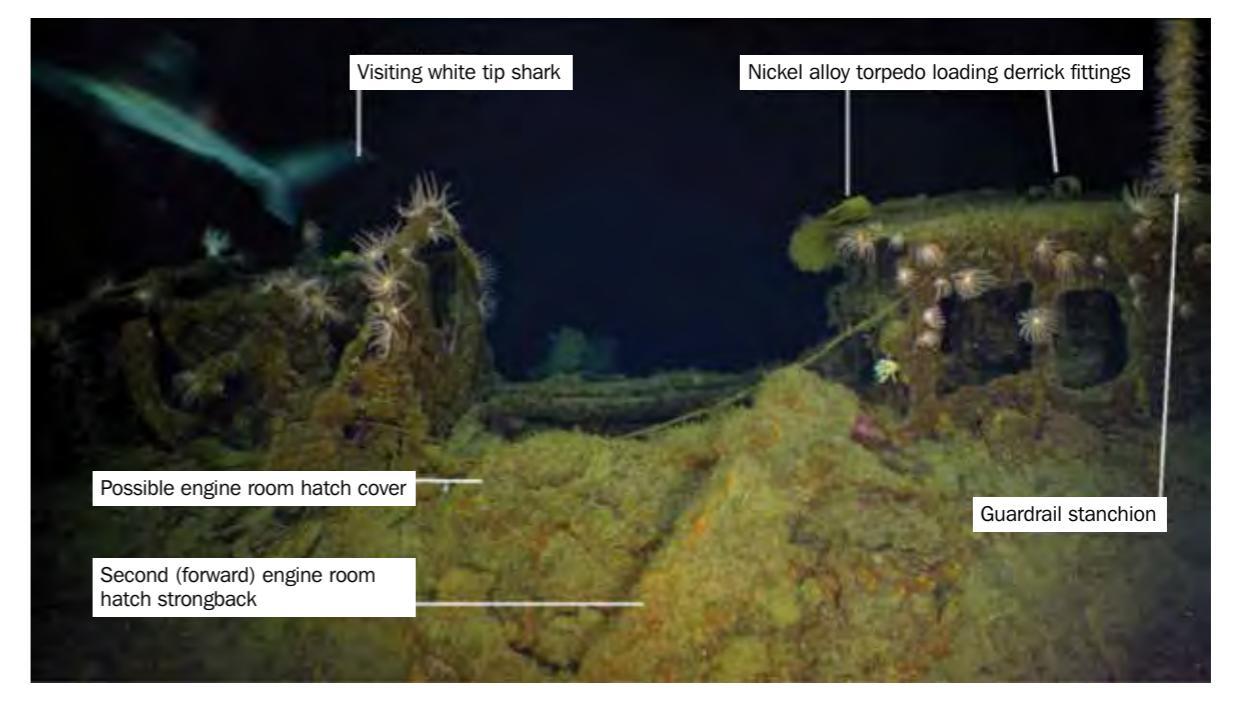
Figure 15 – Engine room hatch from port side. Image courtesy of Paul G Allen, Find AE1, Australian National Maritime Museum and Curtin University. © Navigea Ltd

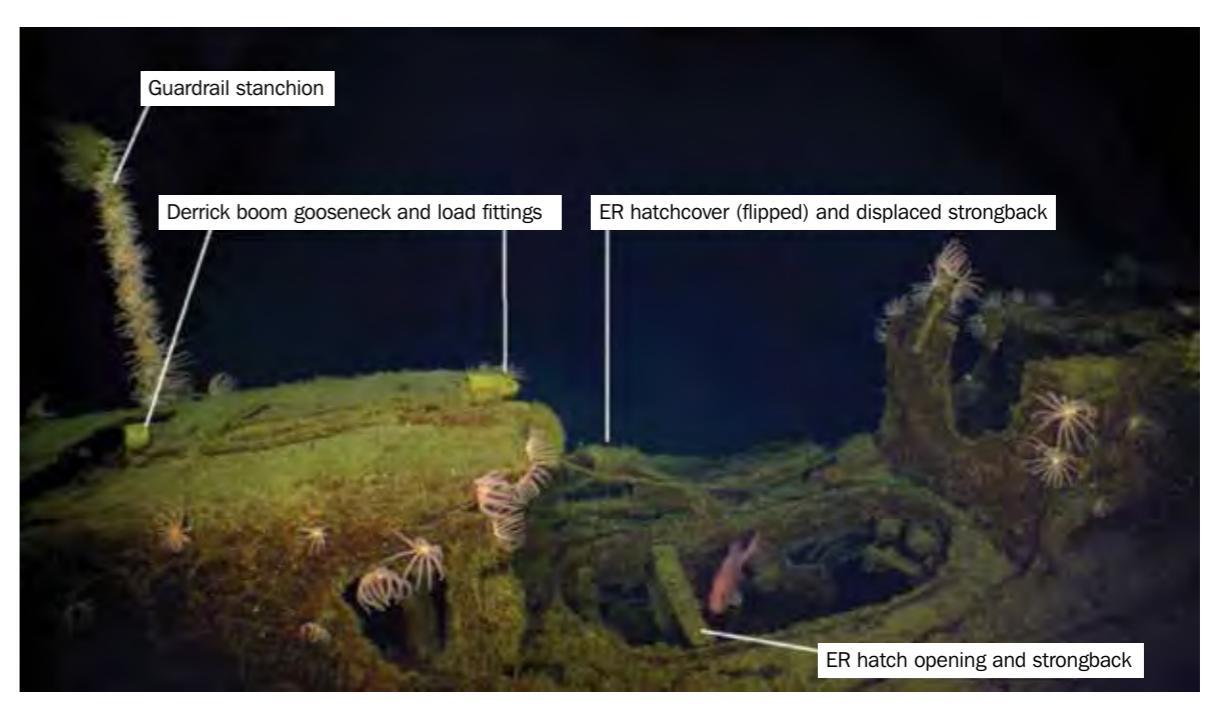
Figure 16 – Engine room hatch from starboard. Image courtesy of Paul G Allen, Find AE1, Australian National Maritime Museum and Curtin University. © Navigea Ltd

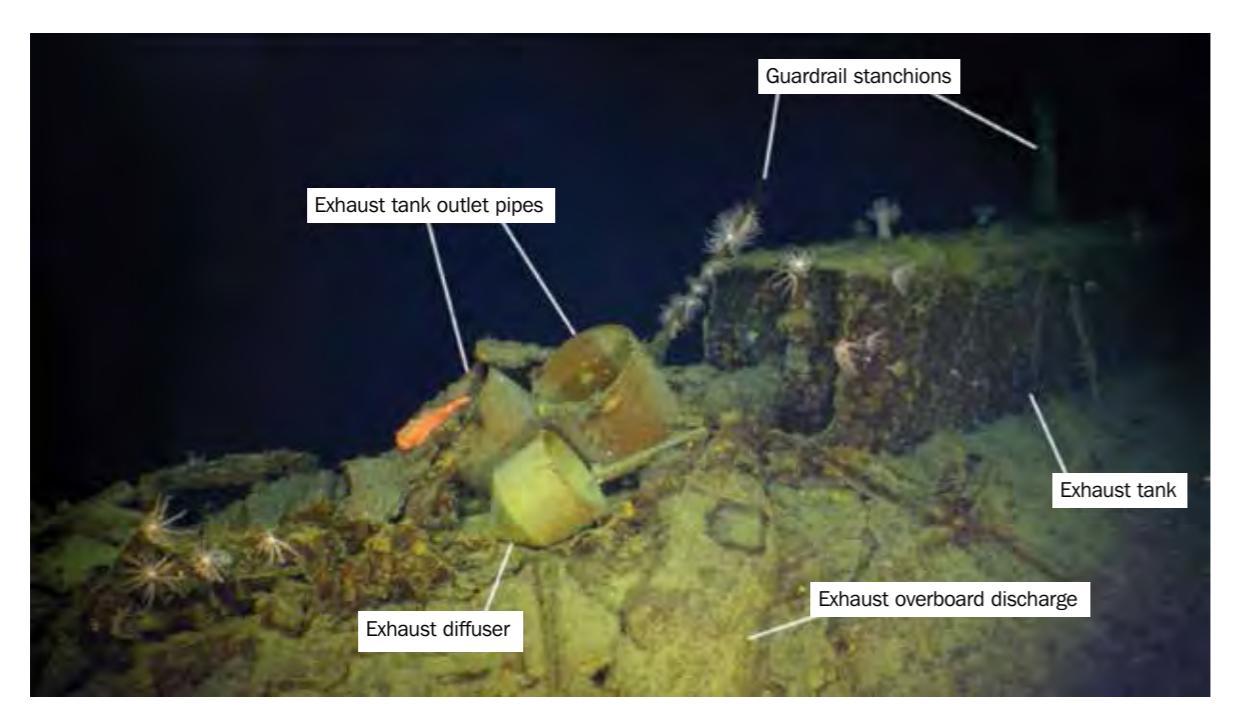
Figure 17 – Exhaust tank outlet pipework.

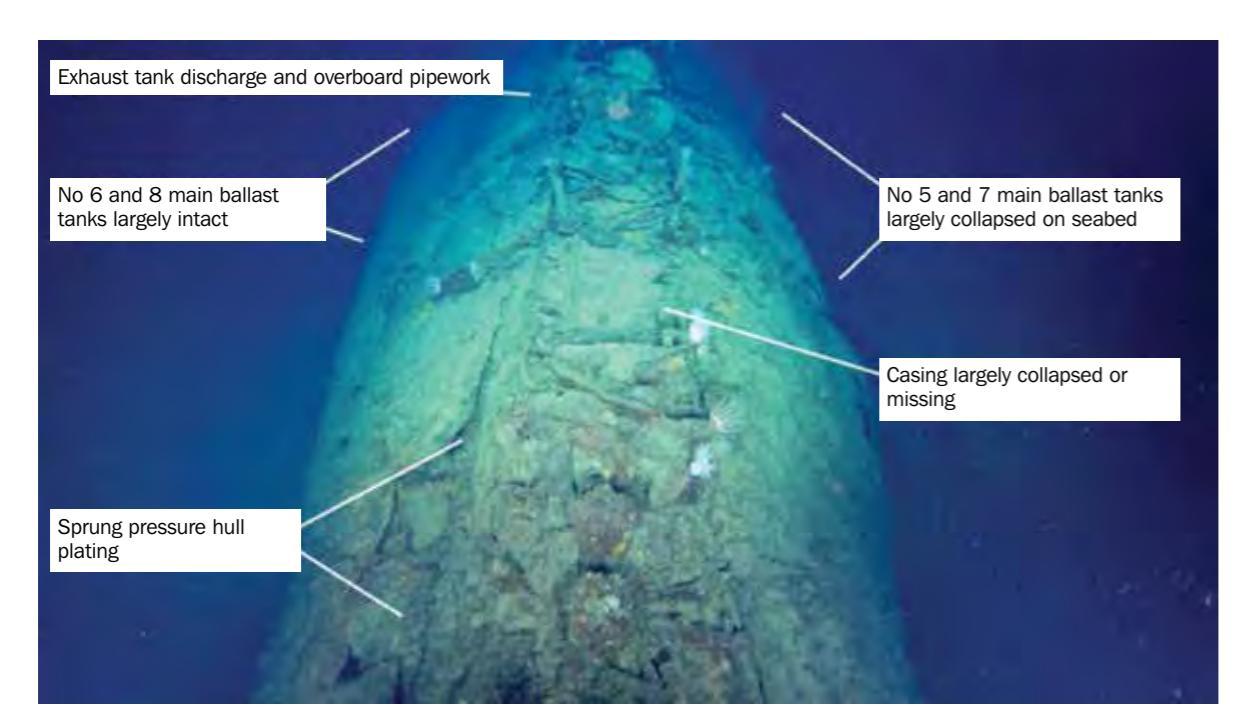
Figure 18 – After casing area. Note how little of the casing remains. Image courtesy of Paul G Allen, Find AE1, Australian National Maritime Museum and Curtin University. © Navigea Ltd

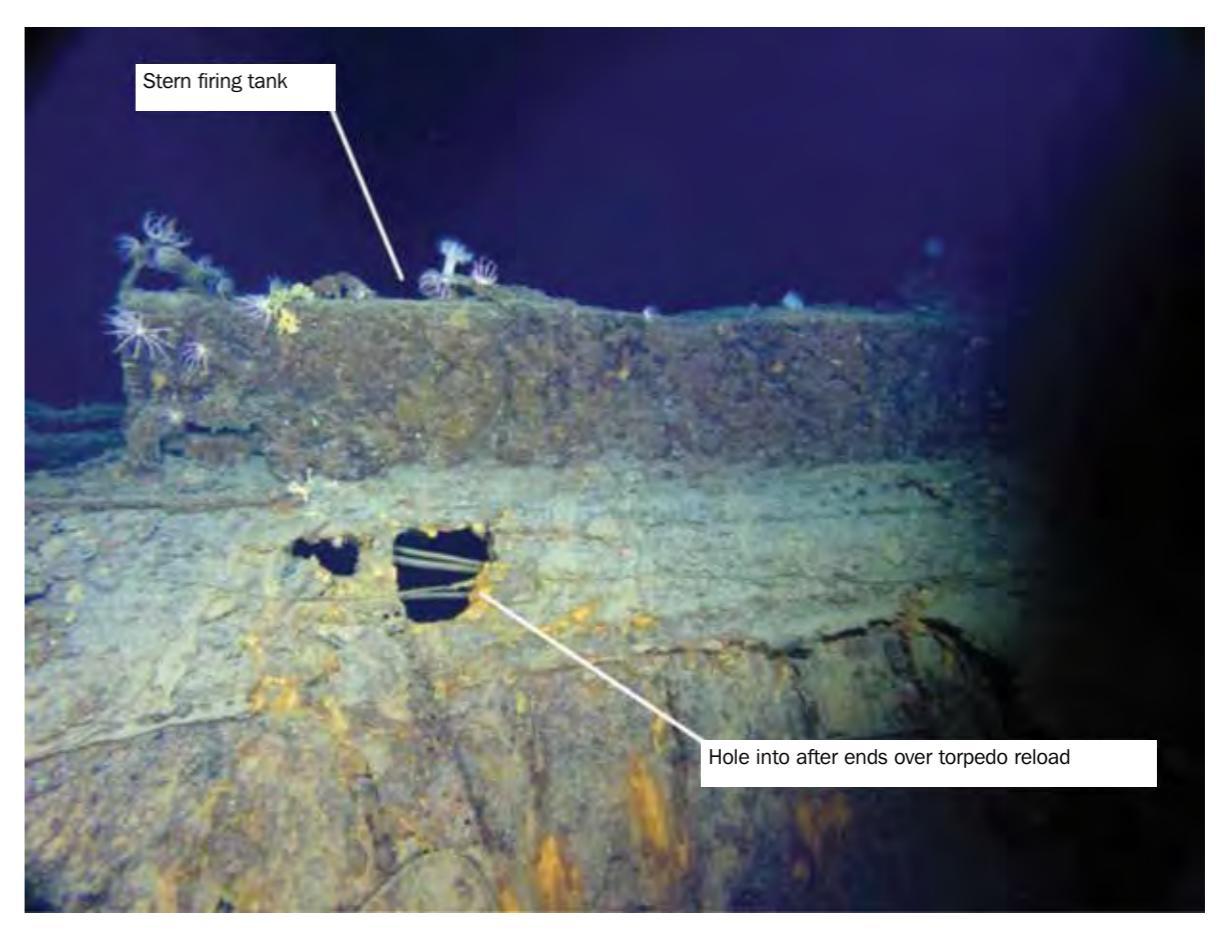
Figure 19 – Stern firing tank and hole over after ends (viewed from port). Image courtesy of Paul G Allen, Find AE1, Australian National Maritime Museum and Curtin University. © Navigea Ltd

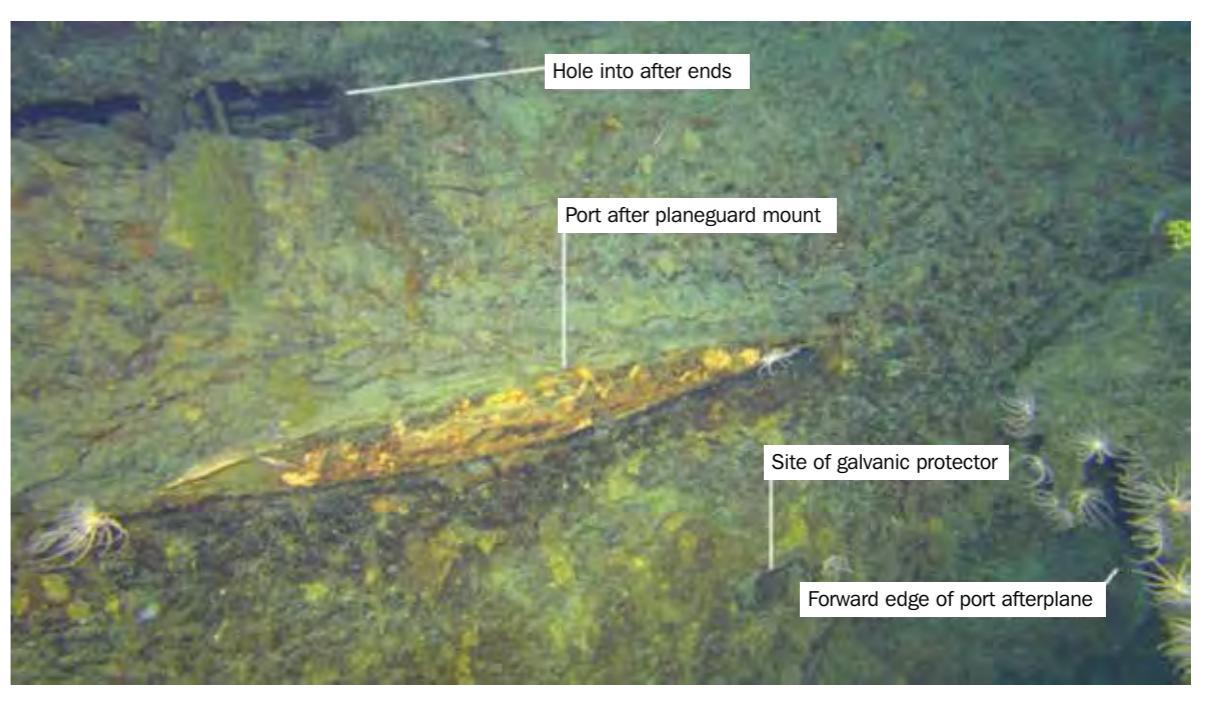
Figure 20 – Port after planeguard mount. Image courtesy of Paul G Allen, Find AE1, Australian National Maritime Museum and Curtin University. © Navigea Ltd

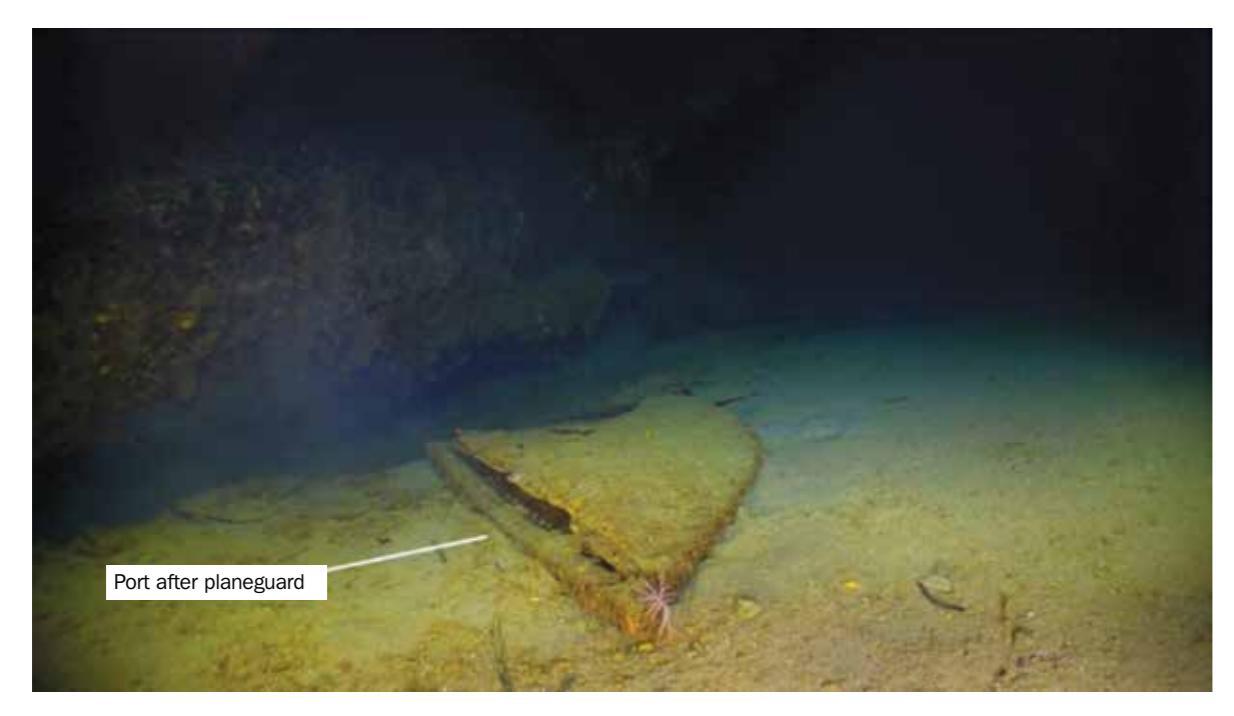
Figure 21 – Port after planeguard. Image courtesy of Paul G Allen, Find AE1, Australian National Maritime Museum and Curtin University. © Navigea Ltd

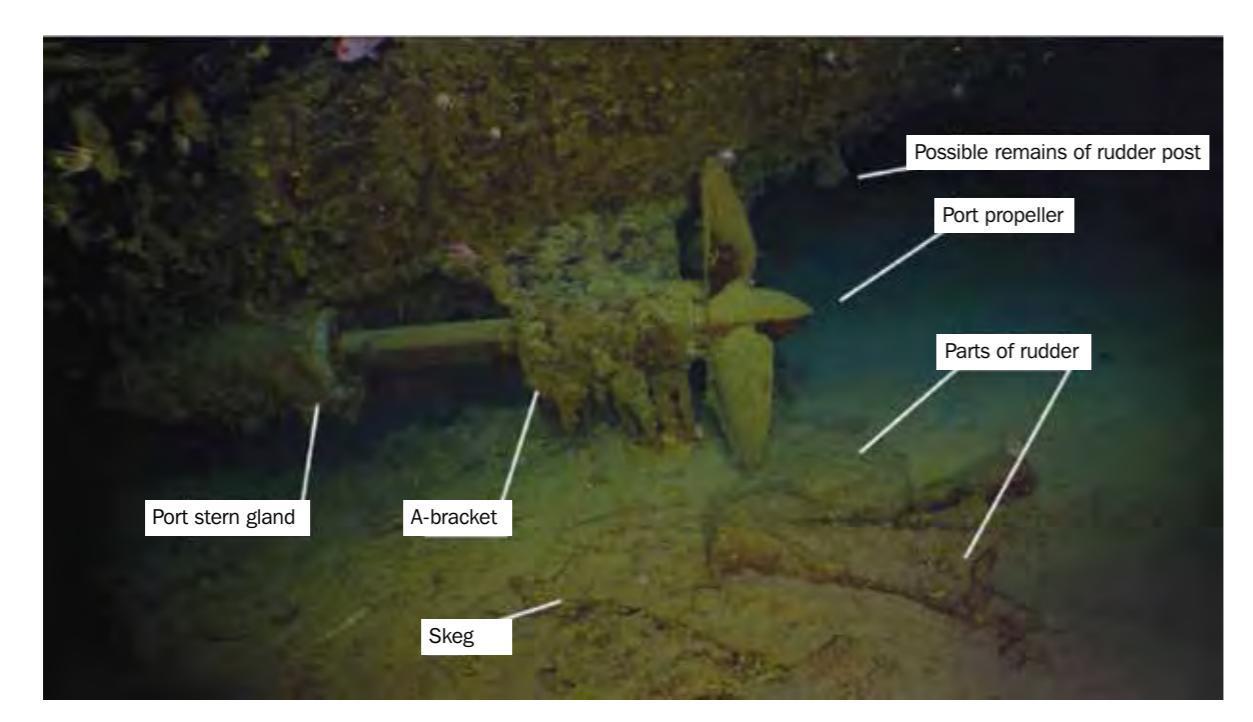
Figure 22 – Port propeller shaft, rudder and skeg. Image courtesy of Paul G Allen, Find AE1, Australian National Maritime Museum and Curtin University. © Navigea Ltd

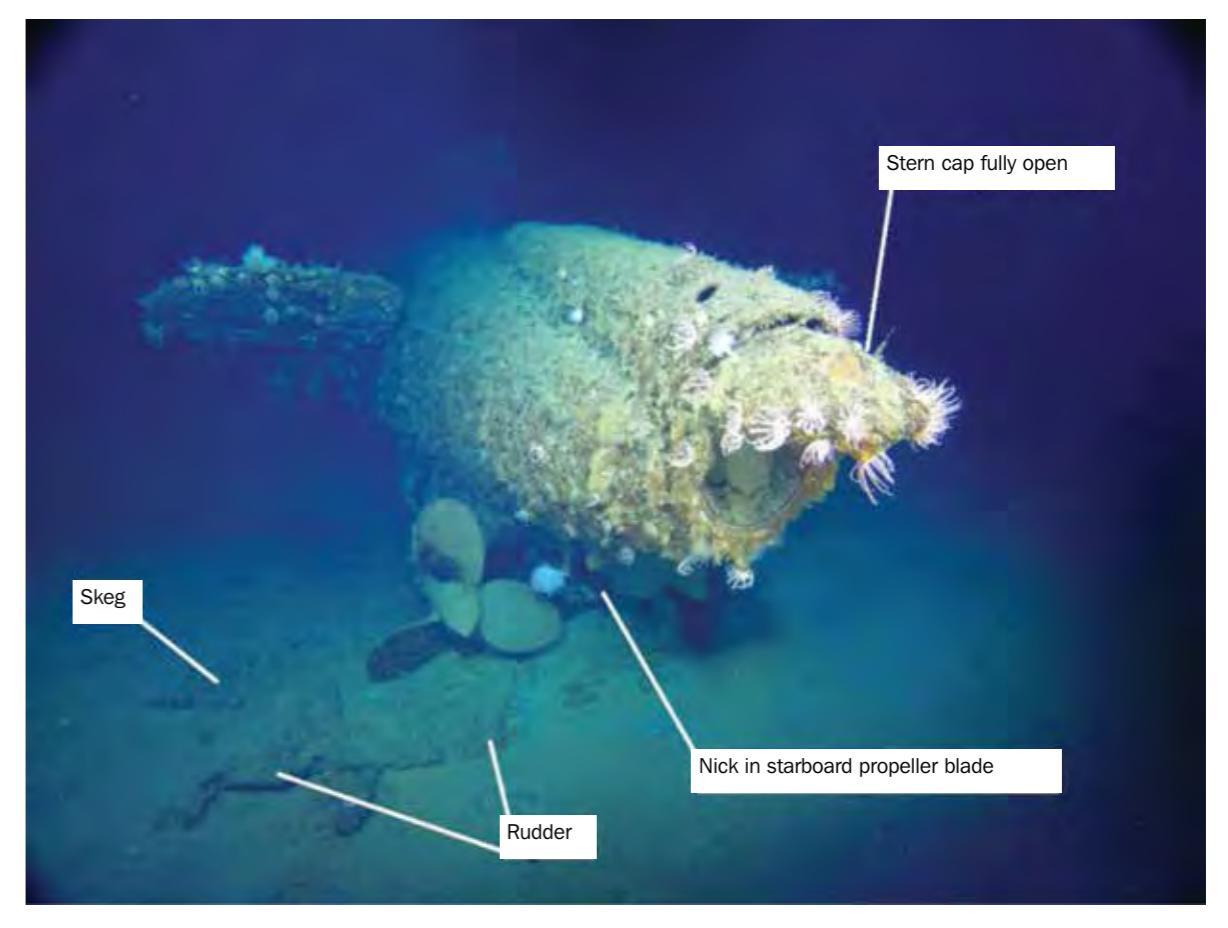
Figure 23 – Stern tube, rudder and skeg. Image courtesy of Paul G Allen, Find AE1, Australian National Maritime Museum and Curtin University. © Navigea Ltd

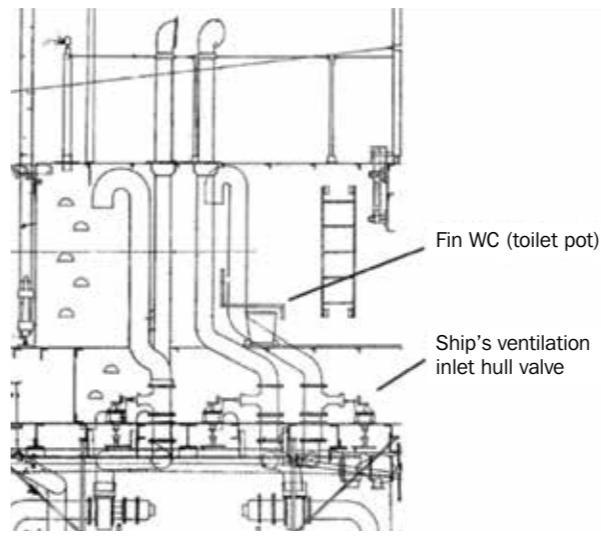
From this we can only conclude that the valve was at least part-opened at the time of the accident. It is possible that it was fully open at the time of diving, which resulted in a flood to the ventilation trunking. On seeing the flood, attempts were made to shut the valve, resulting in it being in its current position.

If the submarine were to dive with the valve open or part (60%) open it would result in a large ingress of water at pressure to the ship's ventilation supply trunking. The build specification calls for the trunking to be fitted with a quick-closing valve similar to those fitted to the battery ventilation system. However, the drawings - neither ship and battery ventilating system drawing no. 2923 nor the general arrangement show such a valve and the configuration of the internal pipework is such that it is hard to see where it could be successfully fitted. That is not to say a quick-acting valve was not fitted but it does increase the possibility that the open sluice valve could have led to a flood.

Figure 25 - Extract from general arrangement drawing of ventilation hull valves (L) and ship's ventilation hull valve (Petrel) (R). Image courtesy of Paul G Allen, Find AE1, Australian National Maritime Museum and Curtin University. © Navigea Ltd

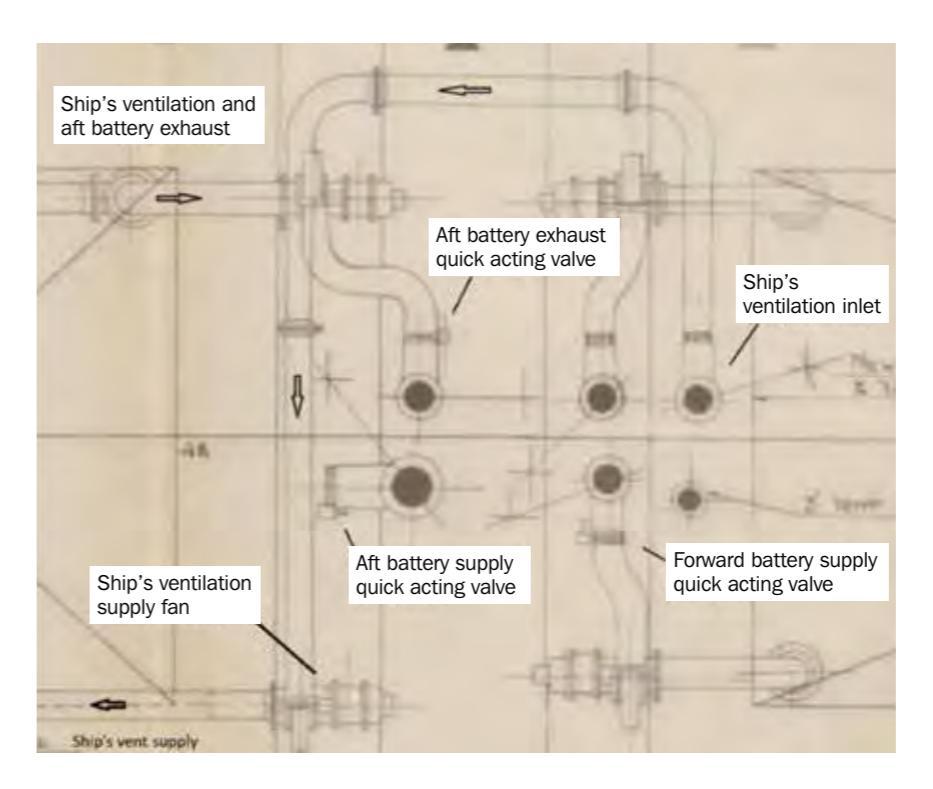
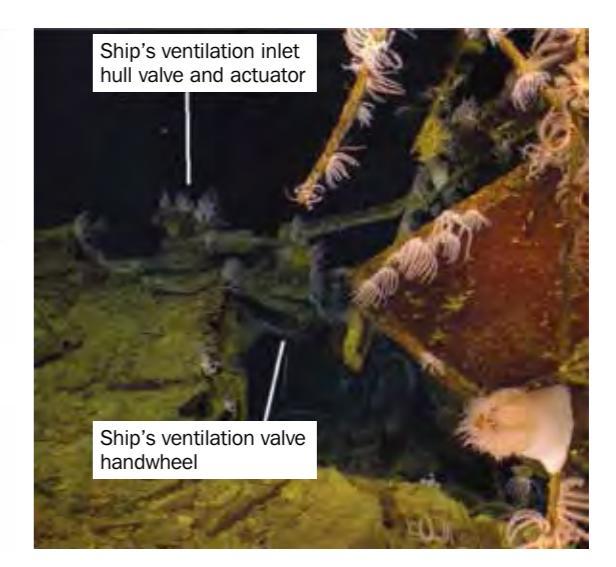
Figure 26 – Extract from ship's drawing No. 2923, 'Battery and ship's ventilation'. Note absence of quick-acting valve from ship's supply trunking. Image courtesy of NAA: MP551/1. 109/77

A comparison of the battery and ship's ventilation drawing (Figure 26) with the (later) general arrangement drawing (Figure 27) shows that the forward battery supply quick acting valve was moved to be just above its entry to the battery tank. It was in this position that such a valve was seen in *AE2*. The change to the design was presumably made because of the physical difficulty of mounting such a valve in the overhead trunking. There would have been similar difficulties with the ship's ventilation supply. It is also possible that in the face of those practical difficulties, a quick-acting valve was considered less of a priority when the trunking did not lead into a battery tank.
