Research Vessel Petrel Baseline Survey of HMAS AE1

April 2018

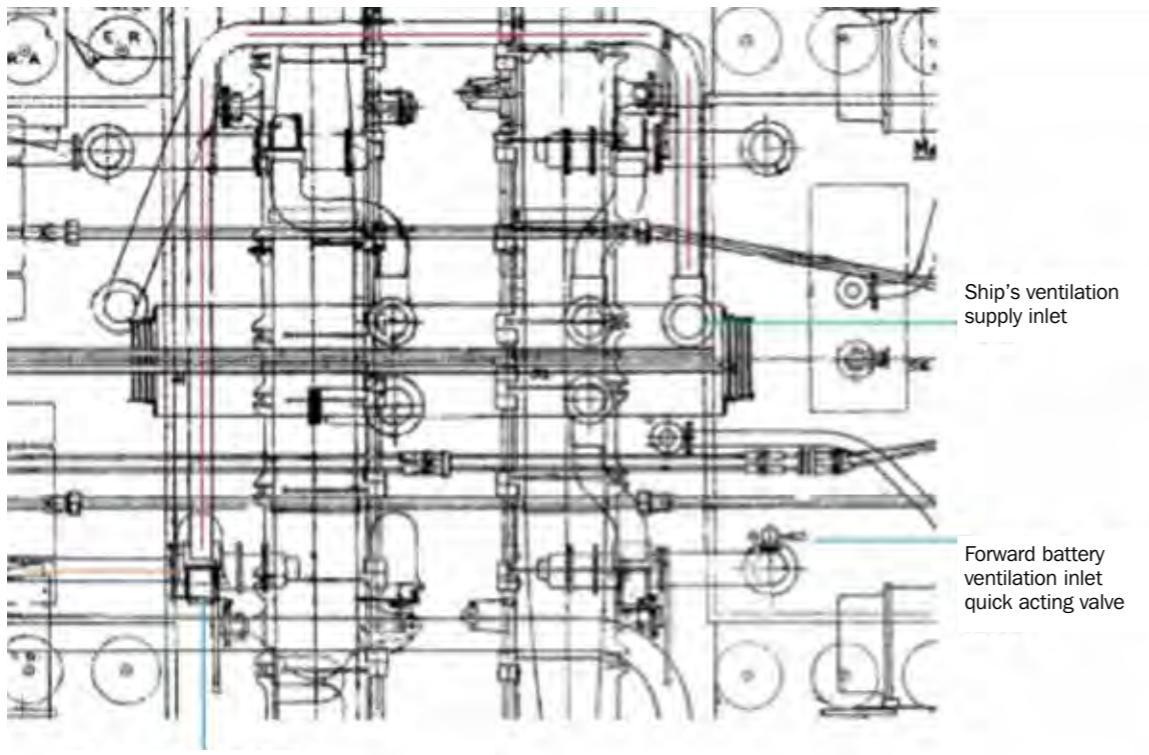
A comparison of the battery and ship's ventilation drawing (Figure 26) with the (later) general arrangement drawing (Figure 27) shows that the forward battery supply quick acting valve was moved to be just above its entry to the battery tank. It was in this position that such a valve was seen in *AE2*. The change to the design was presumably made because of the physical difficulty of mounting such a valve in the overhead trunking. There would have been similar difficulties with the ship's ventilation supply. It is also possible that in the face of those practical difficulties, a quick-acting valve was considered less of a priority when the trunking did not lead into a battery tank.

Figure 27 – Extract from general arrangement drawing of ventilation supply arrangement. Note new position of forward battery vent supply quick-acting valve and absence of quick-acting valve from ship's supply.

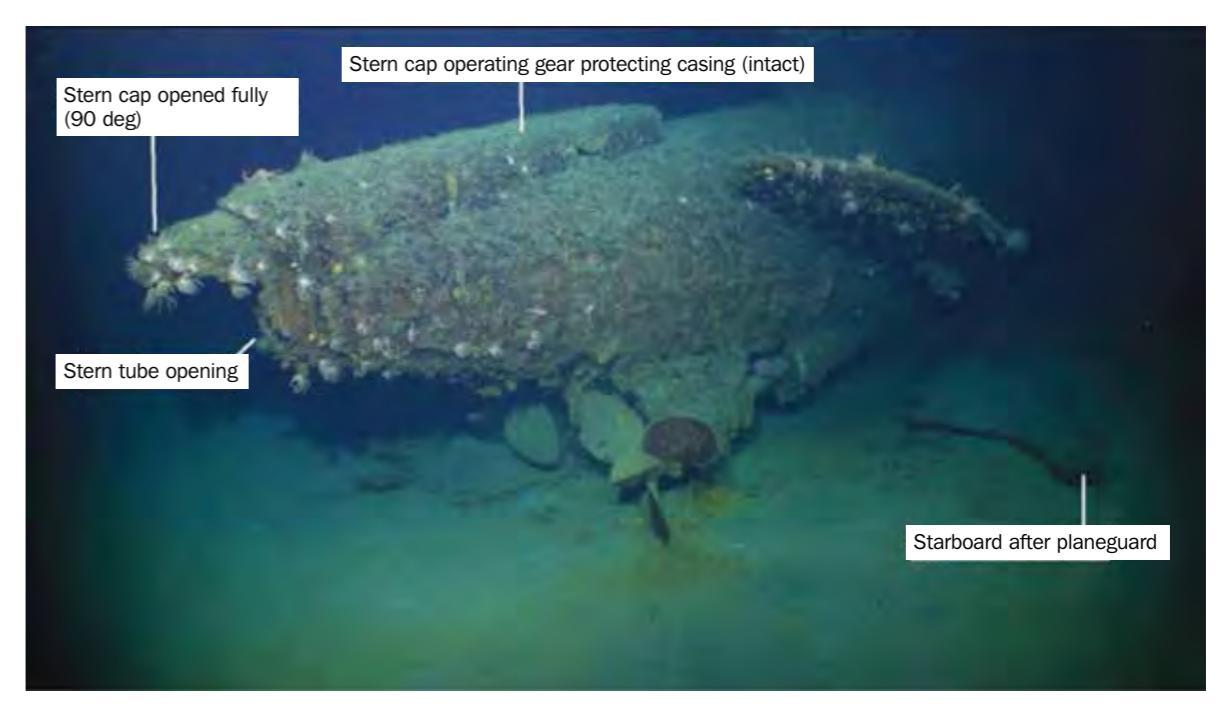
It might be possible given the forces acting in the implosion and the impact with the seabed for the worm gear to slip a tooth or two, but it is hard to imagine that the stern cap could be 'flicked' to the fully open position, particularly as the whole of the stern area is intact and in fact quite well-preserved. Thus, if we accept that the accident occurred on diving (due to the open ship's ventilation valve) we must conclude that the stern cap was deliberately opened prior to the submarine diving.

Given that the stern tube is clear of the water when the submarine is at full buoyancy it is practical for it to be opened when the submarine is surfaced. It could have been opened as part of a weapons drill or perhaps with the intention to achieve a higher level of weapons readiness in the expectation of meeting the German steamer. We cannot know why the stern cap is open but the evidence is that it is.

Figure 28 – View of after ends, showing open stern cap. Image courtesy of Paul G Allen, Find AE1, Australian National Maritime Museum and Curtin University. © Navigea Ltd

With the stern cap open, the outer section of the tube would flood on diving. This represents an increase to the submarine's bodily weight of some 97 gallons (\sim 367 litres, weighing some 440 kilograms) at the extreme after end. If compensation had not been made, the submarine would have had a reduced buoyancy, been heavy overall and significantly out of trim (heavy aft). From this we can conclude that the stern cap being open could have worsened the situation on diving.

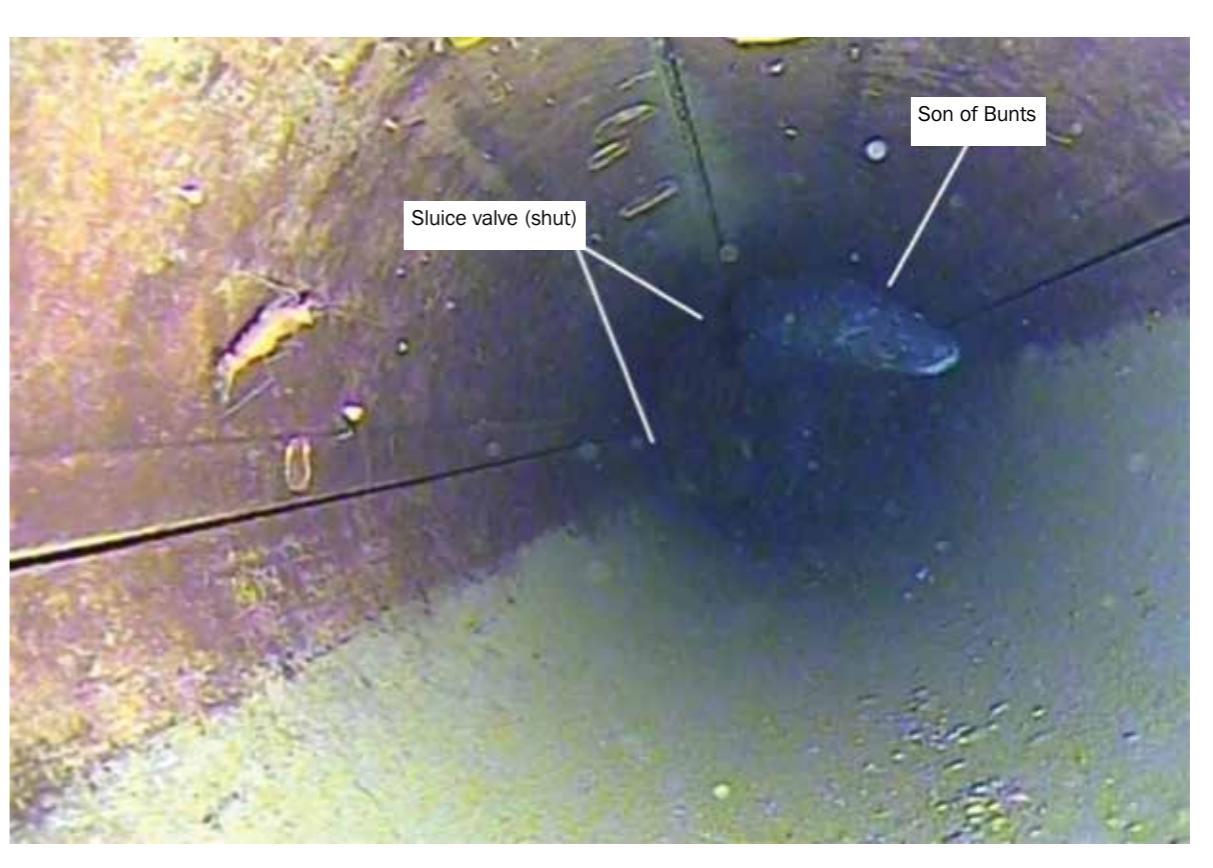
Having the stern cap open provided the opportunity to sight the sluice valve, located some 1.9 metres into the tube. This was successfully done, despite it being diligently guarded by a large eel.

Figure 29 – Inside the stern tube. Image courtesy of Paul G Allen, Find AE1, Australian National Maritime Museum and Curtin University. © Navigea Ltd

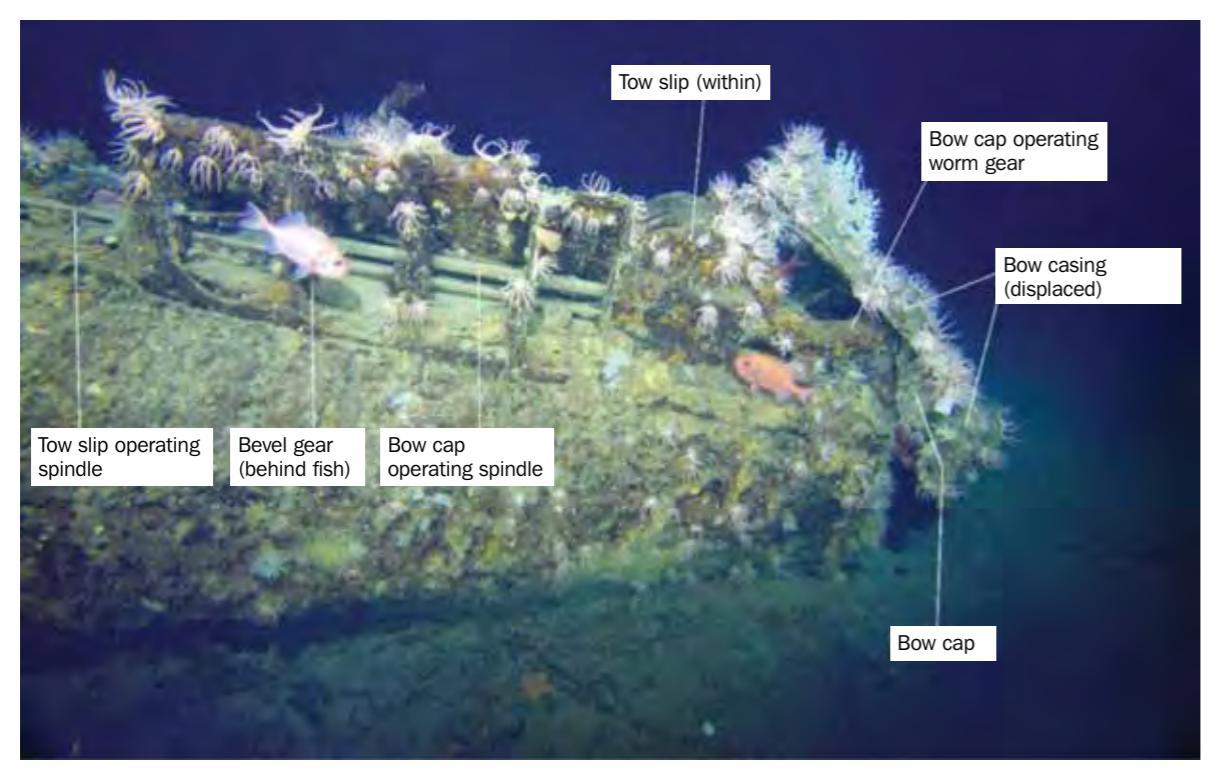
- The forward torpedo tube outer door (bow cap) is open by some 20-25 degrees.
- The forward casing has slumped forward and down over the bow cap and can be confused with the bow cap itself, presenting a confusing perspective from some aspects.
- The forward tube rear door is exposed in the imploded forends area, allowing inspection of the rear door and the operating handwheels (see Figures 4, 30 and 31).
- Three of the four rear door retaining butterfly clips (4, 8 and 11 o'clock) have been dislodged. The fourth is obscured.
- The bow cap operating handwheel has been badly distorted downwards.
- The sluice valve operating handwheel has been dislodged but appears intact.
- Access to inspect the tube sluice valve was prevented by the narrow opening of the bow cap and the slumped casing.

The bow cap operating mechanism is similar to that of the stern tube, being a worm gear actuator operated by rod linkage which passes through two bevel gear actuators, all operated by a handwheel located to port of the rear door. The linkage is protected by the forward casing, which is now badly damaged through a combination of collapse and corrosion. The operating handwheel has been subjected to strong downward forces, presumably the consequence of the implosion.

Figure 30 - Forward torpedo tube. Image courtesy of Paul G Allen, Find AE1, Australian National Maritime Museum and Curtin University. © Navigea Ltd

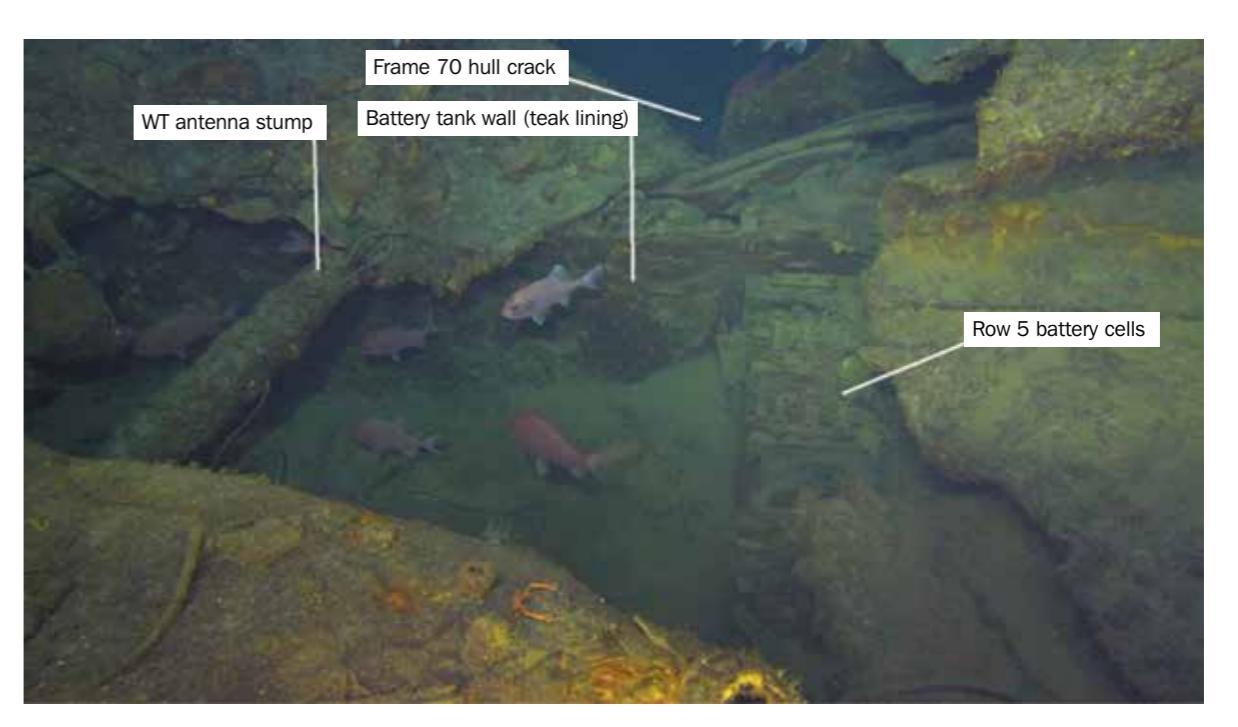
The pressure hull has experienced a major rupture at Frame 70. This is visible in Figure 32 but also in Figure 6 (starboard side internal) and Figure 33 (port side internal). The crack appears to have opened by 1–3 degrees and has allowed the pressure hull forward of this area to have settled somewhat lower than if the hull were complete.

It was a surprise to find that much of that area is now fully open. The deck and its canvas cover have gone and a row of battery cells (row 5 counting from forward) has been exposed at the forward end of the battery tank (see Figures 6 and 33). One cell from row 6 is visible under the collapsed pressure hull on the outermost starboard side. The curiosity is that the remainder of rows 6 and aft are not visible. Instead, there is an apparently level area of sediment placed some 0.4 metres lower than the top of the battery cells of row 5. In Figure 33 the battery tank's teak wall (port side) can be seen extending aft from row 5. The height of the wall edge above row 5 is as per the drawings at around 0.2 metres. This suggests that the entire battery from row 6 aft has slumped by around 0.4 metres to provide a level area which has then been subject to sedimentation.

For interest, the upper section of the WT antenna stump has fallen into the battery tank void and is visible in Figure 33.

Figure 33 – Battery tank from starboard. Image courtesy of Paul G Allen, Find AE1, Australian National Maritime Museum and Curtin University. © Navigea Ltd

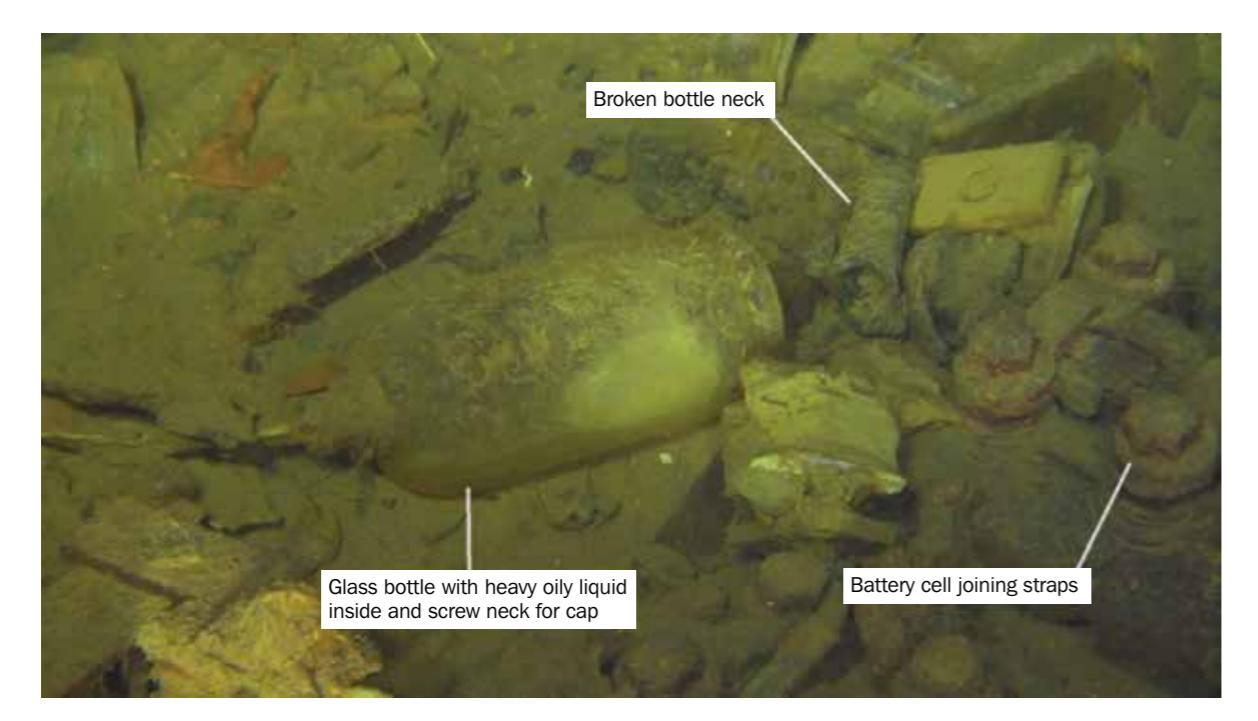
It may also be noted (Figure 34) that there is what appears to be a screw-top bottle, missing its top but containing the residue of a heavy straw-coloured liquid, located on the debris above row 4 of the battery. Next to it is the broken neck of another glass bottle. To the left of the bottle is a square cornered piece of (probably) teak, which could be a remnant piece of furniture. Row 4 of the battery is directly beneath the after end of the officers' quarters. It is reasonable to assume that these items fell to their current position from the writing desk or the wardroom table. It is a delightfully curious coincidence that this, the only real 'human' artefact observed in the wreck, is a drink-related item located in exactly the same position as the port decanter found in the wreck of HMAS *AE2*.

Figure 34 – Bottle located on row 4 battery. Image courtesy of Paul G Allen, Find AE1, Australian National Maritime Museum and Curtin University. © Navigea Ltd

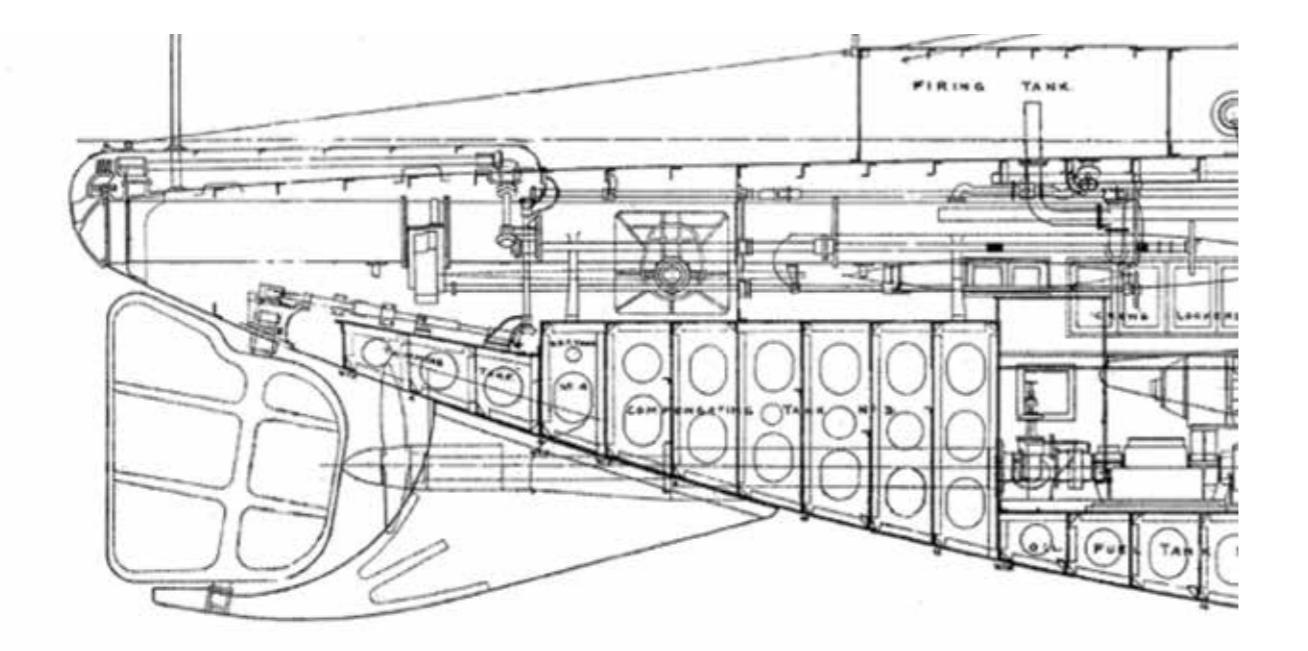
Figure 35 – Extract from general arrangement to show rudder and skeg.

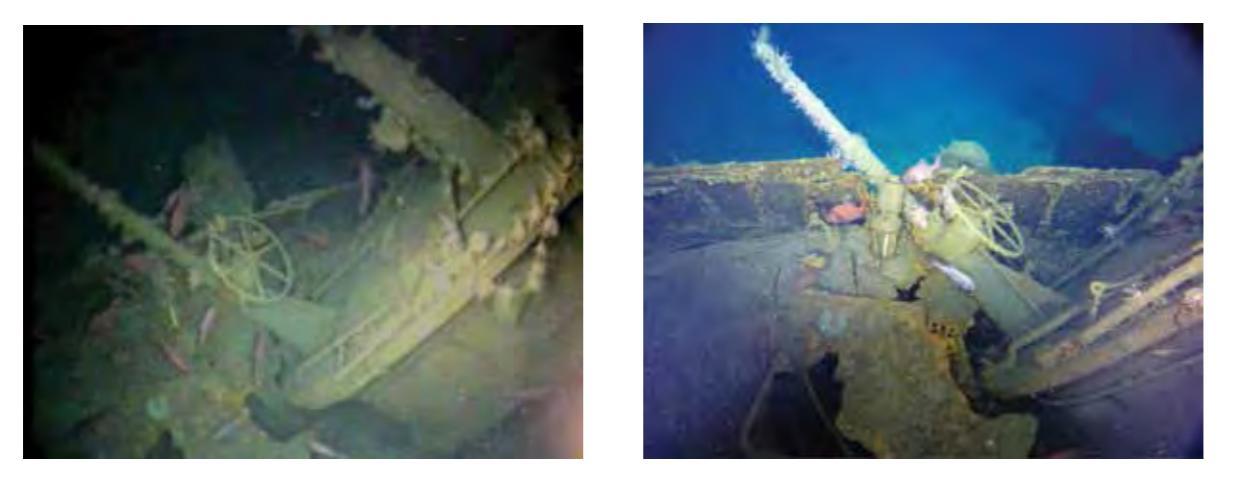
The combination of the submarine striking the seabed aft then falling onto its keel conspired with the momentum of the fin itself to cause it to begin its topple into the imploded control room.

By how much it moved at that stage cannot be estimated but the movement has certainly continued, presumably as a consequence of the pressure hull softening with the subsequent corrosion. Indeed, it is quite possible that the fin did not begin to topple until some time (possibly decades) after the sinking and did so only after its supporting flange and pressure hull had lost strength due to corrosion.

Figure 37 – Comparison of fin angle from Fugro image (L) to Petrel image (R). Images courtesy of Paul G Allen, Find AE1, Australian National Maritime Museum and Curtin University. © Navigea Ltd

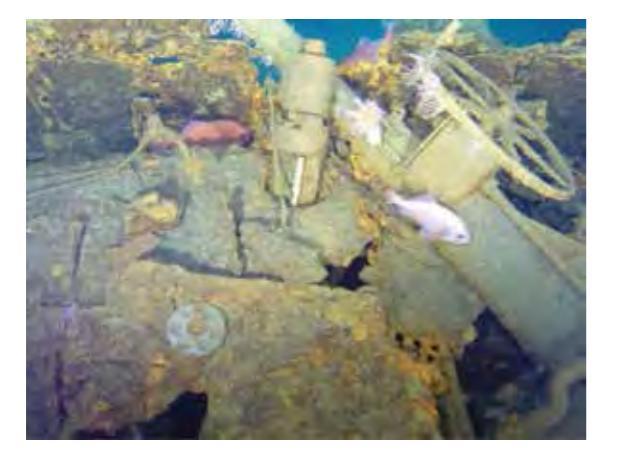
The Fugro imagery revealed that there were certainly two, and possibly three, metallic discs resting on the pressure hull at different points. There was some conjecture as to where they had come from and how they had got to where they were. The Petrel imagery revealed that there are in fact six such discs, listed as follows:

- MD1, located at Frame 65 lying on the pressure hull by the WT stump
- MD2, located at Frame 56 lying on the port pressure hull/saddle tank join adjacent to a flanged hull opening.

Figure 38 – Mystery discs 1 and 2. Images courtesy of Paul G Allen, Find AE1, Australian National Maritime Museum and Curtin University. © Navigea Ltd

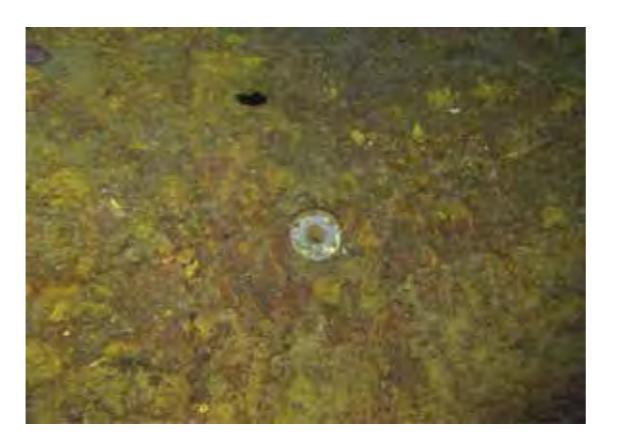
Figure 39 – Mystery discs 3 and 4. Images courtesy of Paul G Allen, Find AE1, Australian National Maritime Museum and Curtin University. © Navigea Ltd

- MD3, located at Frame 54 lying on starboard saddle tank abeam vent trunk
- MD4, located at Frame 75 lying on starboard pressure hull by the windlass.

MD4 is located further forward and immediately over the starboard bilge pump, suggesting that it is the bilge pump high-level discharge outlet (Figure 42).

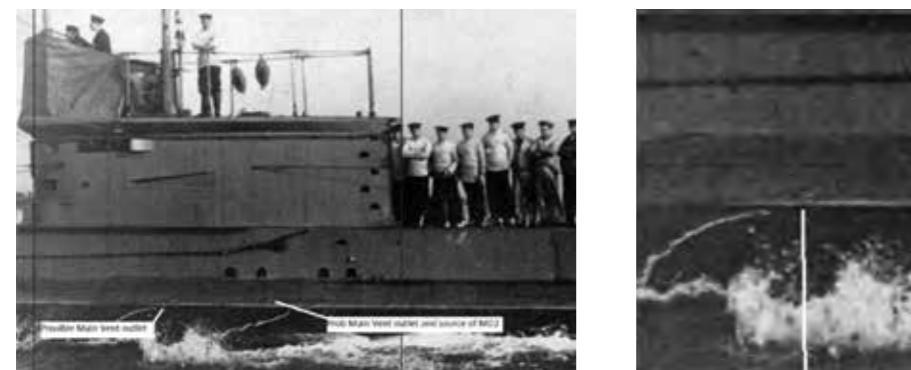
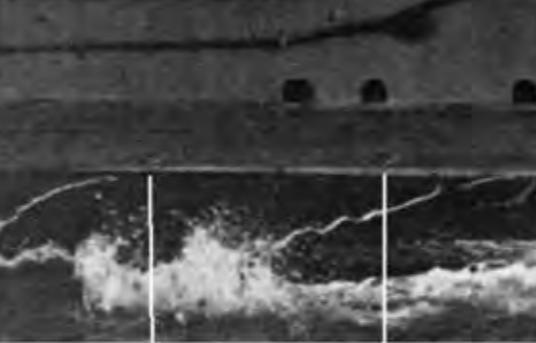
Figure 41 – External view showing No. 2 and No. 4 main vent hull pads

A possible solution to this puzzle emerged from the image of AE1 showing two hull pads mounted on the pressure hull in the vicinity of the fin in a position where we could expect to see the main vent outlets. Based on its location we can propose that MD2 is the outlet for No. 4 main vent. The gasket appears to have fallen from the flanged outlet, probably as a consequence of the securing bolts having corroded. The general arrangement drawings show that No. 3 and No. 4 main vent outlets discharge to short pipe sections under the casing, the former being adjacent to the ship's ventilation valve. If this were the case it would be visible in Figures 24 and 25, whereas it cannot be found in any of the images of that area. This supports the possibility that the design had changed and that the main vents were routed direct to outlet hull pads in the pressure hull clear of the casing.

Prob 2 MV hull pad Prob 4 MV hull pad

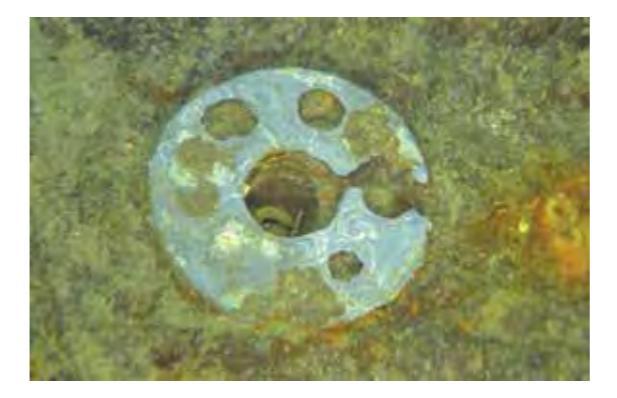
Figure 42 Mystery discs 4 (L) and 6 (R) (close-up). Note the recess behind MD4, suggesting that it is a pipe outlet. Images courtesy of Paul G Allen, Find AE1, Australian National Maritime Museum and Curtin University. © Navigea Ltd

One possible explanation is that some parts of a high-pressure air system remained pressurised at the time of the bottom impact. That part then failed, either due to rupture during the event itself or due to subsequent corrosion. As the system failed, the gasket was freed while at the same time the escaping high pressure air blew it out of the wreck from where it fell to its current position. A possible candidate for such an event for MD6 is the forward torpedo firing air system bottles located nearby.

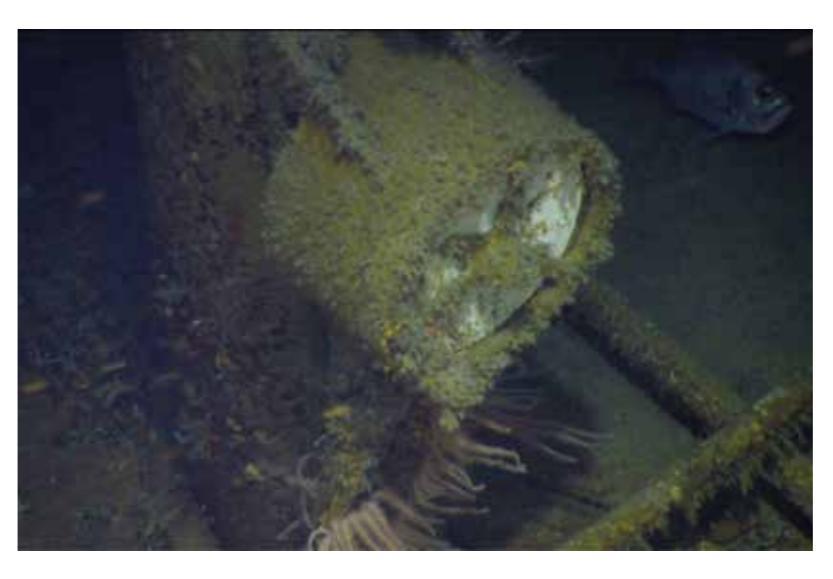
The bridge telegraph in AE1 (Figure 43) appears to have a broad arrow aligned at about 10 o'clock. There may also be a second broad arrow aligned at 12 o'clock. There are three external strengthening webs at 12, 4 and 8 o'clock.

Figure 43 – Engine room telegraph – bridge transmitter. Image courtesy of Paul G Allen, Find AE1, Australian National Maritime Museum and Curtin University. © Navigea Ltd

The lettering on this telegraph cannot be read but from the conning tower telegraph of HMAS *AE2* and the build photographs of a later (unidentified) E-Class, we can conclude that *AE1*'s bridge telegraph is acknowledging an order for half-astern.

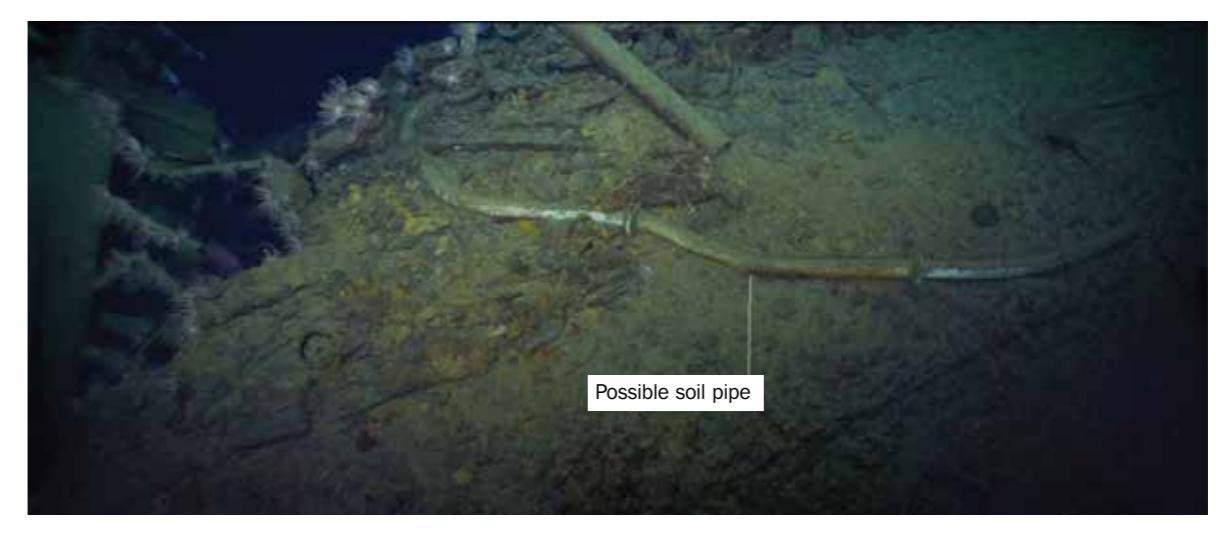
- Flanged entry (white), with remains of a metal gasket (also white) possibly signs of another pipe having been inserted
- Three 2-metre lengths of ~4-inch pipe joined by two flanged joints from which the bolts are missing. Upper section may be a little longer
- No flange on the lower end (open discharge)
- White where the surface is exposed. Some sediment on upper surface
- Appears to have shaped curves in first pipe section (that is, not a straight run).

Figure 45 – Possible soil pipe located by ventilation trunking. Image courtesy of Paul G Allen, Find AE1, Australian National Maritime Museum and Curtin University. © Navigea Ltd

The colour and state of preservation of the pipe suggest that it is made of lead, which was typically used in soil pipework.

The location of the upper-end flange is close to the ventilation system hull valves and directly under the fin WC. Close to it are the blue and white pottery shards which are assumed to be the remains of the fin WC. One possible explanation for the pipe is that the fin WC (shown on the general arrangement drawing as being a simple bucket and seat) had in fact been replaced with a ceramic pan and lead soil pipe. The pipe had been led below the casing such that it would drain directly into the sea.

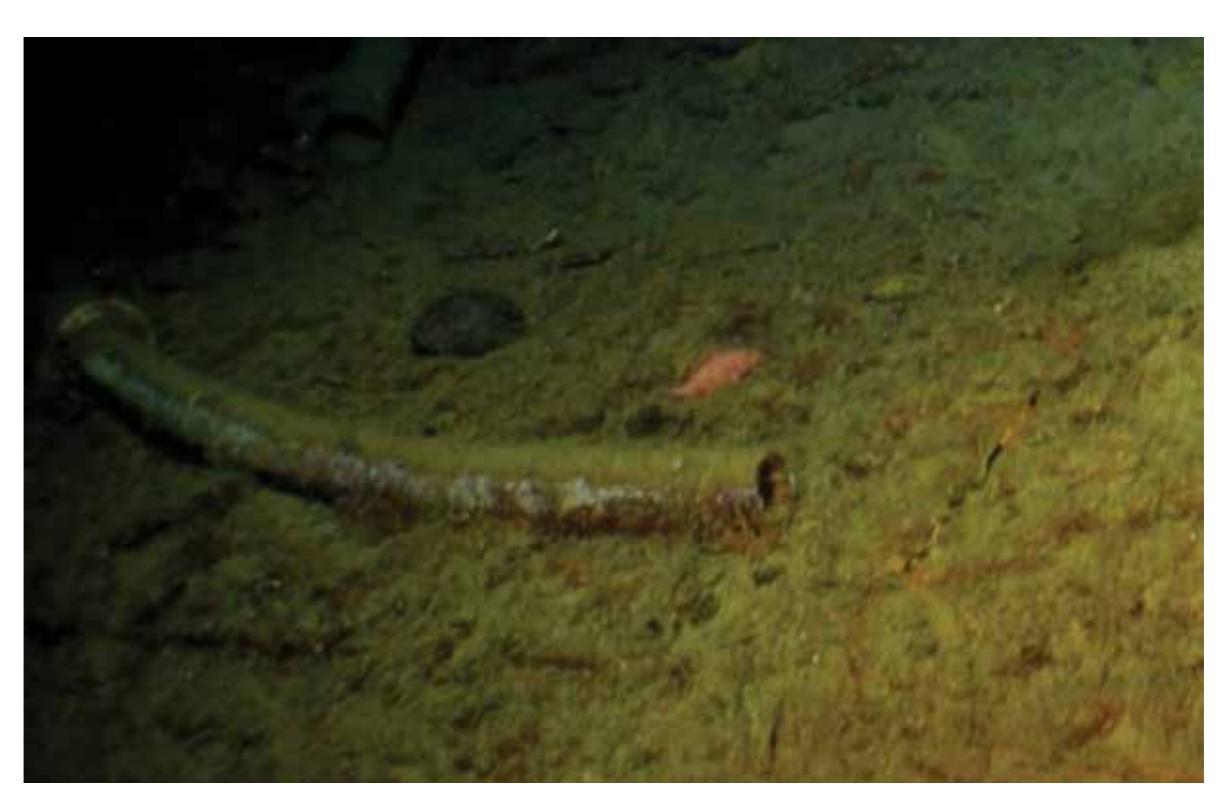
Figure 46 – Possible soil pipe flanged upper opening (L – the other flange is a battery ventilation inlet) and (R) open-ended outlet. Image courtesy of Paul G Allen, Find AE1, Australian National Maritime Museum and Curtin University. © Navigea Ltd

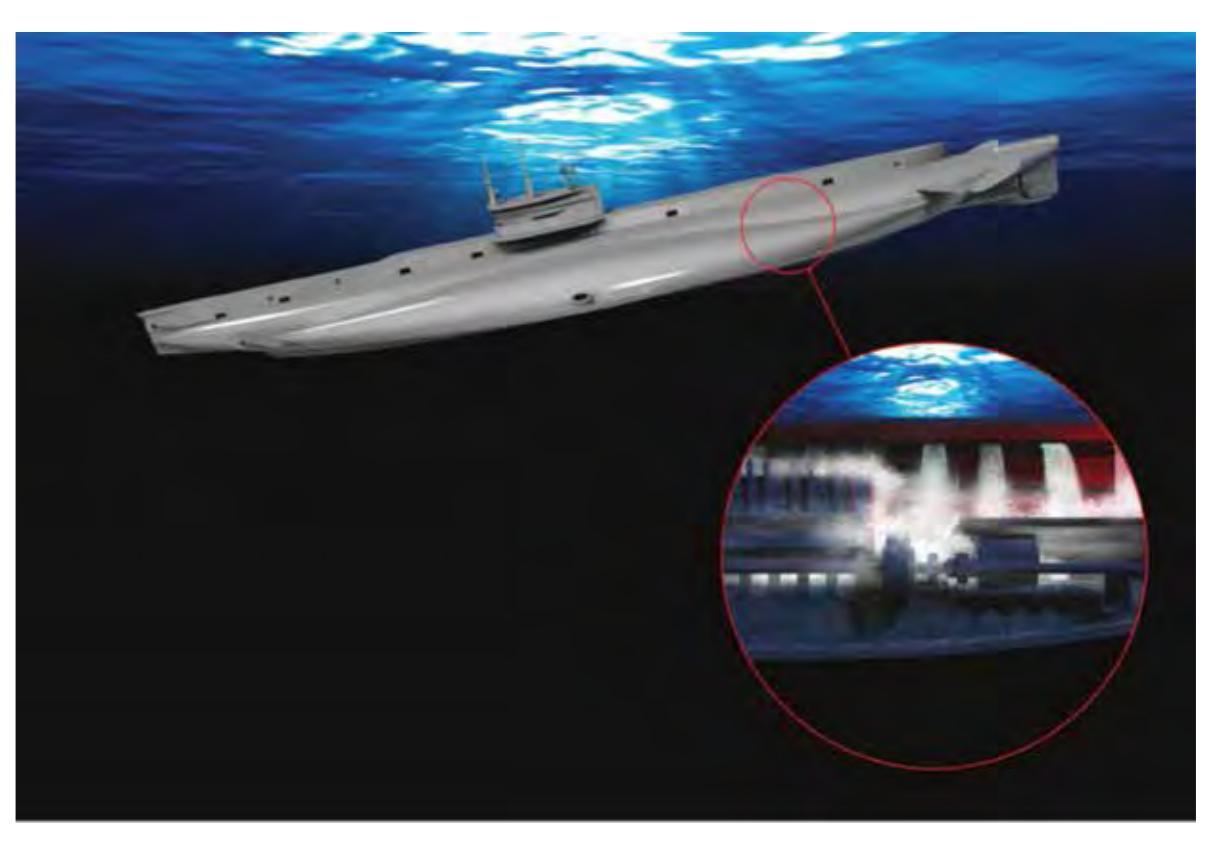
Figure 51 - AE1 diving at or near periscope depth suffers a flood, resulting in loss of buoyancy and trim. Image courtesy of Paul G Allen, Find AE1, Australian National Maritime Museum and Curtin University. © Navigea Ltd

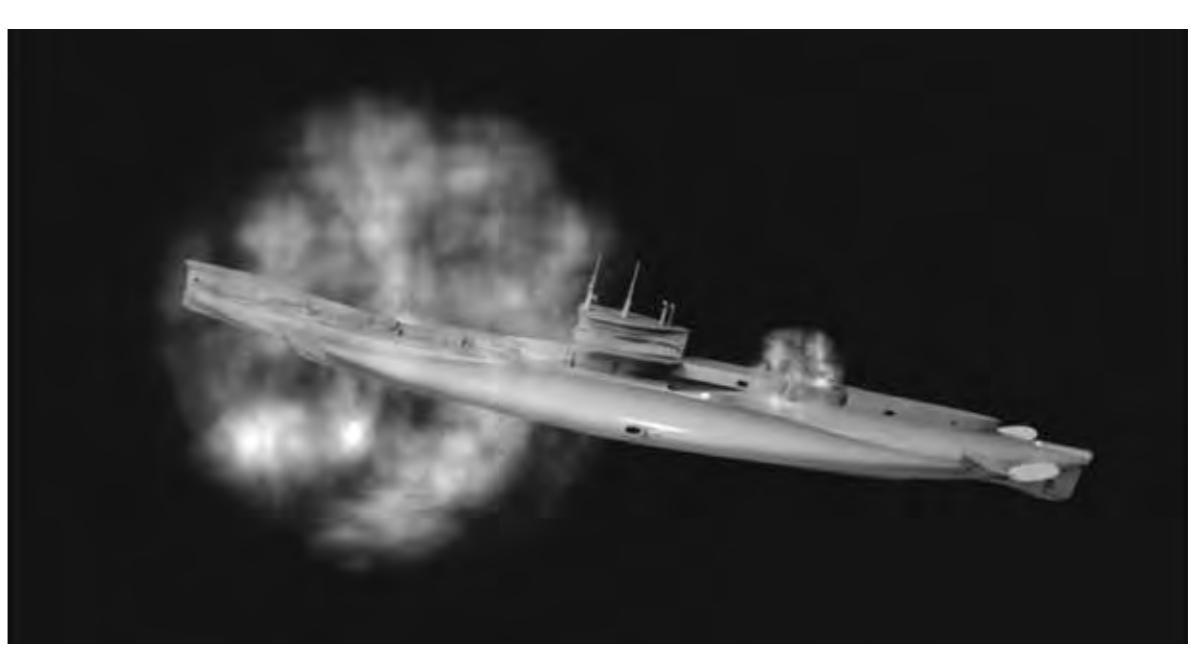
The shock wave blows off the engine room hatch. Image courtesy of Paul G Allen, Find AE1, Australian National Maritime Museum and Curtin University. © Navigea Ltd

Figure 52 – Unable to recover, she carries on down until reaching crush depth when the control room and forward area implodes.

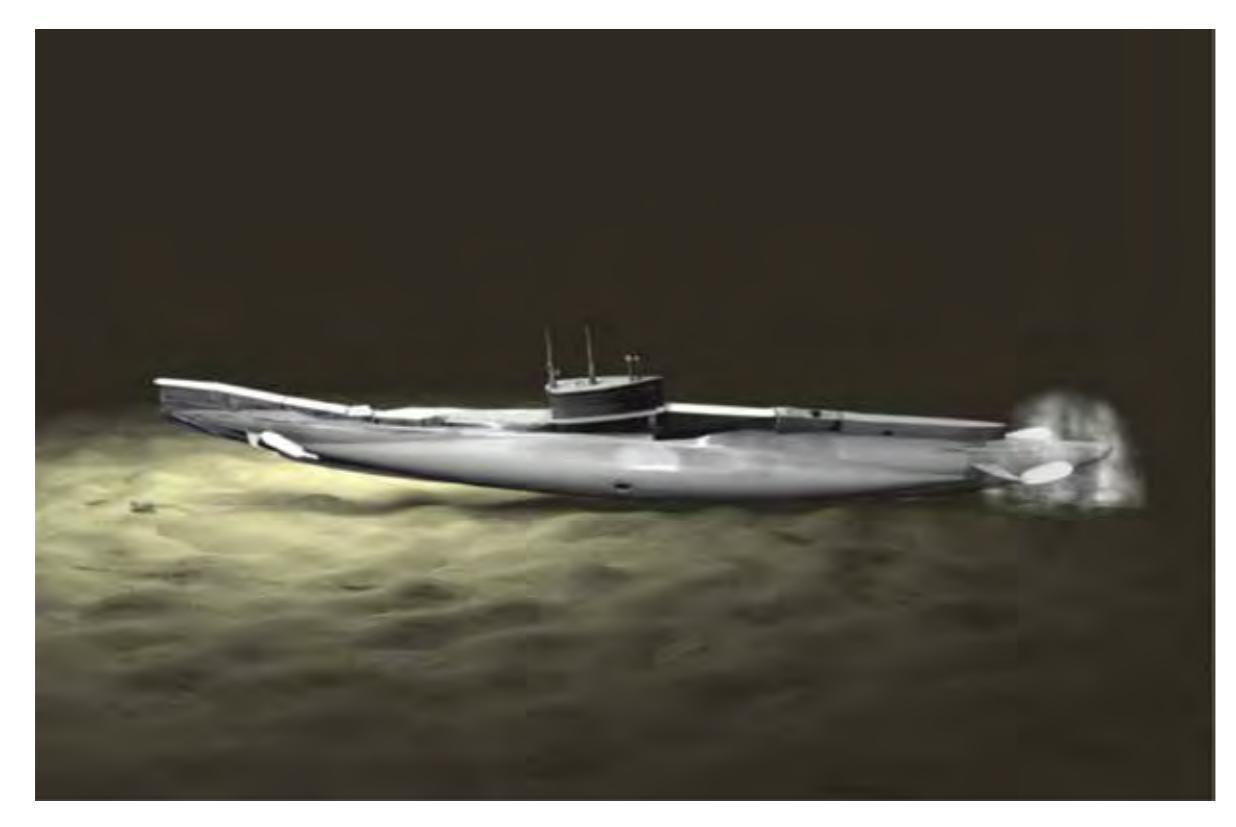
Figure 53 – AE1 continues down, gathering way until she strikes bottom at a bow-up angle of 3–7 degrees, impacting on the rudder and skeg.

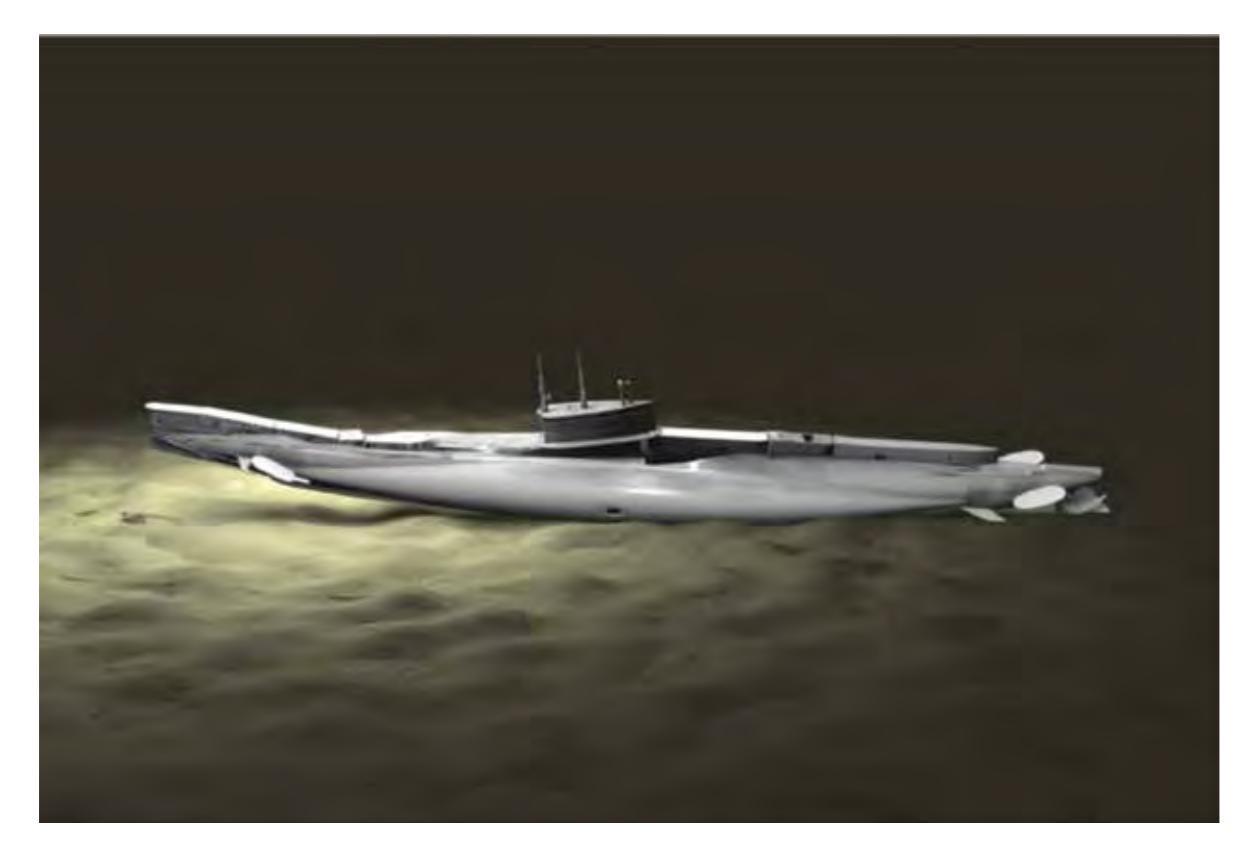
Figure 54 – The skeg and rudder collapse and a second impact occurs on the after end of the keel. Image courtesy of Paul G Allen, Find AE1, Australian National Maritime Museum and Curtin University. © Navigea Ltd

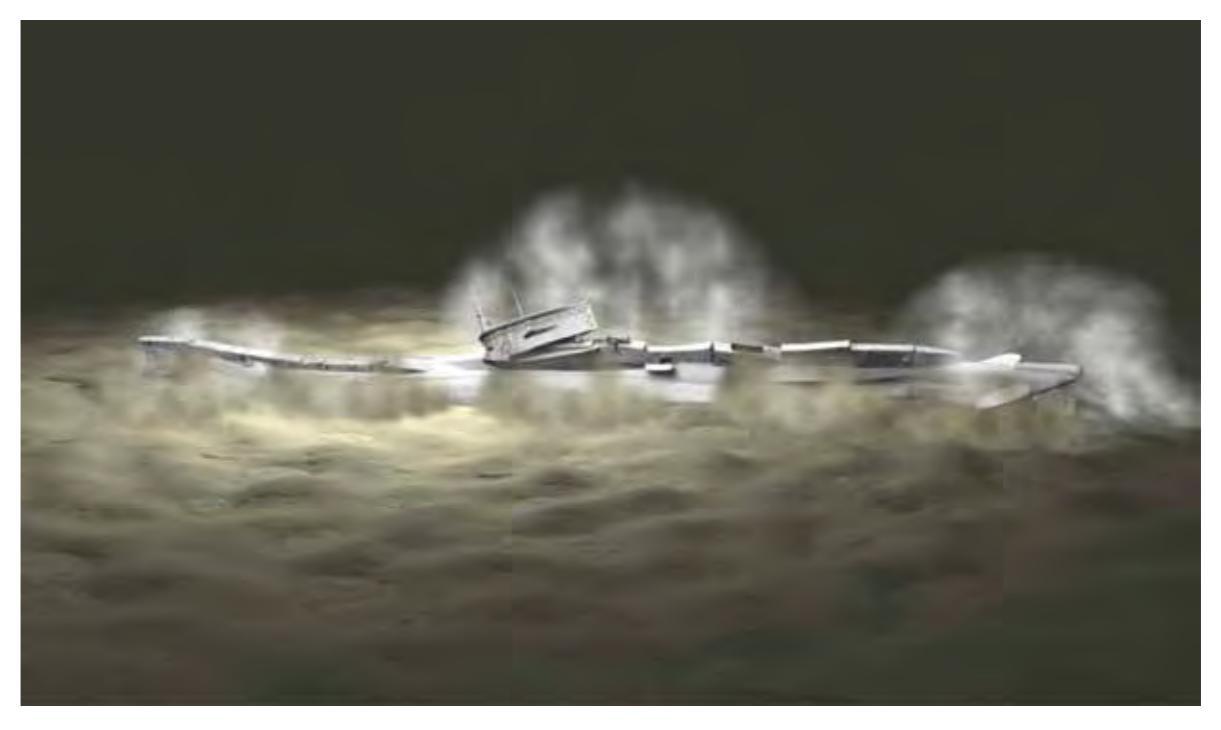
Figure 55 – The hull falls onto its keel, resulting in a third wave of damage, including dislodgement of the hydroplanes and initial dislodgement of the fin. Image courtesy of Paul G Allen, Find AE1, Australian National Maritime Museum and Curtin University. © Navigea Ltd

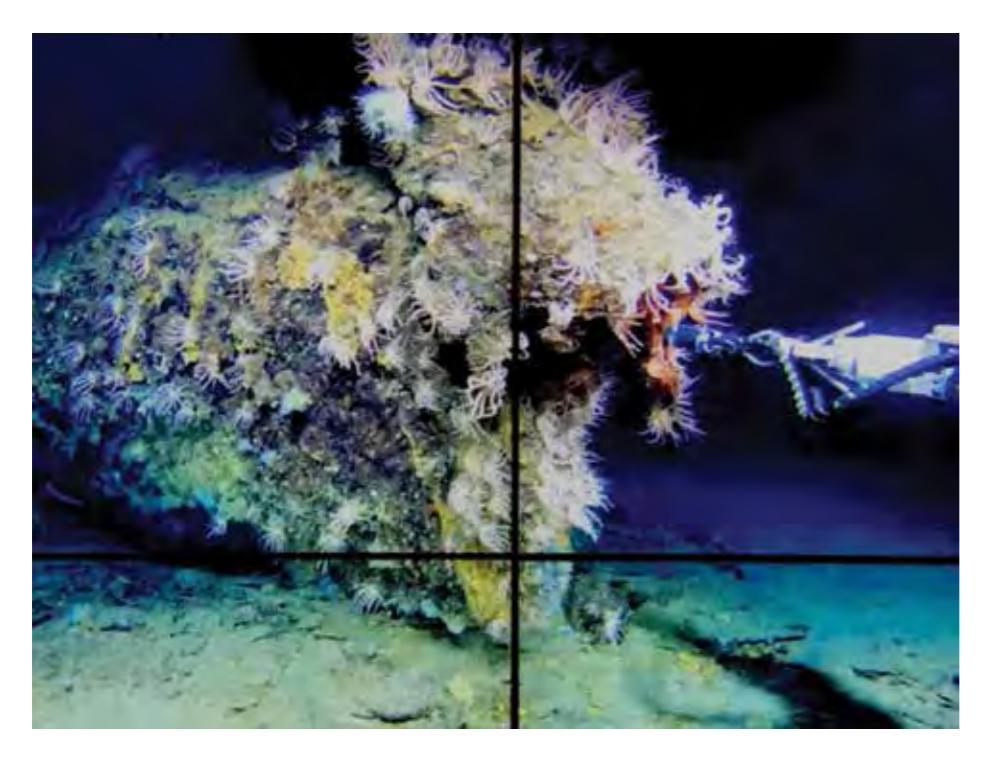
It was noted that the colonisation by anemones was much more intense on both the bow and stern caps than in all other locations on the shipwreck site. Similar localised colonisation processes were viewed on the HSK Kormoran (1943) wreck compared with the HMAS Sydney II and this is most likely due to the higher phosphorus impurities in the Kormoran mild steel which would have been using less than military specifications for the alloys used in its construction (MacLeod and McCarthy 2016). Under the cover of corrosion products from the oxidation of the metallic iron a suite of anaerobic bacteria converts inorganic iron phosphide (Fe₃P) inclusions present as the eutectic phase steadite. Because of their metabolic activity bacteria convert the inorganic metallographic phase into volatile phosphines which promote marine growth, since phosphorus is normally a limiting agent to growth of marine organisms, particularly in the darkness of deep ocean waters (MacLeod 1988).

Figure 3 - Image of the bow cap with prolific marine growth from dive 90. The black horizontal and vertical lines that appear in most of the images are because they were photographed off the high-resolution tiled display at the Curtin University HIVE visualisation facility. Image courtesy of Paul G Allen, Find AE1 Ltd, Australian National Maritime Museum and Curtin University. © Navigea Ltd

The reason why there is much greater growth of the brisingids on the bow and stern caps is due to their different composition, as they are most likely cast iron elements or cast steel which has a richer phosphorus impurity level in it than the plates used in the construction of the casing, the ballast tanks and the pressure hull itself. Under the bow section there appears to be some scouring loss of the seabed, which is consistent with local water movement being associated with the current experiencing resistance from the structure.

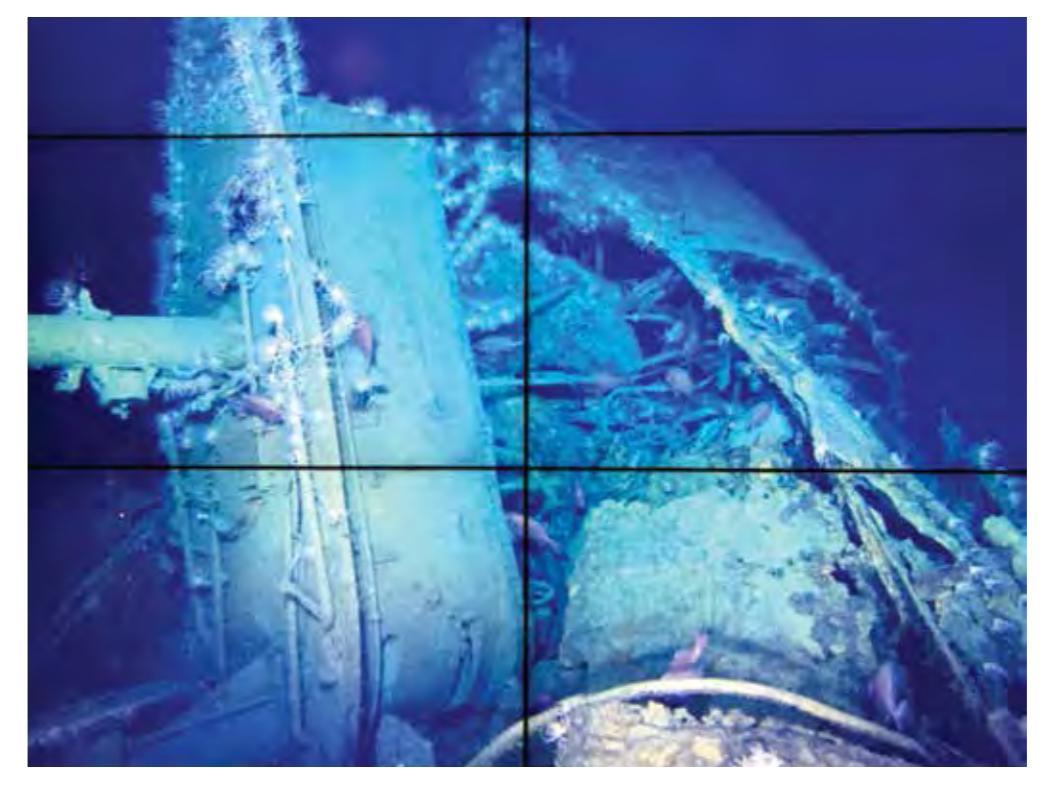
Figure 9 – Image 91-76913, showing fin free of marine concretion and a section of the pressure hull. Image courtesy of Paul G Allen, Find AE1 Ltd, Australian National Maritime Museum and Curtin University. © Navigea Ltd

The pressure hull at the maximum diameter of the submarine was made of 20-pound plate and an inspection of the corrosion data calculations in Table 2 indicates that even with galvanic coupling due to contact with the manganese bronze of the fin (60% Cu, 37% Zn, 2% Mn and 1% Sn) there is still about 5.6 mm of solid metal present in the pressure hull. The image 91-76913 (Figure 9) shows the well-defined remnant hull structure in the immediate vicinity of the fin. Although the residual metal represents a 45% loss of metal thickness since the submarine sank, there is still sufficient metal present to enable the form of the submarine to be maintained. These estimates of corrosion are based on 16-year experiments on various metal couples using a noble metal to iron ratio of \sim 1:7 (Zheng 2011). Naturally, corrosion issues will be exacerbated by the high current flowing through the site, but the data provide a guide to what can reasonably be expected to survive. Where galvanic corrosion is present the negative values for residual metal thickness shown in Table 2 simply mean that all the metal has corroded away, so in the worst-case scenario of galvanic corrosion any plate thickness less than 12.5 pounds per square inch is unlikely to be present. In addition, local effects (galvanic, microbial or both) could add to the rate of deterioration. Since there is no active concretion mechanism operating on the site, the once solid elements will be corroded away and removed by the current to feed the fishes.
