Research Vessel Petrel Baseline Survey of HMAS AE1

April 2018

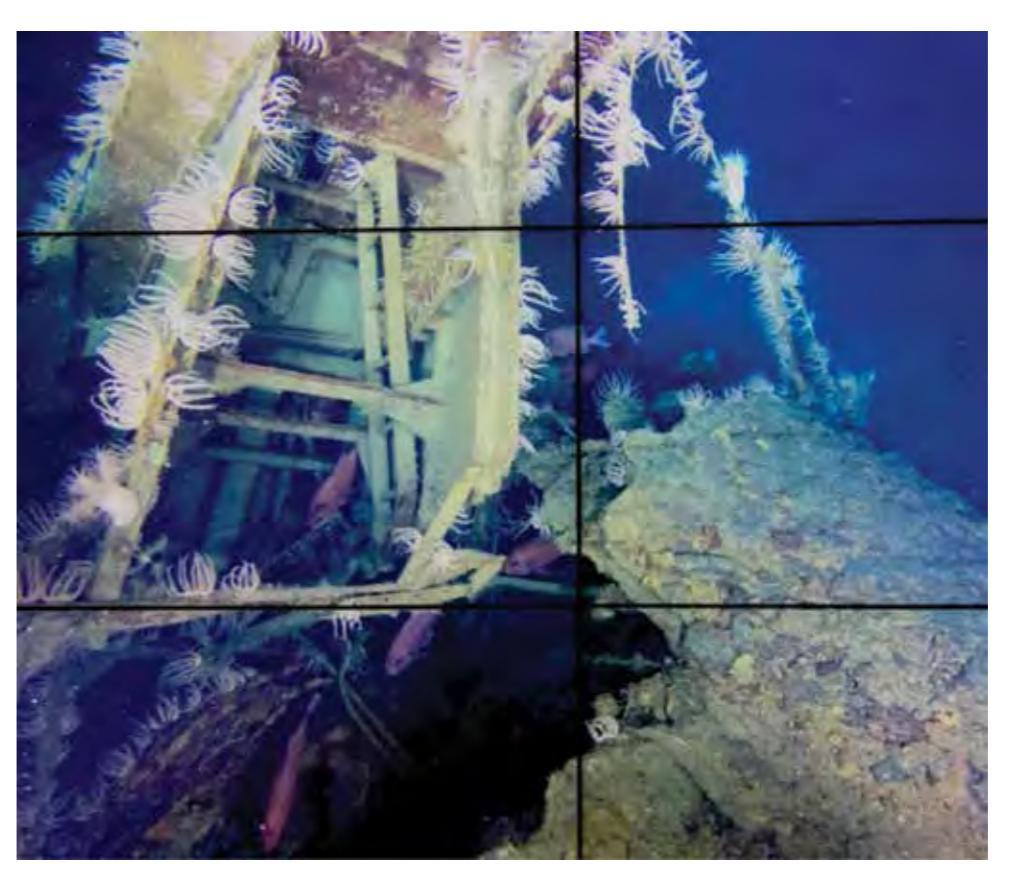
On inspection of the image 91-77813 shown in Figure 10 it was noted that there is essentially no living organism on the flat smooth surfaces of the fin, which appears to be sitting in an almost pristine condition on the wreck site. However, at the leading edges of the structure and on piping leading from the fin there is localised colonisation of the surface with the endemic marine organisms. Given that marine bacteria regularly utilise cycling of manganese ions in their metabolic processes it is likely that the marine organisms are utilising surface corrosion products to enhance their microenvironment. Thus, the enhanced growth on the edges of the fin and its fittings is likely to be due to marine organisms capitalising on the energy source associated with manganese, rather than with phosphorus as is likely on the bow and stern caps. Just as the localised increase in marine activity on the stern and bow caps was viewed as being a response to the release of phosphorus-containing species, resulting from anaerobic metabolic activity (Iversen and Olson 1983), so too the voltage gradient at the sharp edges is sufficient to bring about a subtle change in the corrosion microenvironment. Although the voltage of the fin will be the same throughout the structure, the voltage gradient in terms of the charge distribution is always higher at sharp edges. These differences are clearly enough to provide a niche environment for the colonising organisms. Within the biofilm on the fin's surface there will be a niche microenvironment for the anaerobic bacteria to mobilise the phosphorus in the copper alloy.

Figure 10 – Image 91-77813, showing ladder inside fin and marine organisms on leading edges of the structure. Image courtesy of Paul G Allen, Find AE1 Ltd, Australian National Maritime Museum and Curtin University. © Navigea Ltd

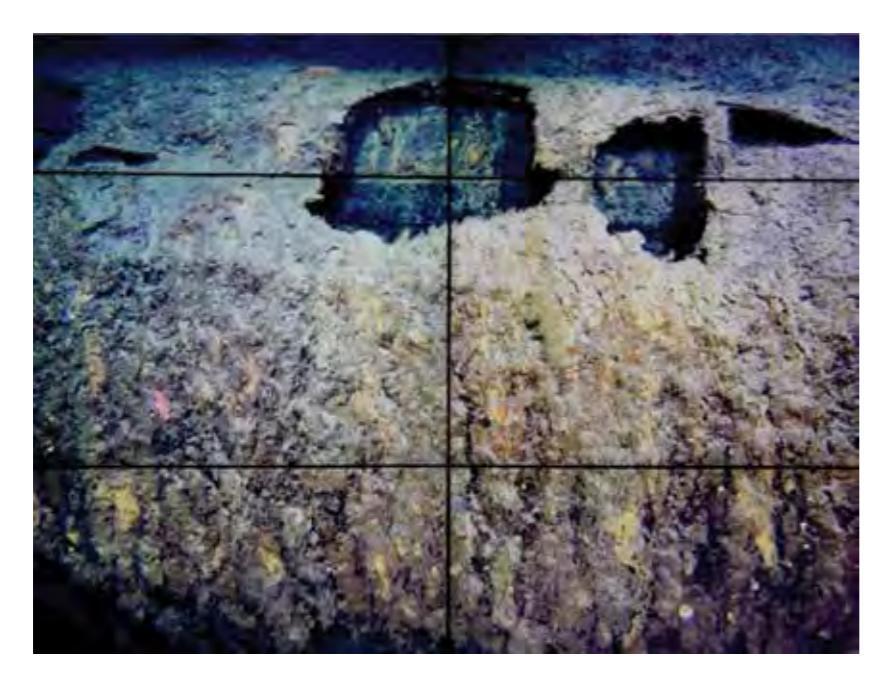
The image no 91-79170 (Figure 12) provides confirmation of the material loss of iron from the submarine in the region of the ballast tanks, which were 8.5 pound per square foot, and according to the data in Table 2, there is between -0.16 and -0.7 mm of residual metal thickness left; that is, there are large holes in the structure, which is clear. The interior image thus exposed is of the pressure hull, which is intact with a calculated residual thickness of between 5 and 5.5 mm, depending on either combination of both sides corrosion or galvanic coupling. It is important to conduct periodic monitoring, on a 5 to 10 year time frame, to monitor the decay of the residual metal structure. At present there are only two points, which are close together and only a few months apart after more than 100 years of decay in the warm, deep, tropical waters off Mioko Island. Without the data from future monitoring it will be difficult to confirm the overall conservation heritage management plan for this historic site, which forms a pivotal point of Australia's maritime heritage.

Figure 12 – Image 91-79170, showing ballast tank holes overlaying the pressure hull.

The image shown in Figure 12 illustrates the general distribution of iron corrosion products on the hull,

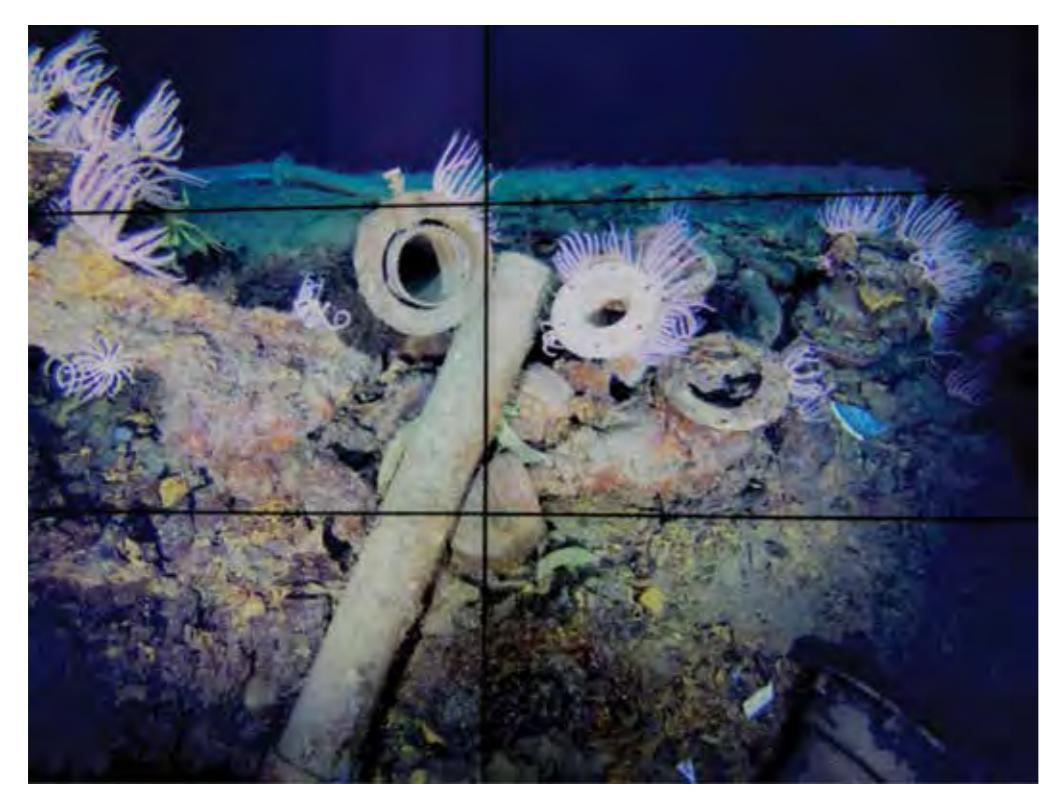
The image in Figure 15 shows three of the five ventilation trunks which once rose from their associated hull valves to their vented openings inside the after section of the fin. The bright white flanged opening has been the subject of considerable debate as to its function and purpose and where any waste material may have exited the submarine. However, some advice on the corrosion products formed on the non-ferrous metal alloys may be of assistance in managing the wreck site. It is highly likely that the piping is a lead alloy as material of this type has been used since the 1870s for removal of waste from steamships through direct porting to the external seawater. Owing to the ease of formability of lead, it was found that in a constrained physical environment the addition of antimony brought about a significant improvement in mechanical strength. The need to overcome the tendency of pure lead to creep and not to maintain its structural form is why the 12-tonne keel for the *Australia II* yacht was cast from a lead–antimony alloy (MacLeod and Kelly 2001). Assuming the colour in the image 91-76750 is reasonably accurate, the off-white patina of the pipe seen top left of the image is likely to be lead sulphate (anglesite) with some mixed lead–antimony oxides, which have a pale brown hue and have been found on 'lead sculptures' where there has been oxidation of the as-cast eutectic alloy composition (MacLeod 1991).

Figure 15 – Image 91-76750, showing debris field of ventilation trunking and flange plates probably associated with waste removal. Image courtesy of Paul G Allen, Find AE1 Ltd, Australian National Maritime Museum and Curtin University. © Navigea Ltd

It is very likely that there is a range of lead and lead-antimony alloys used in the construction of the waste removal system, which is why there is a variety of colours in the patina of the objects. When a lead alloy was being used as a flange seal for a pressure line it is likely that a lead-antimony alloy would have been used, as this will be less likely to lose its mechanical strength under tension and compression. Owing to the ease of fabrication of this system of alloys and the way in which the addition of small amounts (1-3%) of copper produces products that have a very fine surface finish, there is nothing in this image that is inconsistent with the piping and gaskets being made of various allovs in which lead was the principal component. A point of confusion as to why some gaskets appear to be made of copper may be cleared up if they were in fact made of something akin to Britannia metal, a tin-lead-antimony-copper alloy. Selective corrosion of copper can occur when the lead-rich phases have become passivated with adherent corrosion products. Some of the differences in patination are also likely to be due to galvanic coupling between iron of the submarine and the lead alloys. Although the voltage difference in flowing seawater between lead and iron is significantly less than the coupling between copper-based alloys and iron, if there had been galvanic coupling of the lead alloys it is unlikely that the impact would survive to the present times, for lead passivates quickly in seawater (MacLeod and Wozniak 1996). Lead and its corrosion products have good erosion resistance in currents up to a few knots, which is why it was used as an outer sheathing layer of copper-sheathed sailing vessels at the gripe, where the high water flow would too quickly erode the copper sheet (MacLeod and Wozniak 1997).
